FEHMARNBELT FIXED LINK HYDROGRAPHIC SERVICES (FEHY)

Marine Soil - Baseline

Coastal Morphology along Fehmarn and Lolland

E1TR0056 - Volume III

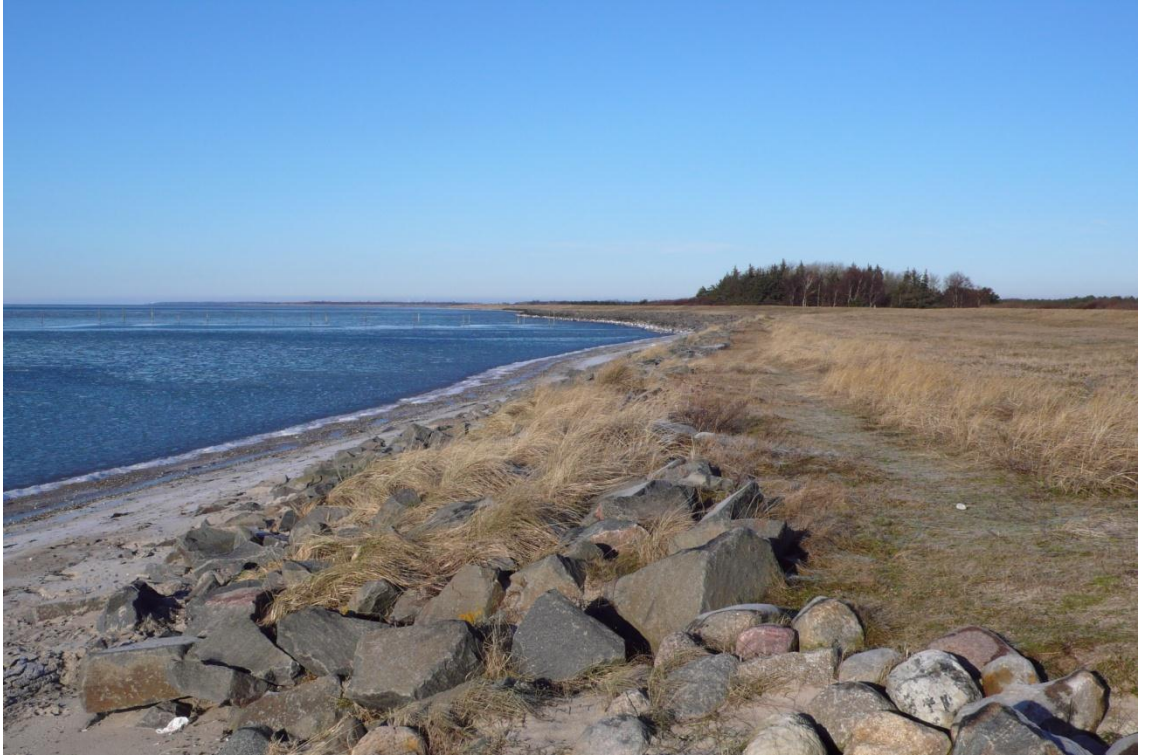
Figure 1.4 *Protected section between Skarholm and Bredfjed summerhouse village, photo taken from the west end of the village*

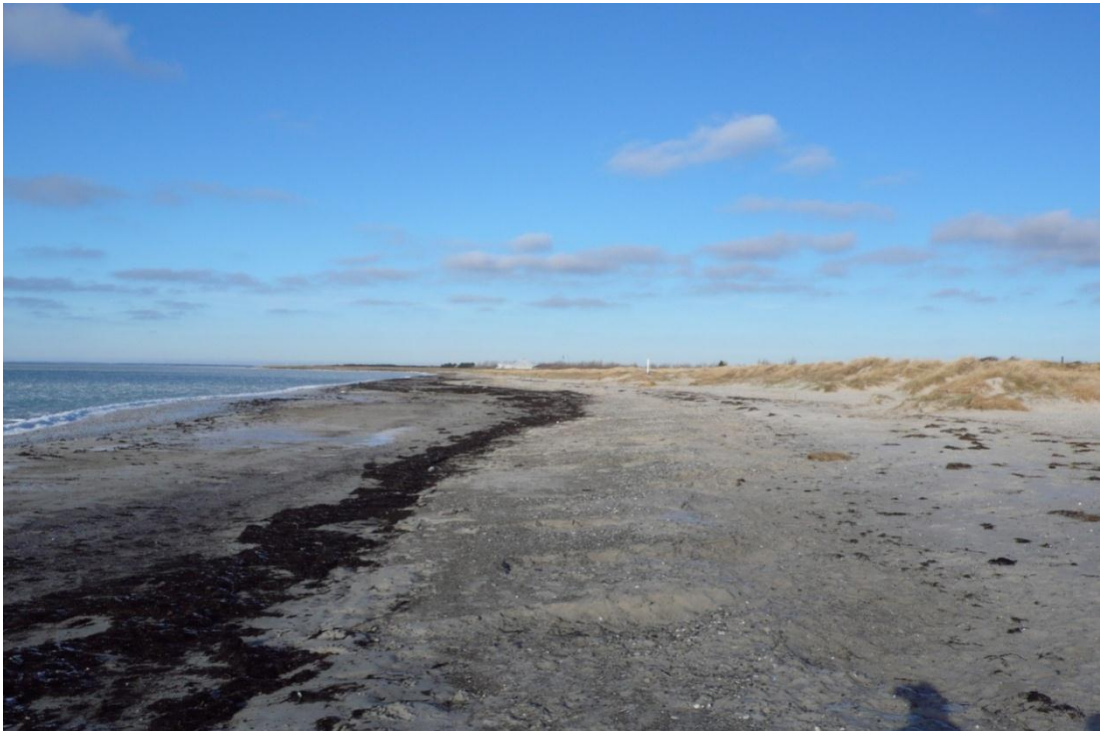
Figure 1.5 *Sand accumulation with a wide beach and dune area west of Rødbyhavn*

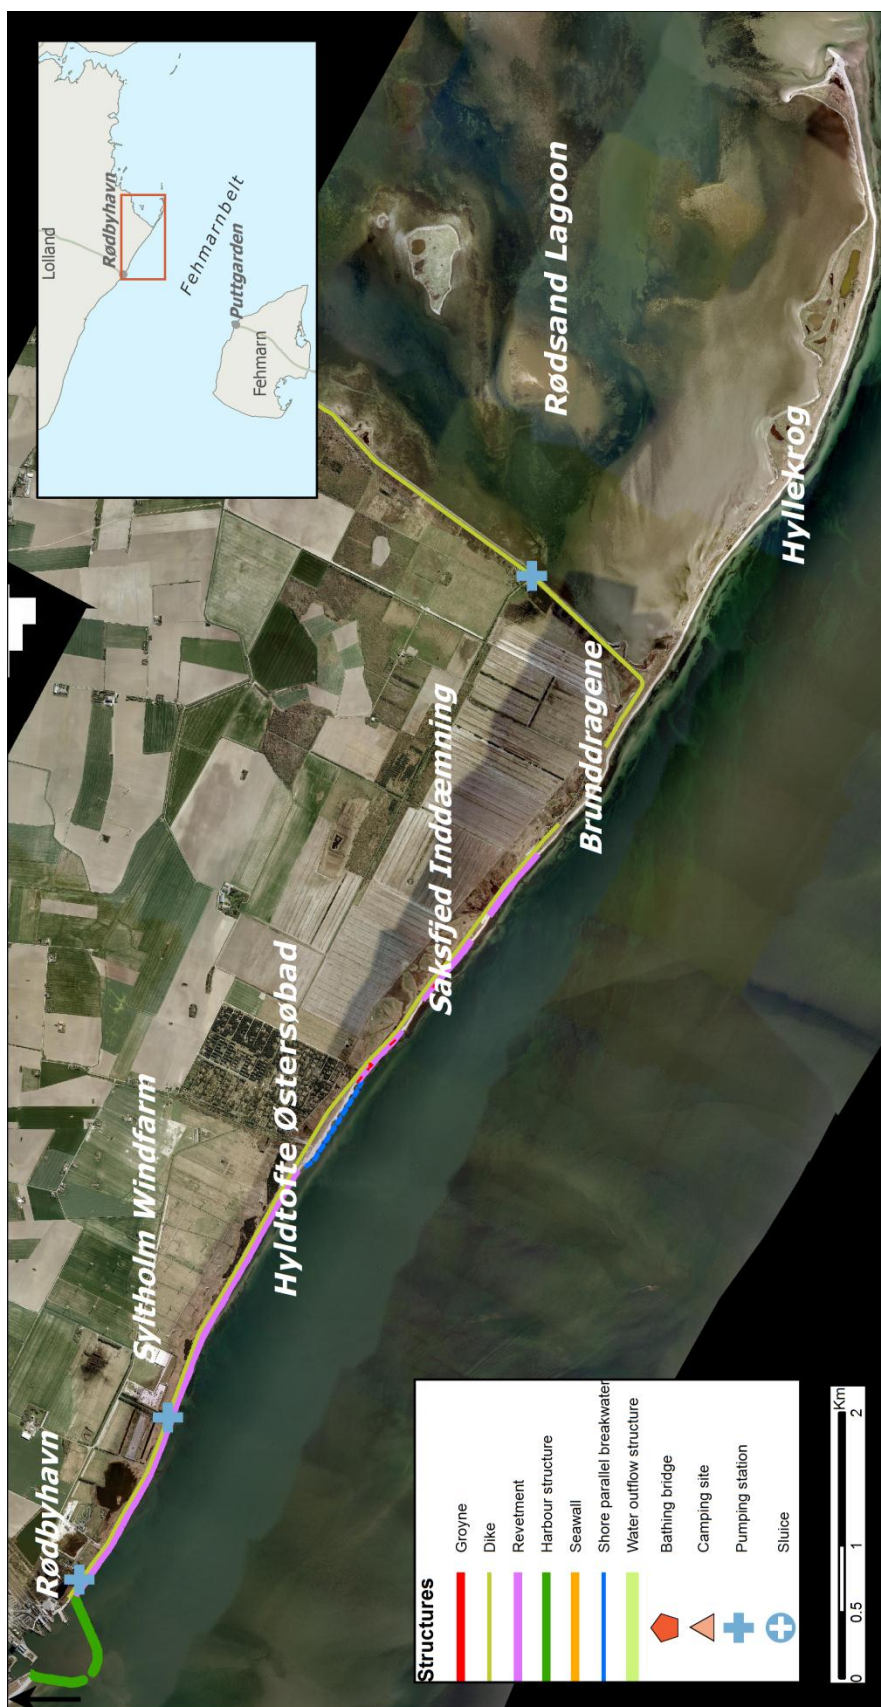
Figure 1.6 Overview of coastline and coastal structures from Rødby Ferry Harbour to Hyllekrog. Aerial photo from 2009 (©COWI Orthophoto April 2009)

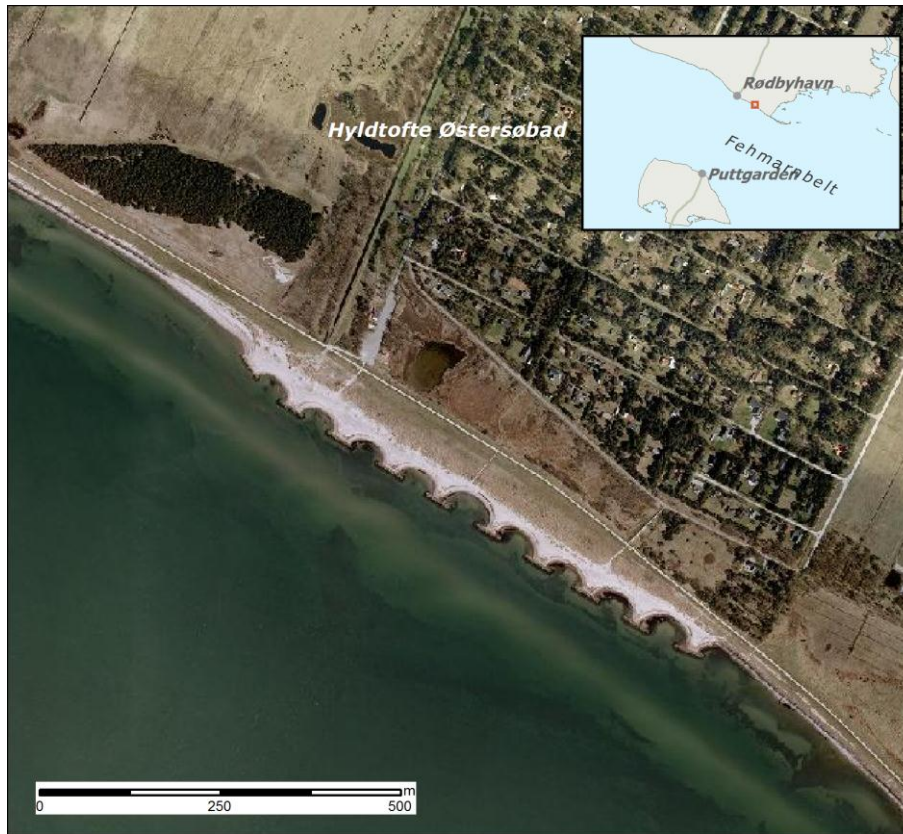
Figure 1.7 Hyldtofte Østersøbad. Aerial photo from 2009 (©COWI Orthophoto April 2009)

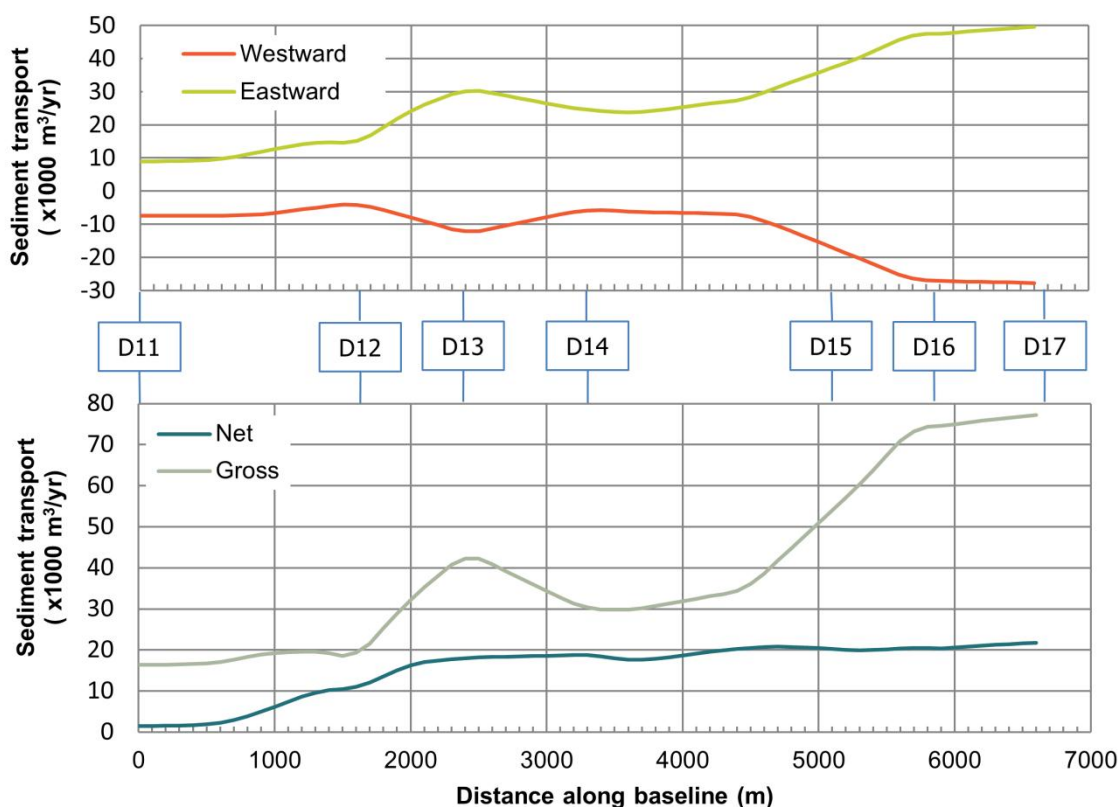
Figure 1.10 Average littoral drift transport rates east of Rødbyhavn (top figure). Middle figure: east- and west going transport conditions. Lower figures: net and gross transport rates. Aerial photo from 2009 (©COWI Orthophoto April 2009)

Further southeast of Hyldtofte Østersøbad in front of Saksfjed Inddæmning and towards Brunddragene a slightly increasing net transport rate is found causing shoreline retreat. The increase of the transport is the result of several physical mechanisms. The coast becomes more exposed to westerly and north-westerly waves as well as the south-easterly waves, which become more important. The beach orientation turns slightly anti-clockwise increasing the eastward transport rates. On the other hand, the beach gradually becomes less steep from about Hyldtofte Østersøbad and eastwards. The littoral drift decreases for decreasing profile steepness. The gross transport rates increase from about 15,000 m³/year at the harbour to about 80,000 m³/year off Brunddragene.

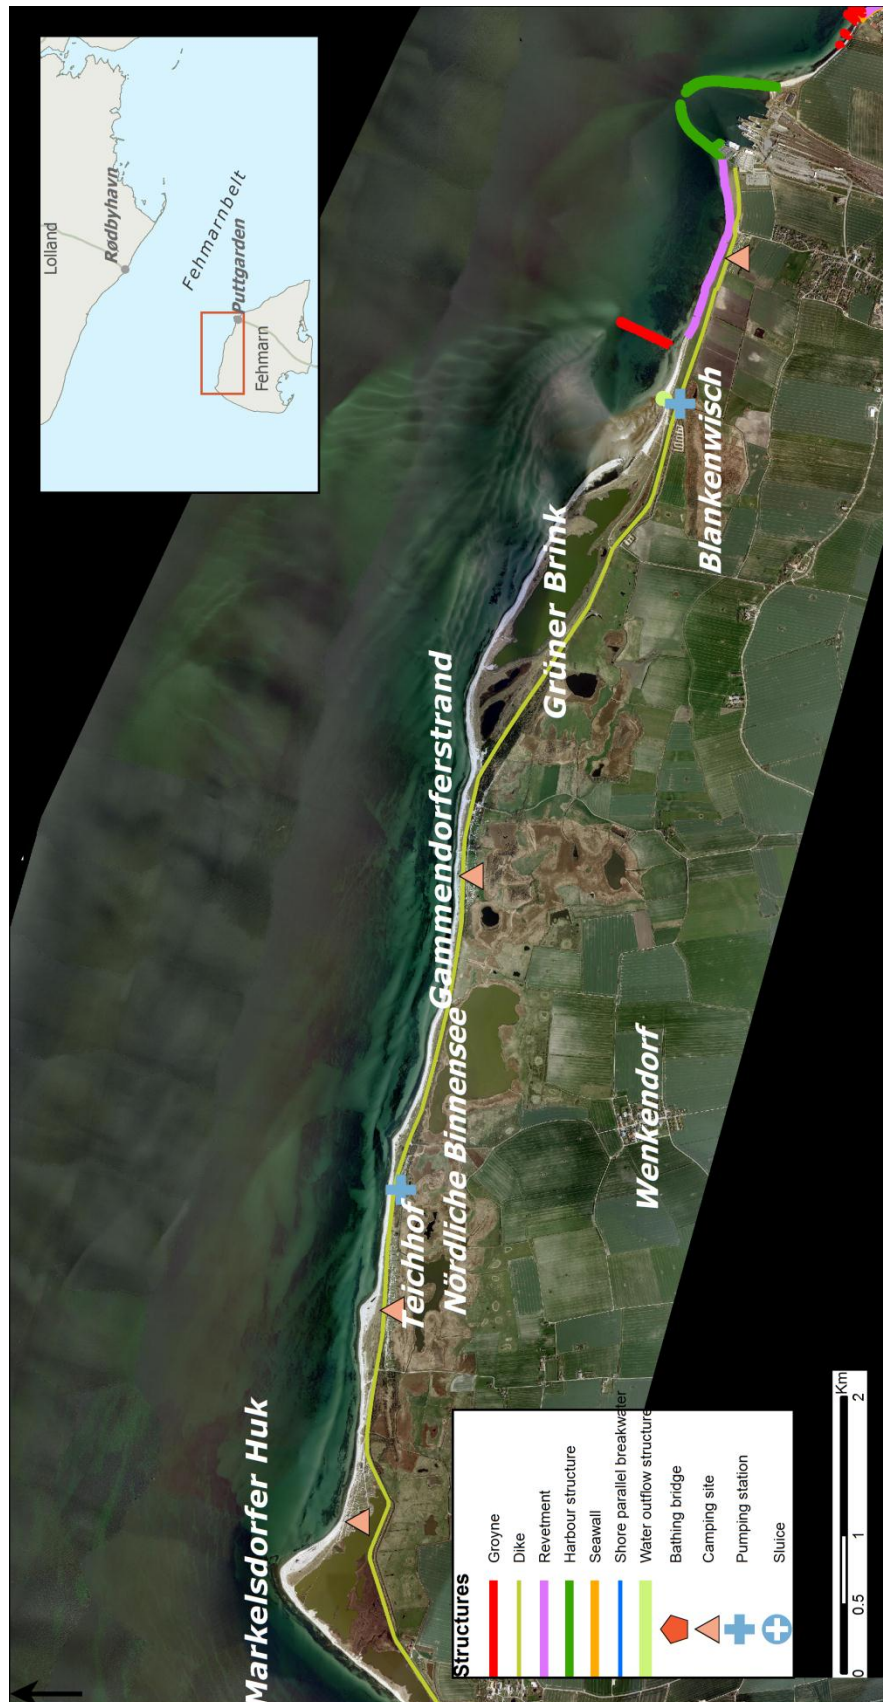
Figure 1.12 Overview of coastline and coastal structures from Markelsdorfer Huk to Puttgarden. Aerial photo from 2009 (©COWI Orthophoto April 2009)

The entire north coast of Fehmarn is characterised by beaches, sand spits, coastal lagoons, dune areas, meadows and salt marches. An aerial photo from 2009 of the coastline and an overview of the structures along the coast are provided in Figure 1.12.

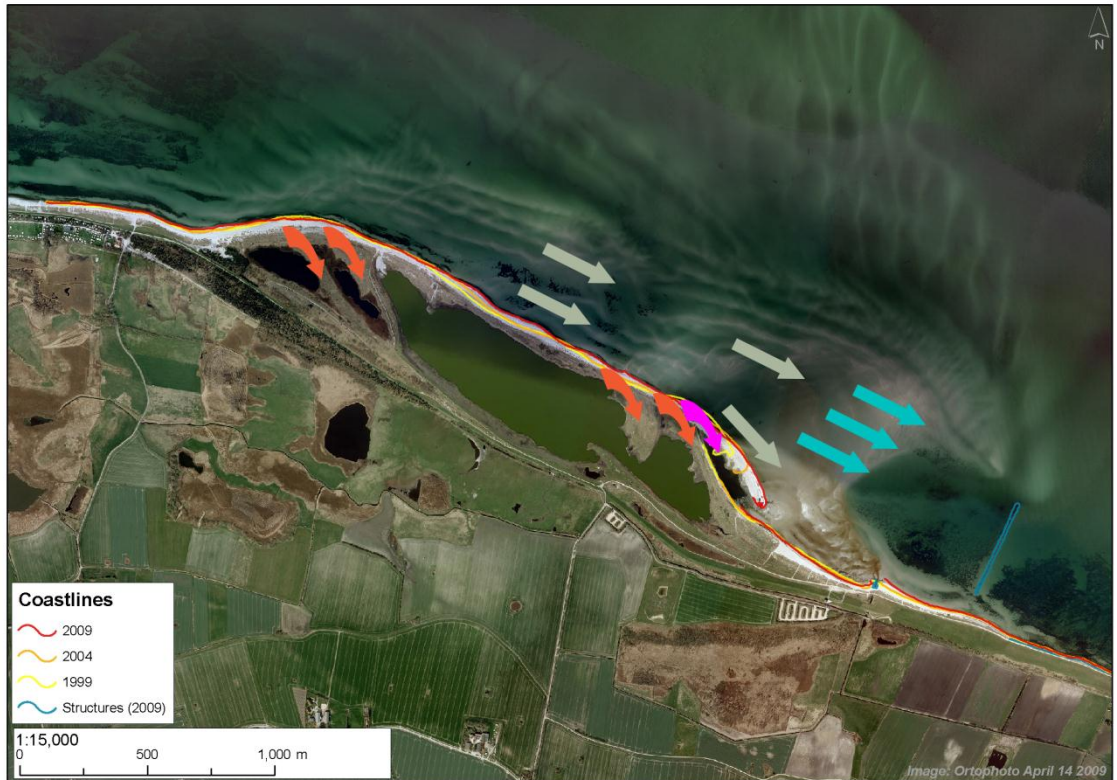
Figure 1.13 Grøner Brink formation, aerial photo 2009, with coastlines from 1999, 2004 and 2009, see Section 4.3. Overall morphological development of Grøner Brink indicated with arrows: red arrows indicate remains of old spits. Pink arrow indicates present day movement of the spit. Blue arrows indicate progression of the formation below the water level. Grey arrows indicate transport of sediment which deposits on the steep slope or offshore front. Aerial photo from 2009 (©COWI Orthophoto April 2009)

The morphological development of Grüner Brink is sketched in Figure 1.13. The alongshore transport of sand from the coast east of Grüner Brink is transported along the submerged part of the formation (extending 300-600 m into the water from the shoreline) and feeds the spit in the east, but also the submerged 'offshore front'.

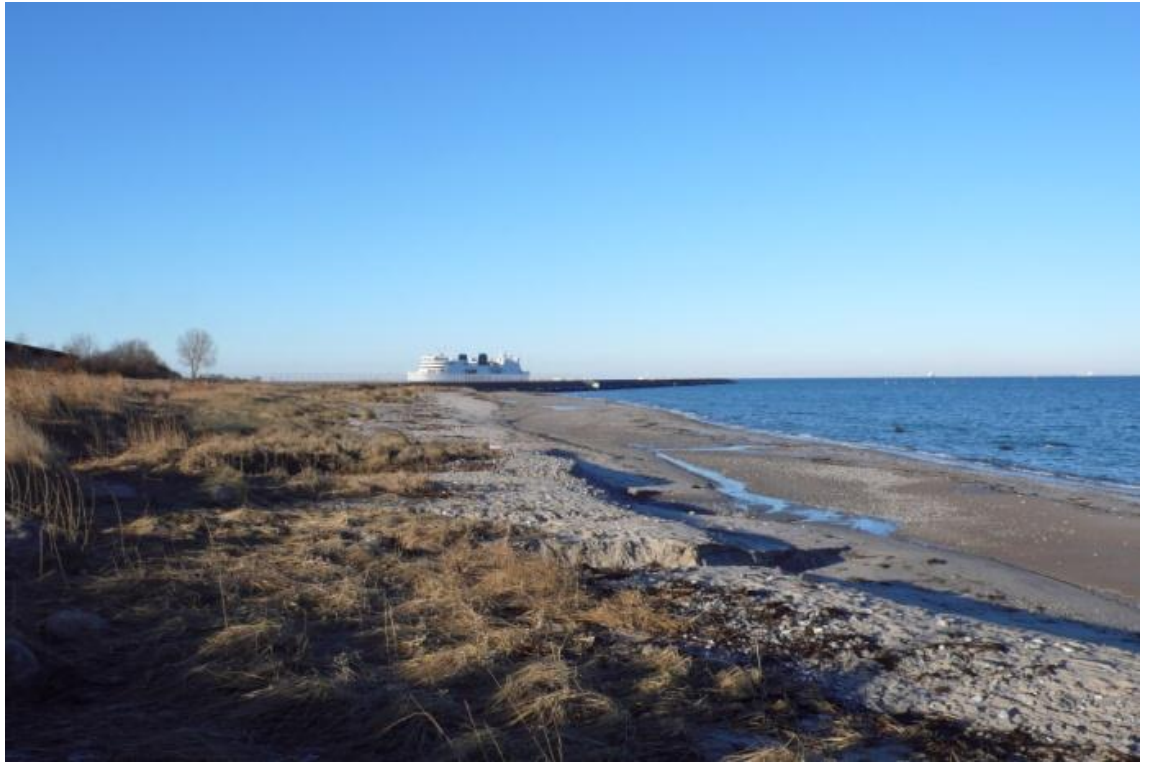
Figure 1.14 Sand accumulation SE of Puttgarden

A small sand accumulation is located SE of the east breakwater of Puttgarden, in the corner between the breakwater and the coastline, see Figure 1.14.

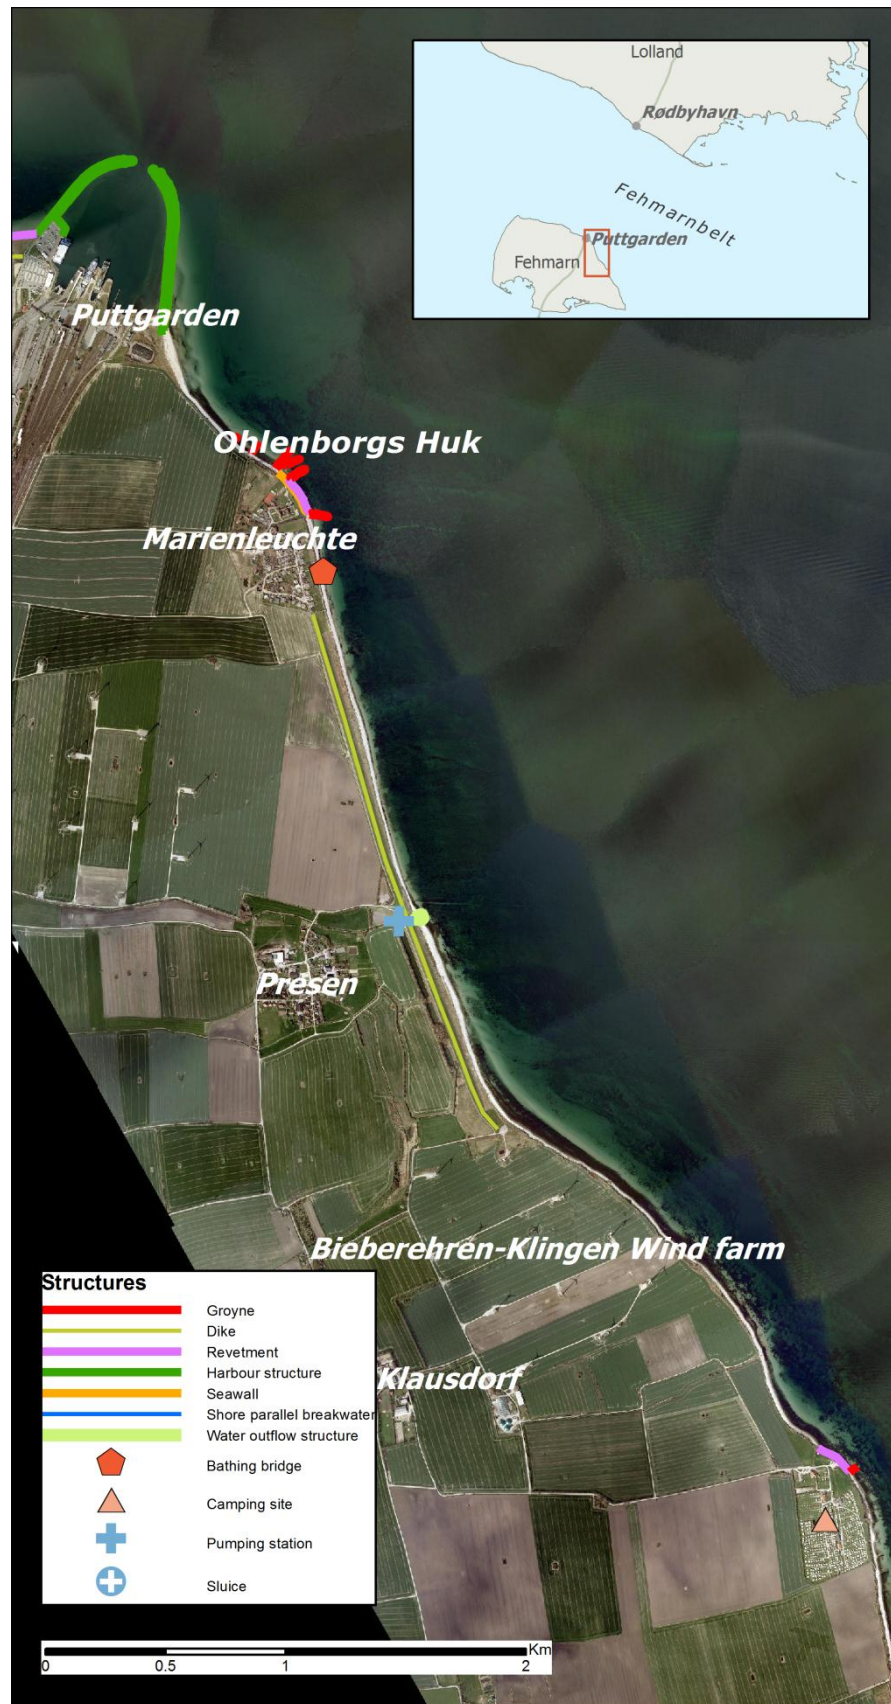
Figure 1.15 Overview of coastline and coastal structures from Puttgarden and Klausdorf. Aerial photo from 2009 (©COWI Orthophoto April 2009). Note: Bieberehren-Klingen wind farm is not the correct name of the wind farm south of Presen

The coastline southeast of Puttgarden is in general characterised by low cliff formations. A low grass-covered dike, however, protects the low-lying land in the area off the village Presen. For an overview of this part of the coastline and the coastal structures see Figure 1.15.

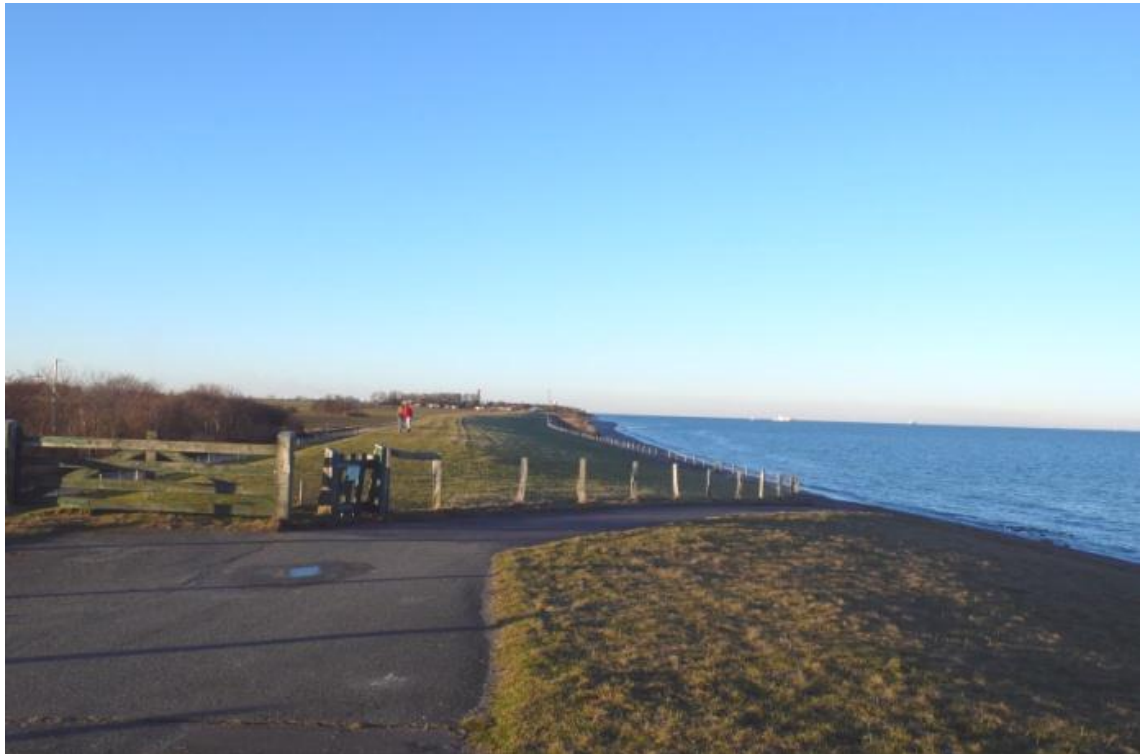
Figure 1.16 *Dike between Marienleuchte and the till cliff off Klausdorf, protecting the low-lying land around Presen*

Immediately south of Marienleuchte, the level of the hinterland falls. A low grass covered dike protects the low-lying land in the area of the village of Presen from just south of the village of Marienleuchte to the cliff east of Klausdorf, see Figure 1.16. The beach in front of the dike is sandy with some gravel.

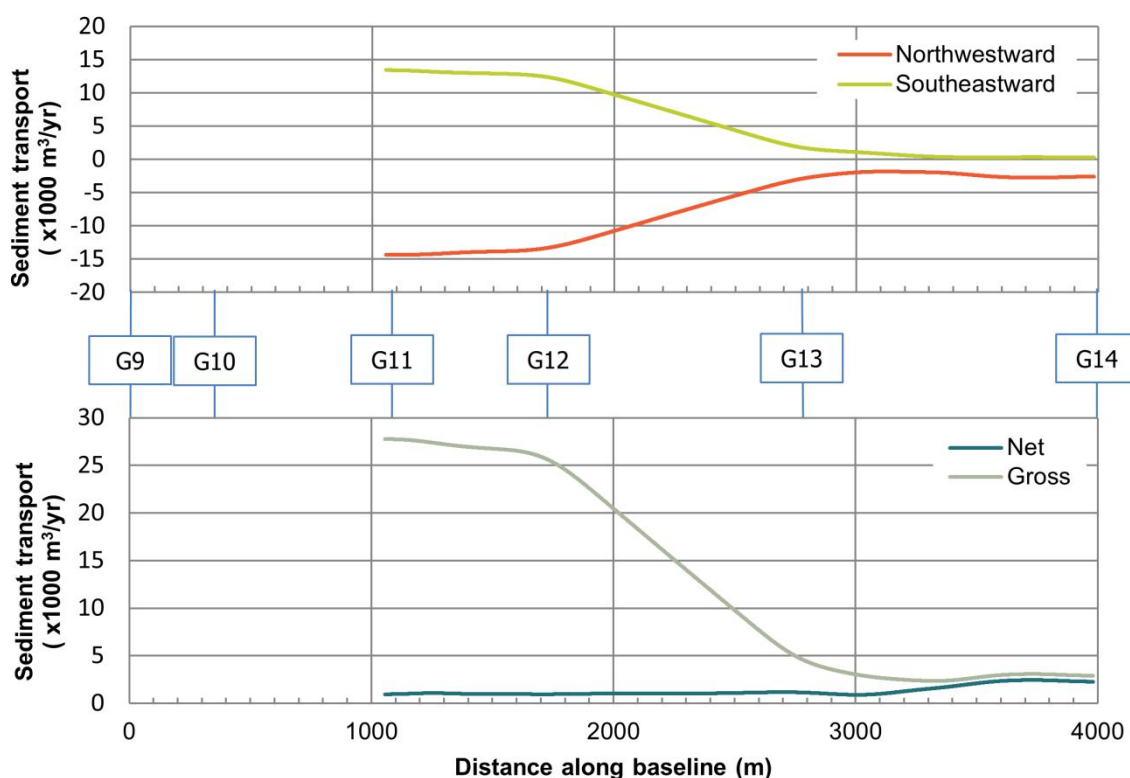
Figure 1.19 Littoral drift transport rates east of Puttgarden (top figure). Central figure: northwest- and southeast going transport conditions. Lower figure: net and gross transport rates. Aerial photo from 2009 (©COWI Orthophoto April 2009). Note: Bieberehren-Klingen wind farm is not the correct name of the wind farm south of Presen

The net transport rate just southeast of the eastern harbour breakwater is about 1,000 $m^3/year$. This fits well with the very small shoreline changes observed in this area and the small built up of sand in the profiles. At location G10 further south-east, a high net *potential* transport rate towards the north is calculated. This transport is not effectuated due to small groynes, the seawall/revetment protecting the Ohlenborgs Huk from erosion and the lack of loose sea bed material on the sea bed.

Between Presen and further south (G13-G14) the beach orientation turns clockwise by about 20°. This induces an increase in the net sediment input of sand from south to this section. This leads to a deposition along this section.

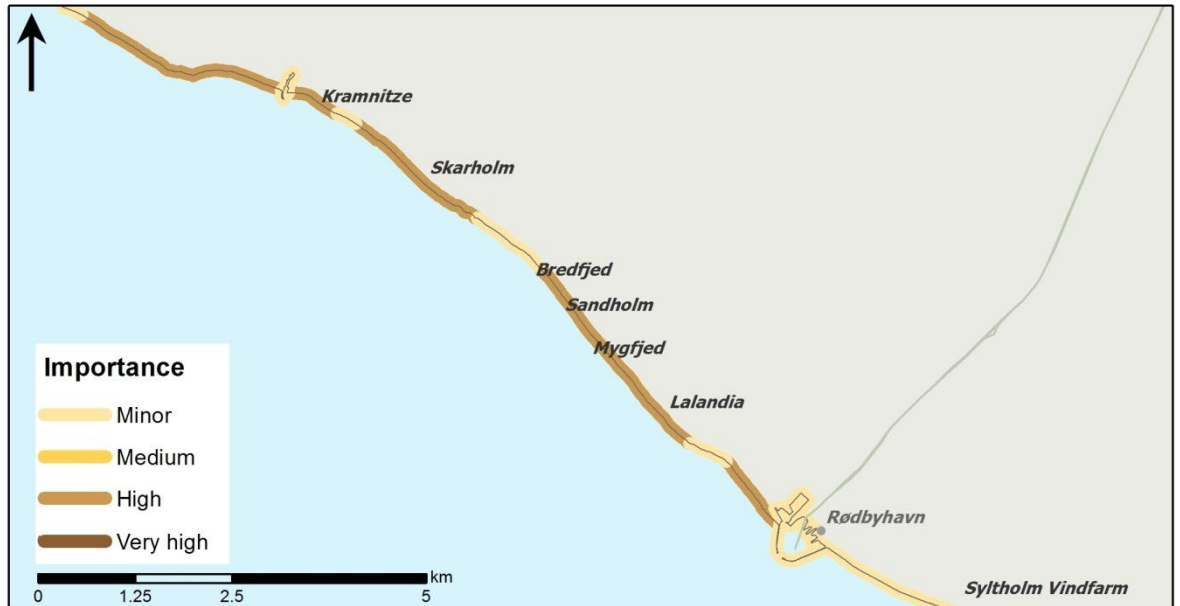
Figure 1.20 Importance levels for the sub-factor Marine Soil component Coastal Morphology along the Lolland coast

Maps showing the importance for coastal morphology along relevant sections of the Lolland and the Fehmarn coasts are presented in Figure 1.20 and Figure 1.21.

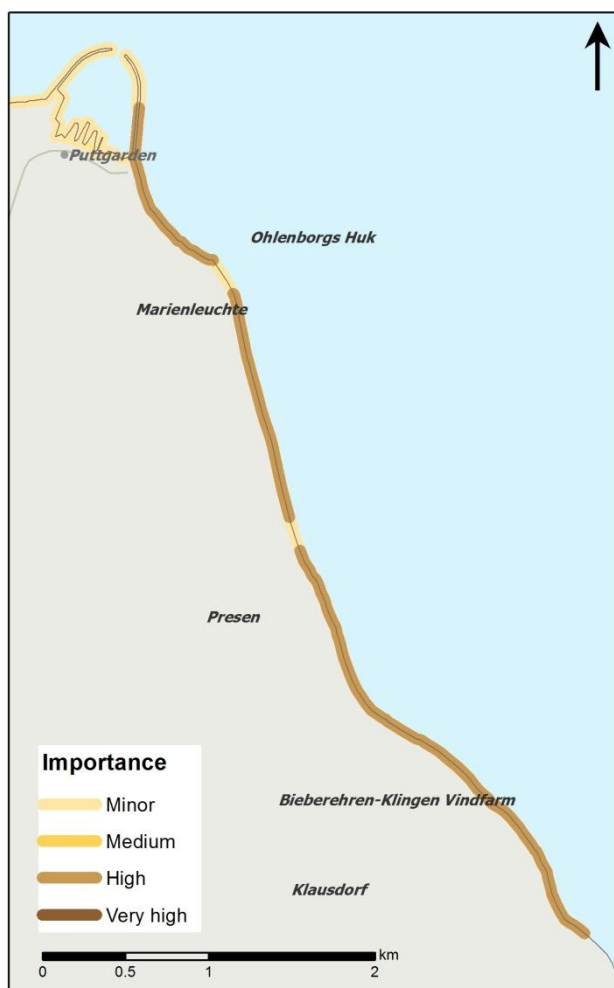
Figure 1.21 Importance levels for the sub-factor Marine Soil component Coastal Morphology along the Fehmarn coast. Note: Bieberehren-Klingen wind farm is not the correct name of the wind farm south of Presen

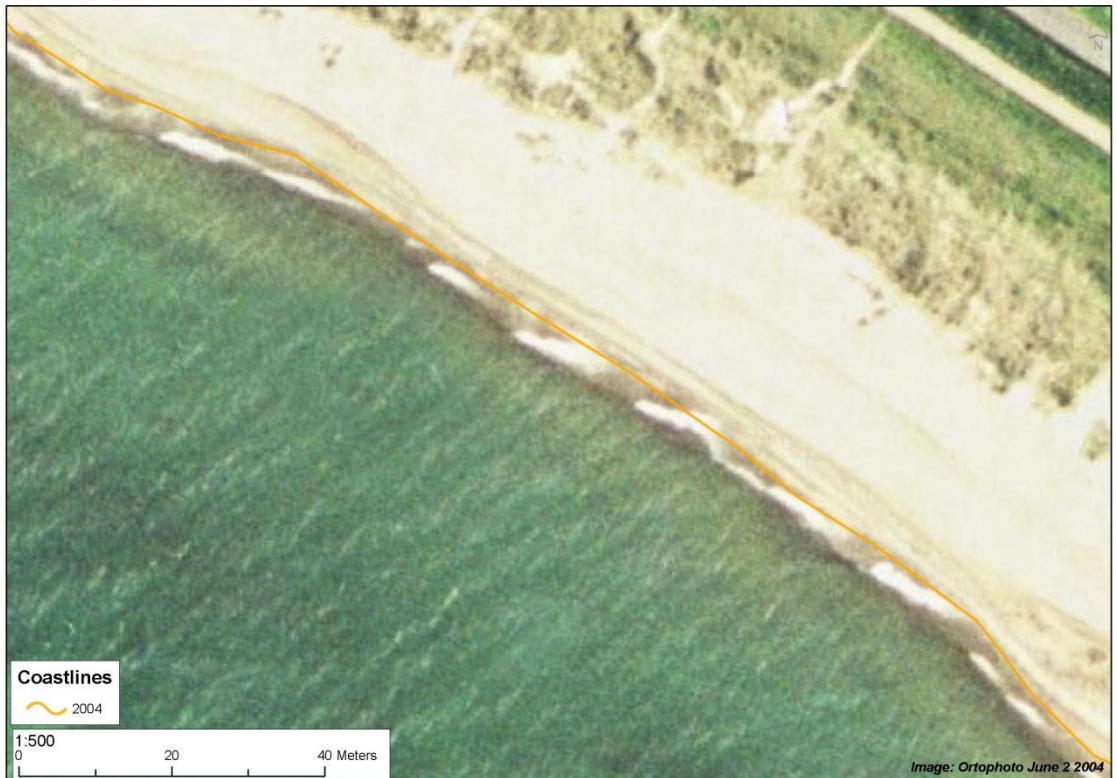
Figure 4.5 Example of digitizing of instantaneous waterline on 2004 image. Aerial photo from 2004 (©COWI Orthophoto Spring/Summer 2004)

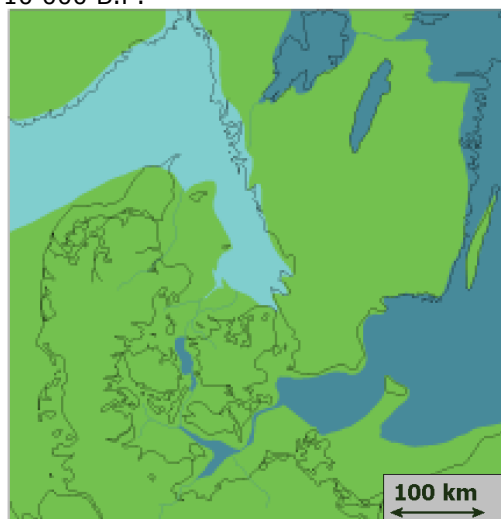
Figure 6.1 Stages in the late/post-glacial development of land and sea/lake conditions in the Fehmarnbelt area. Modified from (Jensen et al 2002)

A summary of the depositional environment and the character of the deposition in the late/post-glacial period are presented in Table 6.1 following (Rambøl Denmark A/S and Arup JV 2010) in which a more detailed description can be found. Please note that the timing of the development in this figure is slightly different from the time-line in Figure 6.1; however, the overall description and processes are in agreement.

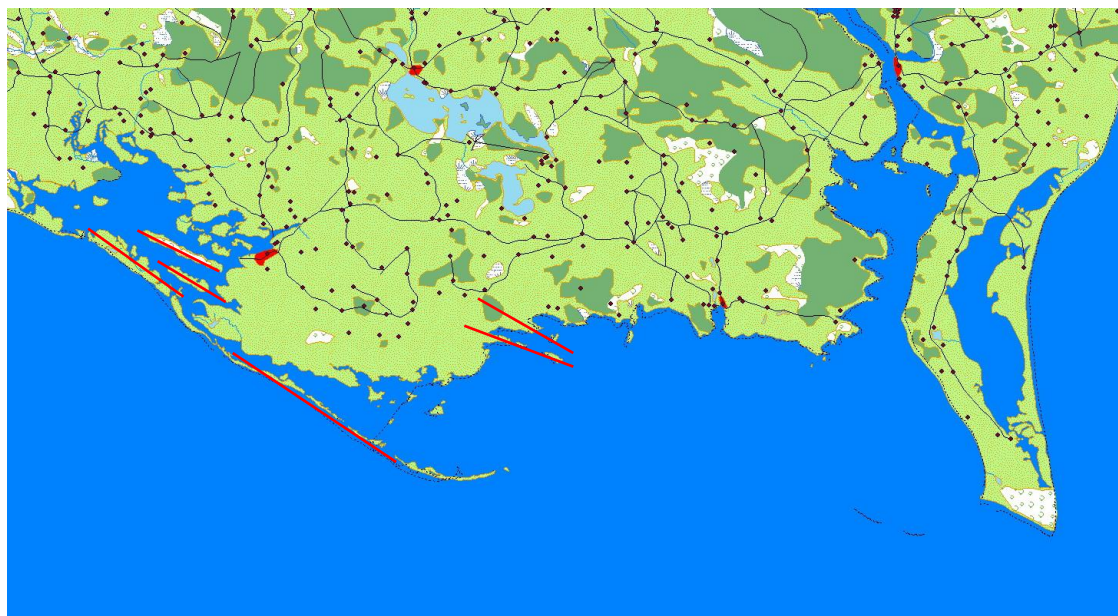
Figure 6.3 Ridge-runnel morphology at the southern part of Lolland shown as red lines on top of the historical map from 1763 – 1805 by Scientific Society (Contains data from the Danish Geodata Agency, 2010, "Videnskabernes Selskab")

Lolland is a low-lying area, originally prone to flooding from the sea during storm surges as well as during heavy rain due to difficult draining conditions. Figure 6.3 in the previous chapter shows a historical map from the period 1763-1805 and Figure 7.23 shows the existing situation in aerial photos from 2008.

Before the dike was constructed, the coastal area was an archipelago consisting of a system of coast-parallel islands intersected by shallow coastal lagoons, the so-called Rødby Fjord, see a map of the area near Rødbyhavn from year 1842 in Figure 7.25 and of the Rødby/Rødsand Lagoon area in Figure 6.3 (1763-1805). The islands facing the Fehmarnbelt had the character of barrier islands, which means that they were formed by onshore transport of sand and smoothed by longshore transport processes. These outer islands were clearly different in nature from the other (more inshore) islands due to the active coastal processes. The location and shape of these islands originate from the last glaciation period, where the ice movement was from SSE, see the geological description of this phenomenon in Section 5.

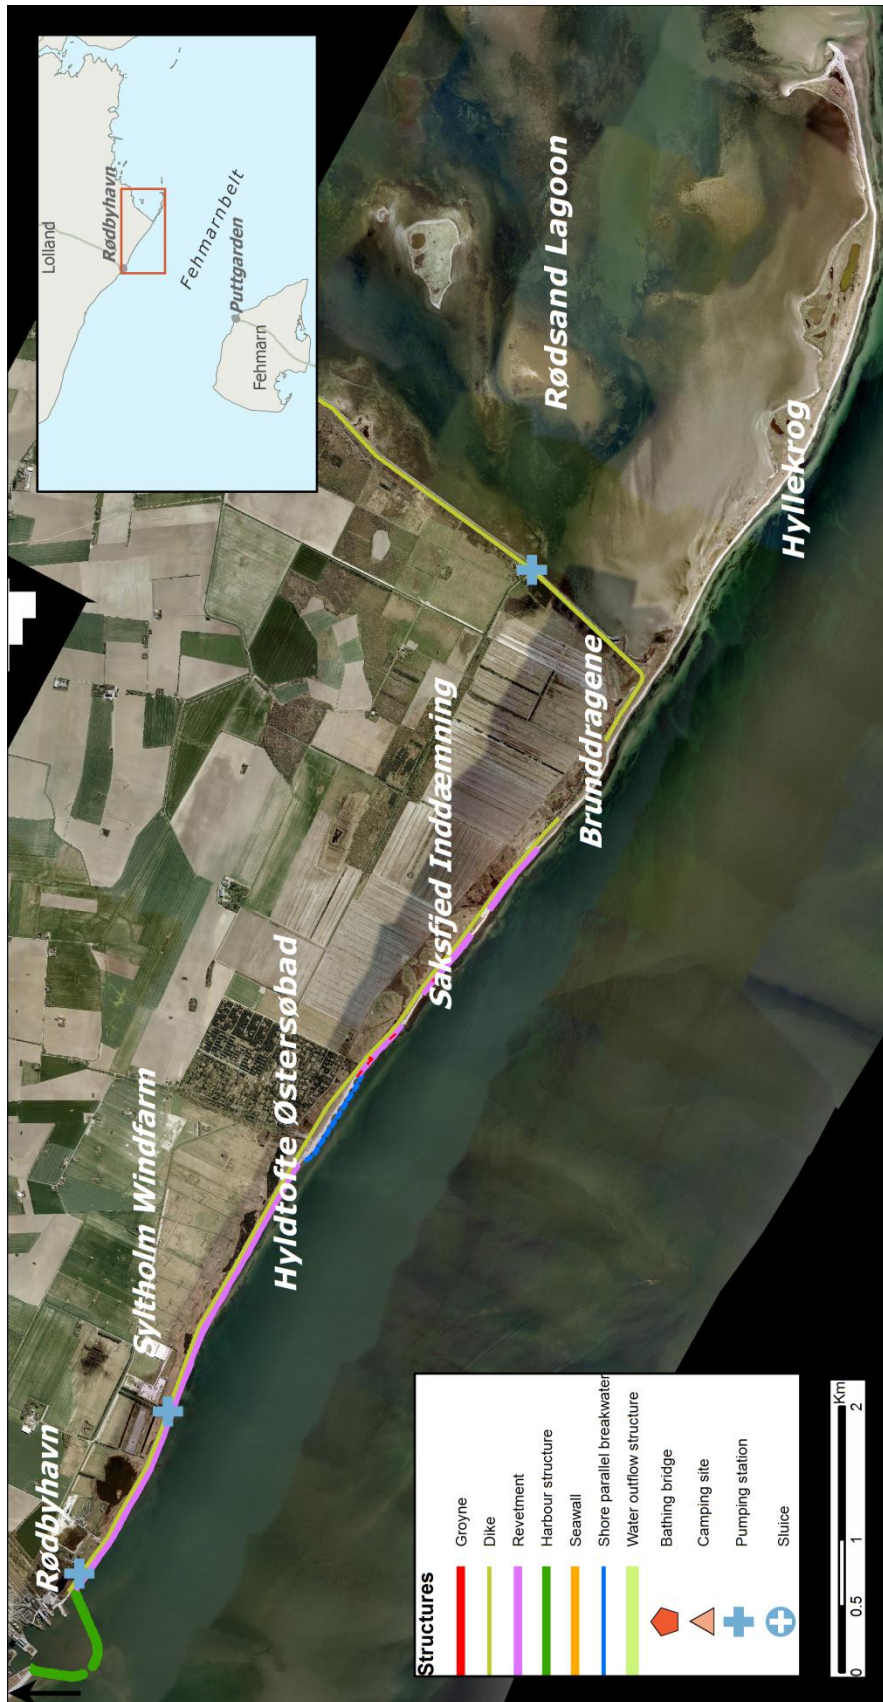
Figure 7.3 Overview of coastline and coastal structures from Rødby Ferry Harbour to Hyllekrog. Aerial photo from 2009 (©COWI Orthophoto April 2009)

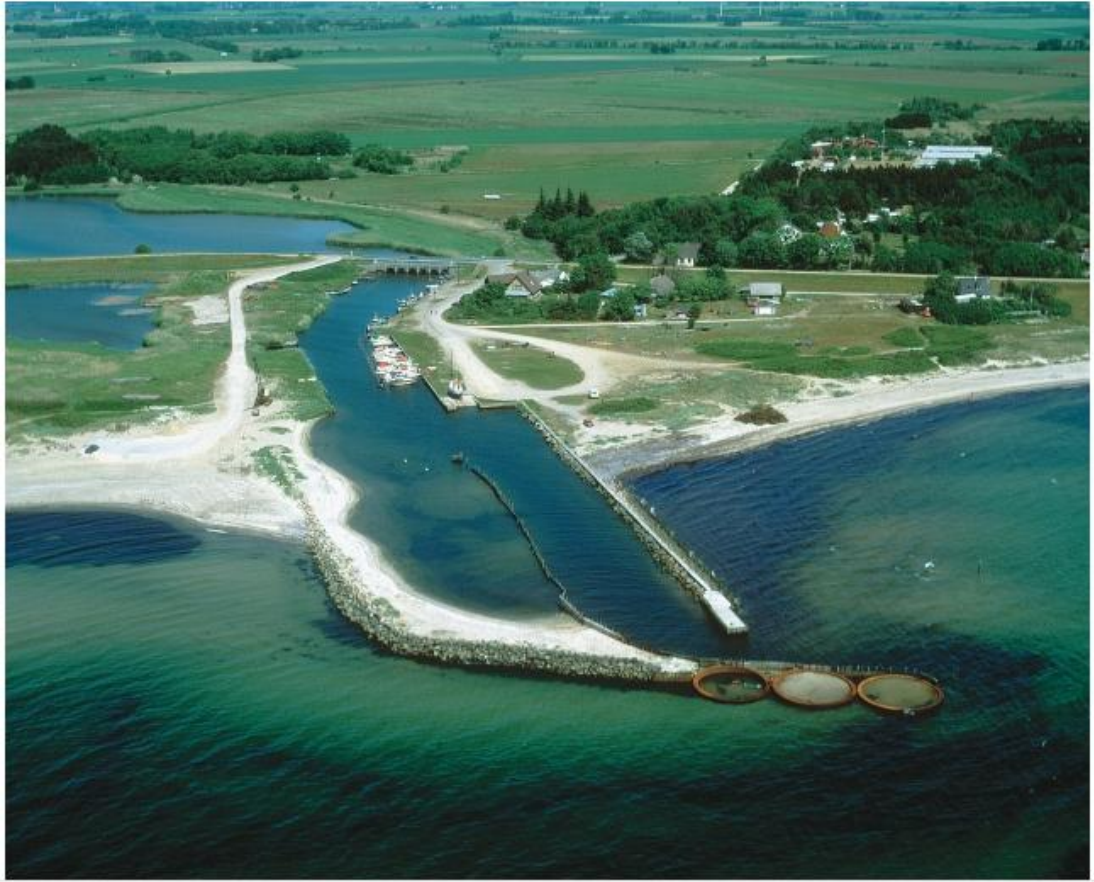
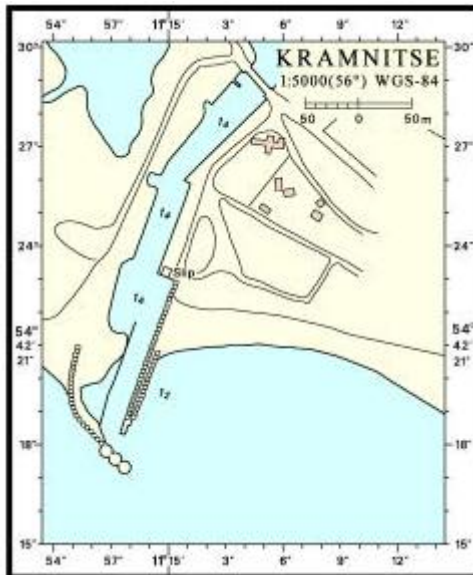
Figure 7.4 Kramnitze Fishery Harbour, sea chart and photo 1997 from "Den Danske Havnelods". @Geodatastyrelsen 2013.

The entrance to the harbour suffers from sedimentation, see Figure 7.4. The latest major maintenance dredging was performed about 10 years ago, but there is no exact information on the amount of sand dredged at that time. The entrance is cleaned each year. Major maintenance excavation of sand has been performed in the past, e.g. in 1994 where 31,000 m³ of sand was excavated. The dredged material was used for beach nourishment at a beach 13 km west of Kramnitze (at Næsby) in connection with construction of 14 small coastal breakwaters (Fehmarnbelt Environmental Consultants 1996 and Det Lollandske Digelag 1994). About 5,000 m³ sand has been nourished every year during the period 1994-2006 along the stretch between Kramnitze and Næsby. The sand for these nourishments has been taken from the sand accumulation area west of Kramnitze Harbour (personal communication with Dike Engineer S. Aa. Sørensen). The dredged volumes are estimated to 30,000 m³ for the five-year period 1999-2004 and 15,000 m³ for the period 2004-2006.

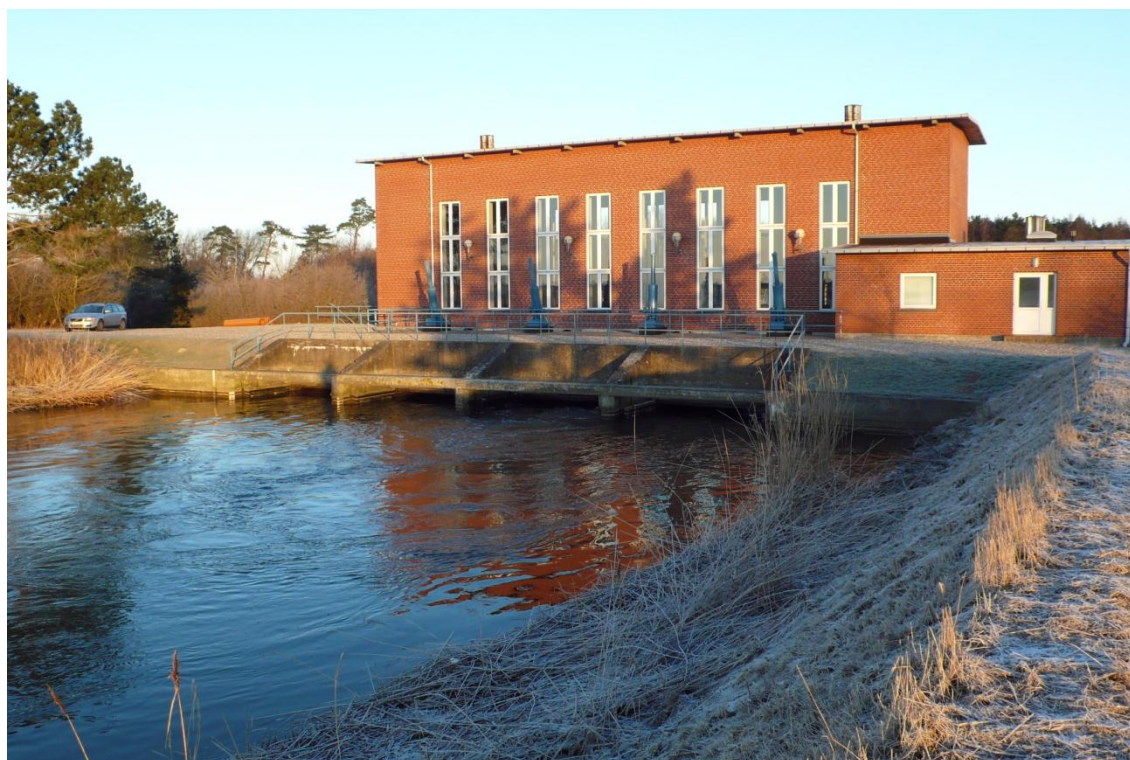
Figure 7.6 *The "new" pumping station at Kramnitze built in 1966*

A pumping station discharging water through the harbour causes a persistent flow to the harbour breakwaters, which helps to keep the harbour entrance open. The average discharge is 1.6 m³/s and the max discharge is in the order of 20 m³/s. Kramnitze pumping station (Figure 7.6) is the largest pumping station in northern Europe and it drains an area of 20,000 ha = 200 mio m².

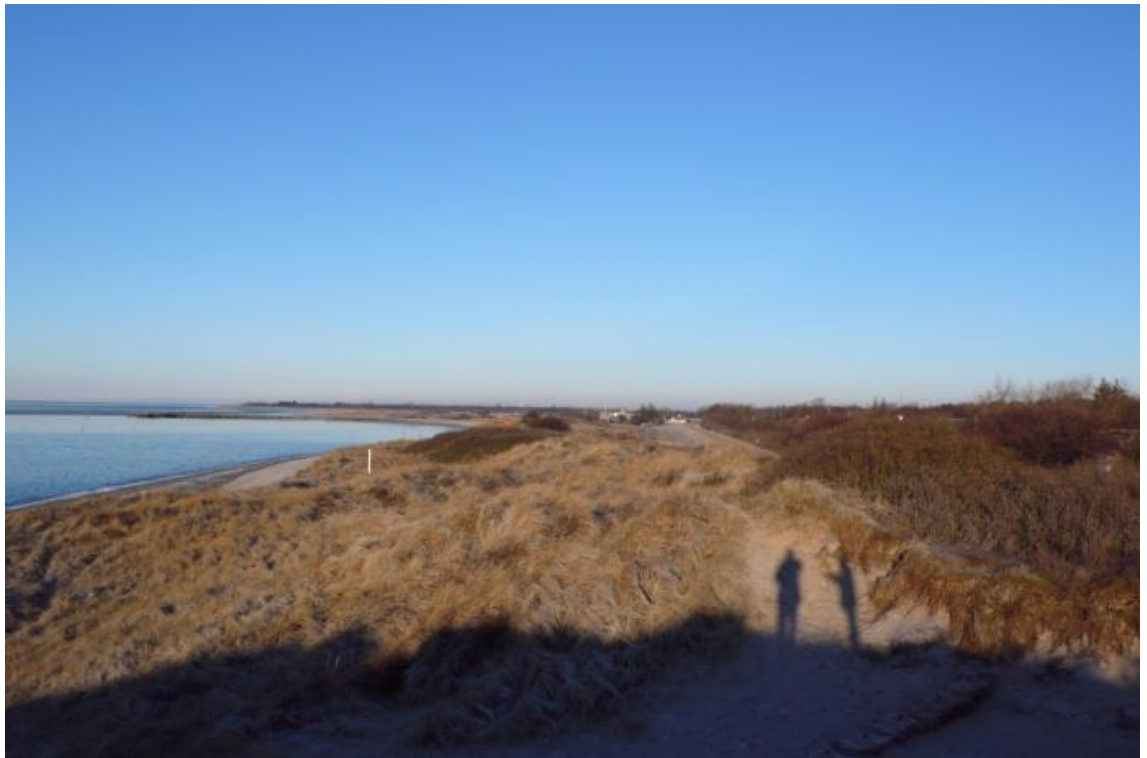
Figure 7.7 Beach conditions east of Kramnitze Harbour. Sandy beach and high dunes covering the dike

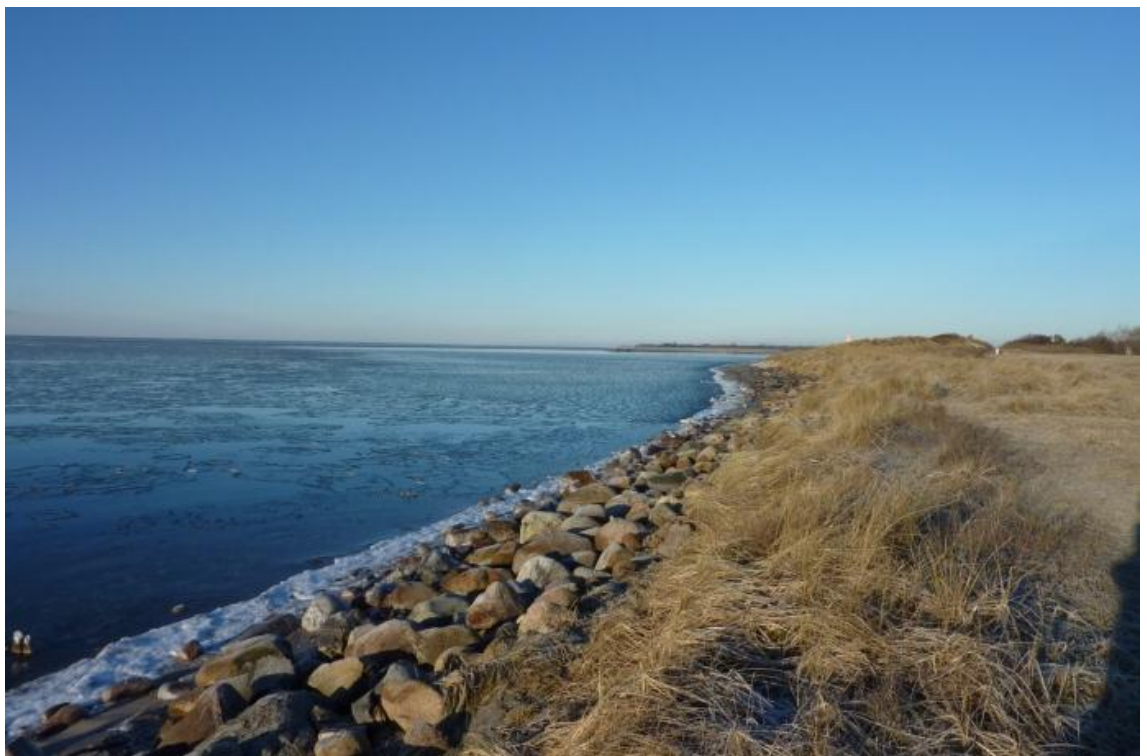
Figure 7.8 Revetment and no beach off the eastern part of Kramnitze
