FEHMARNBELT FIXED LINK HYDROGRAPHIC SERVICES (FEHY)

Marine Soil - Baseline

Coastal Morphology along Fehmarn and Lolland

E1TR0056 - Volume III

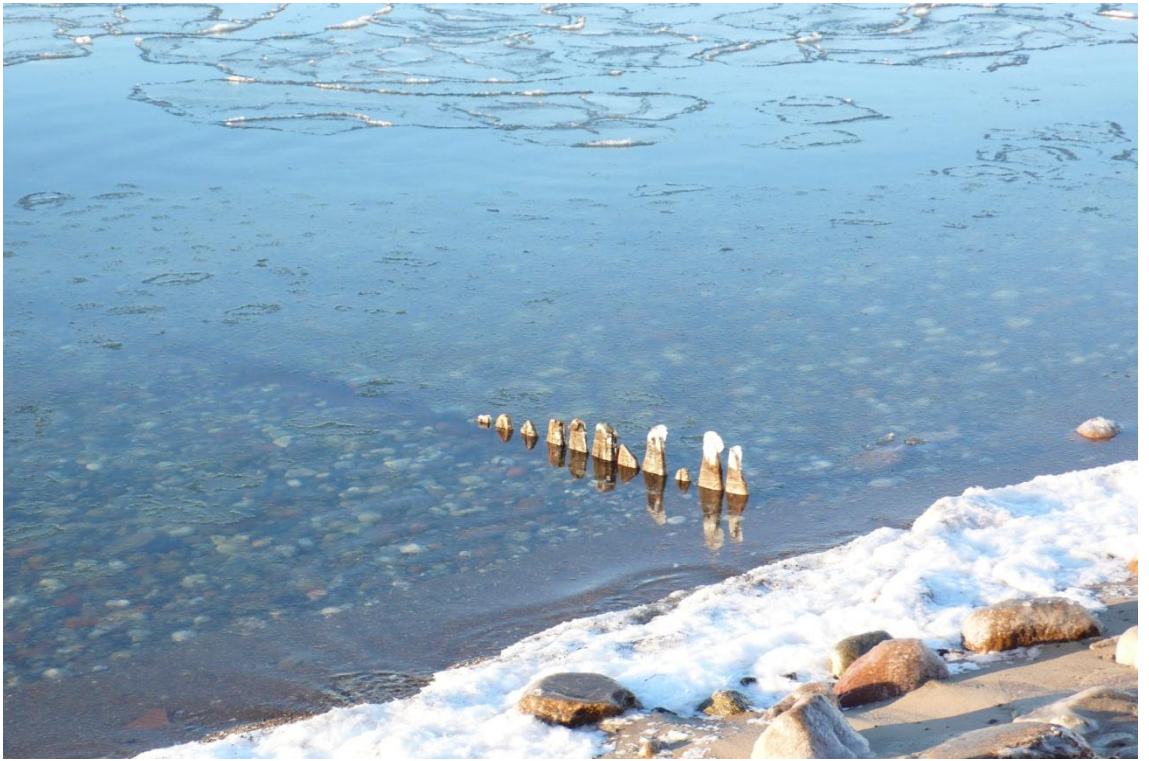
Figure 7.9 Seabed in front of revetment off eastern part of Kramnitze, seabed covered by pebble

Remains of wooden pile groynes are seen in this area. The seabed is covered by pebble, see photo in Figure 7.9.

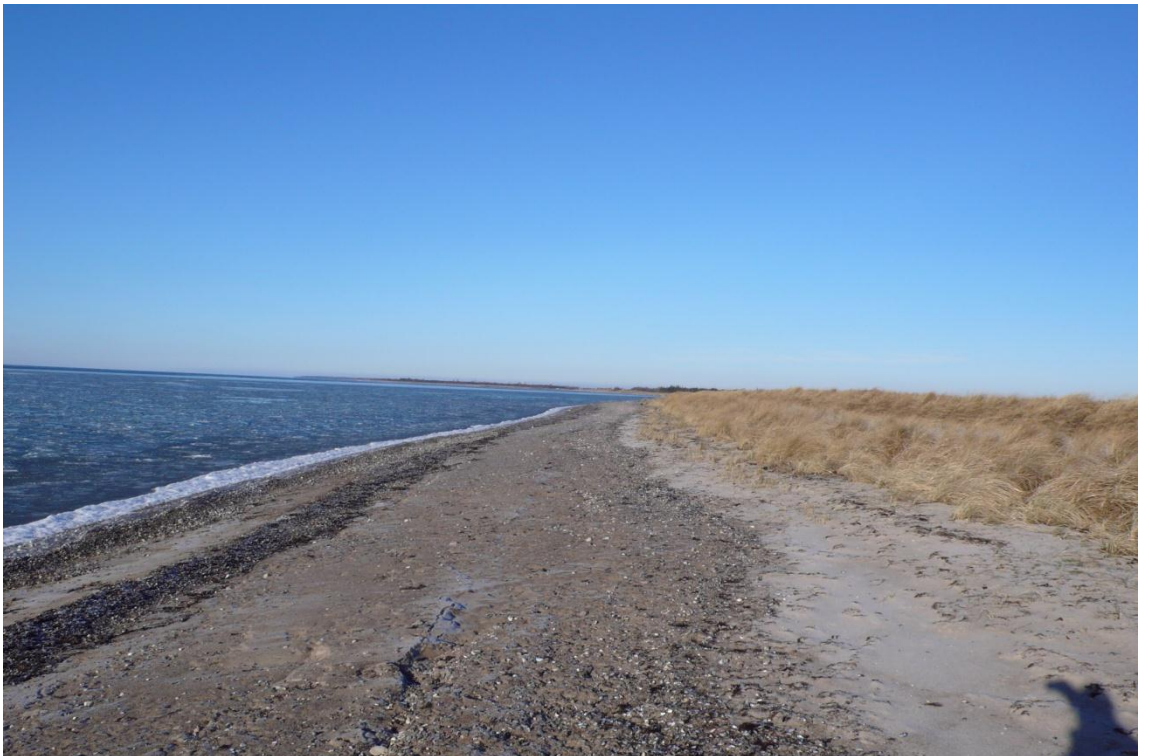
Figure 7.10 Sandy beach with some gravel off Skarholm, there is a narrow dune in front of the dike

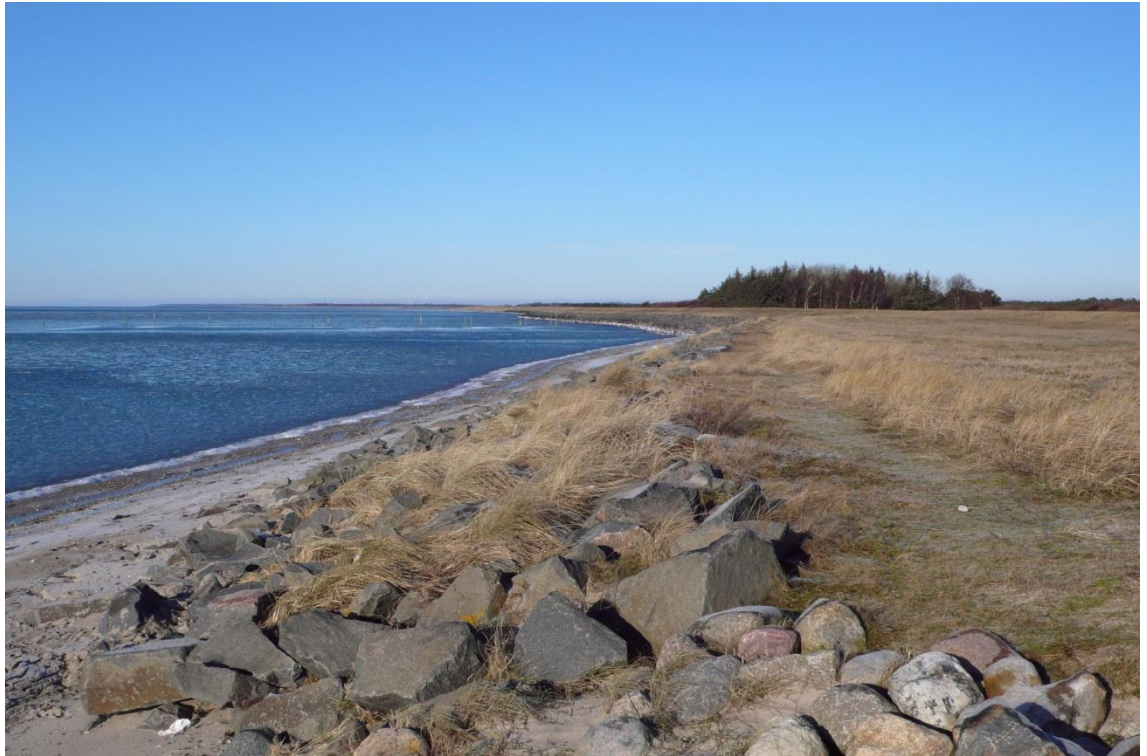
Figure 7.11 Protected section between Skarholm and Bredfjed summerhouse village, photo taken from the west end of the village

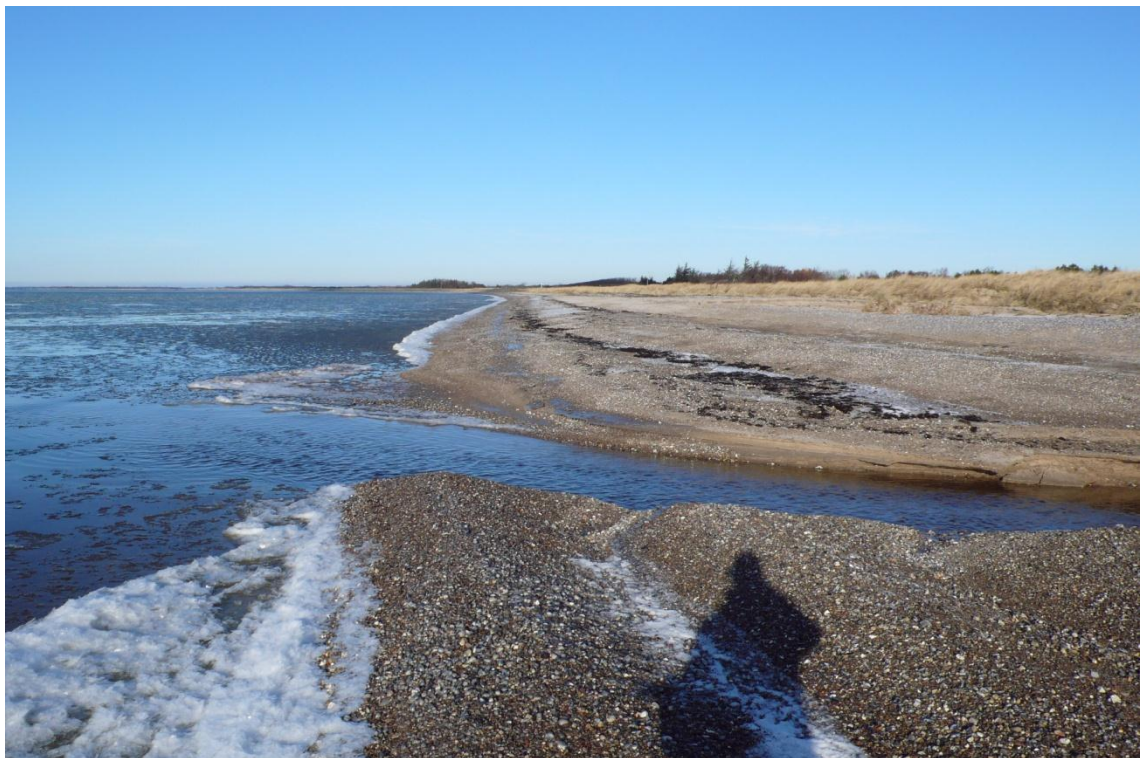
Figure 7.12 Sandy beach with gravel at the Bredfjed – Lalandia stretch, dunes in front of the dike. Photo taken at the outlet from Dragsminde Sluice in the eastern end of the stretch

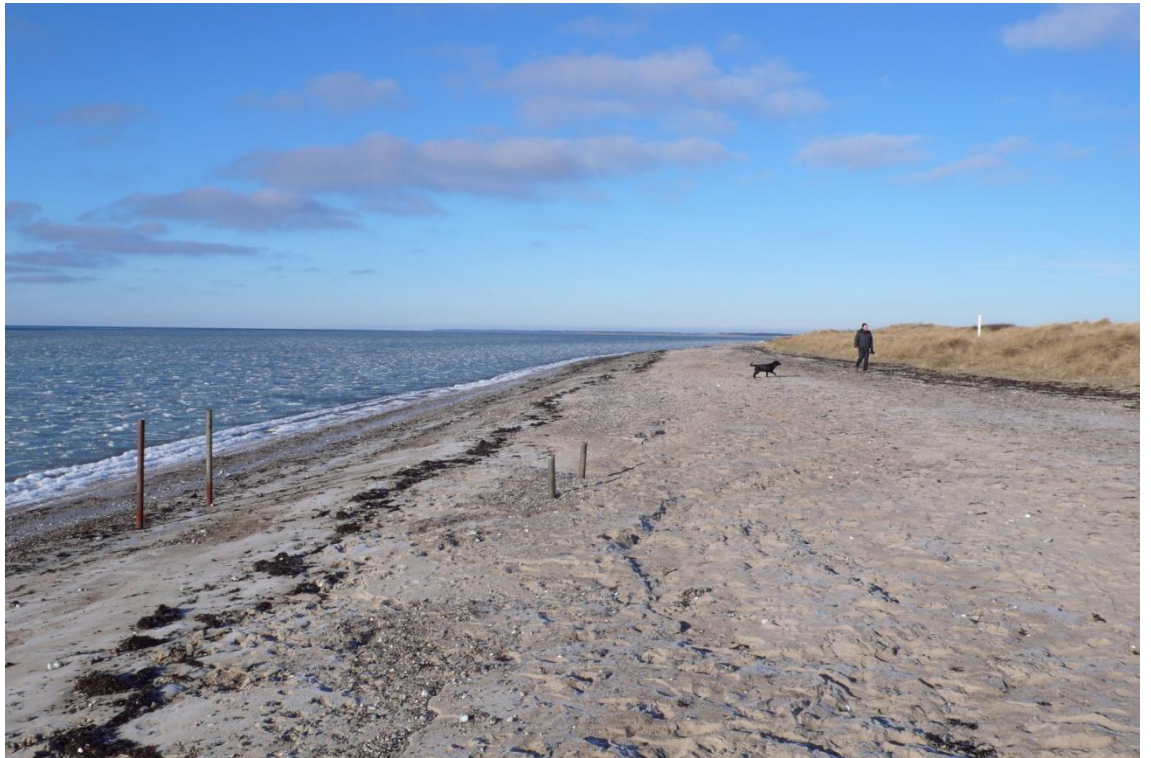
Figure 7.13 Sandy beach off Lalandia with dunes in front of the dike, steel piles for bathing bridge in the foreground

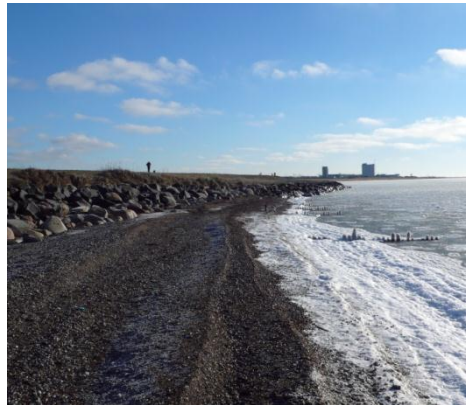
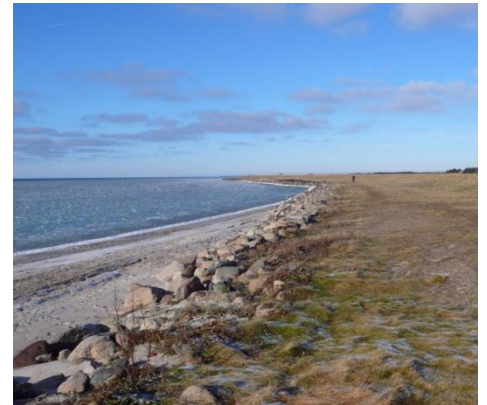
Figure 7.14 Revetment off the eastern end of Lalandia. Left: west end of revetment, remains of wooden pile groynes. Right: east end of revetment, sand accumulation west of Rødbyhavn has started

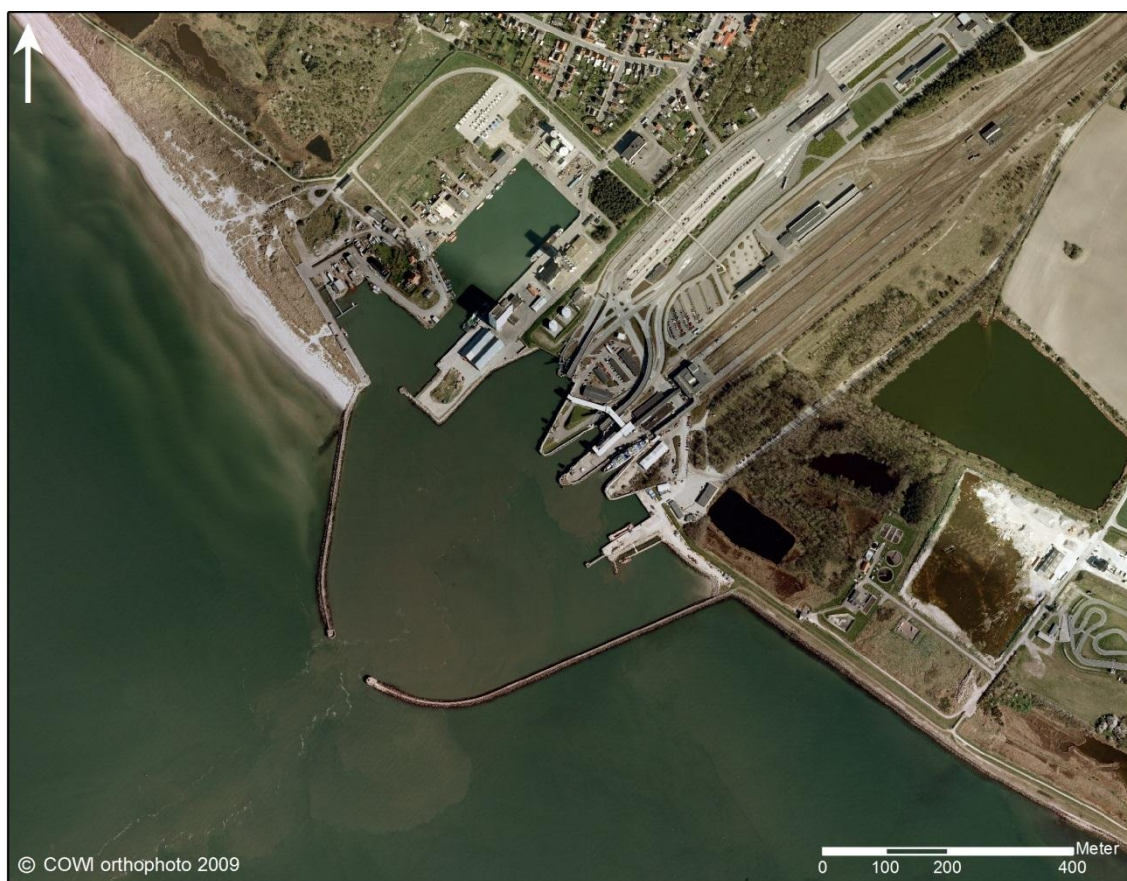
Figure 7.15 Rødbyhavn, consisting of the ferry harbour basin and some minor basins to the north of the ferry basin (the west basin and the north basin). Aerial photo from 2009 (©COWI Orthophoto April 2009)

The shoreline east of the harbour is heavily protected by a rubble mound revetment indicating erosion of the shoreline caused by the harbour blocking sediment transport from the east. The erosion has caused disappearance of the beach originally fronting the dike. No accumulation of sand is seen east of the harbour.

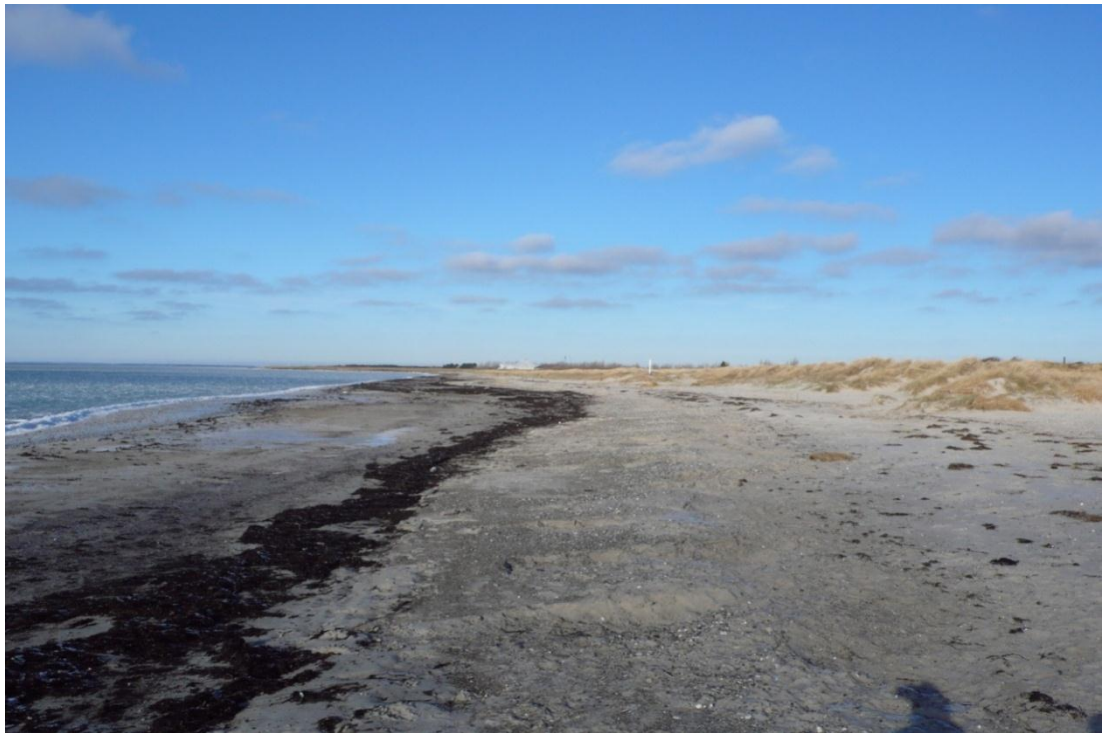
Figure 7.17 Sand accumulation with a wide beach and dune area west of Rødbyhavn

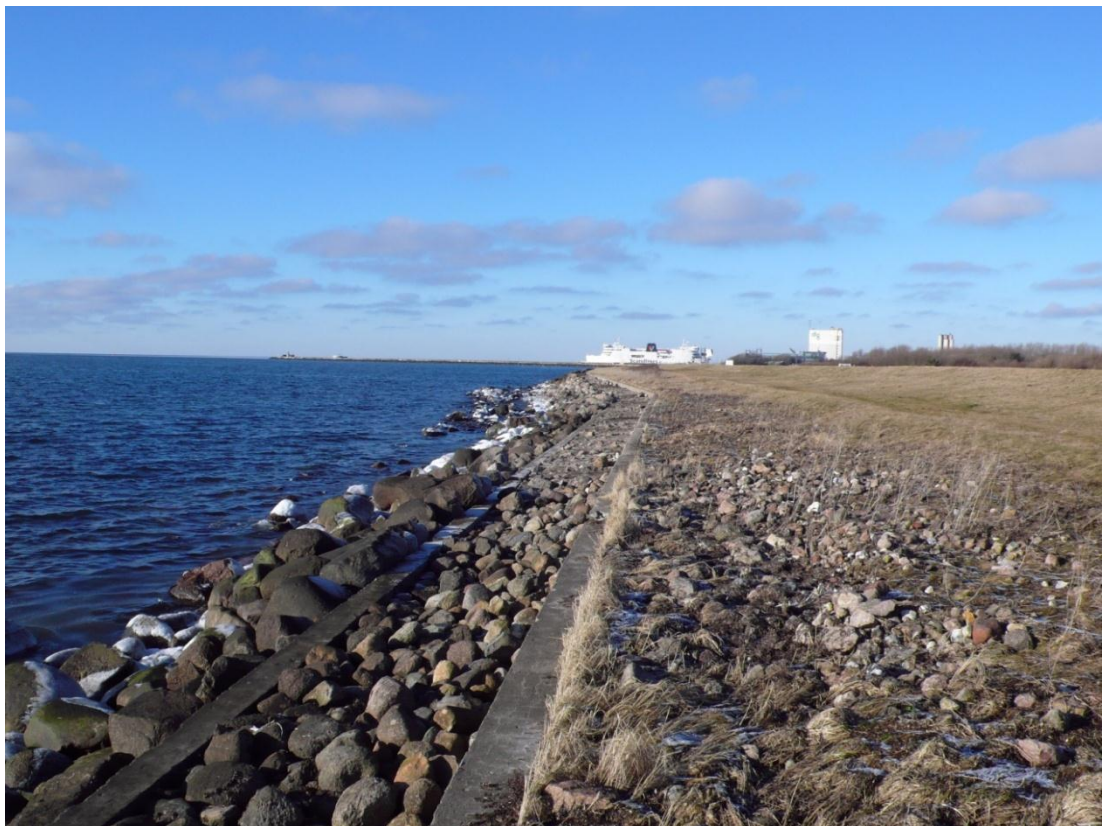
Figure 7.18 Heavily protected dike SE of Rødbyhavn. The revetment is a combined concrete cell and rubble mound structure

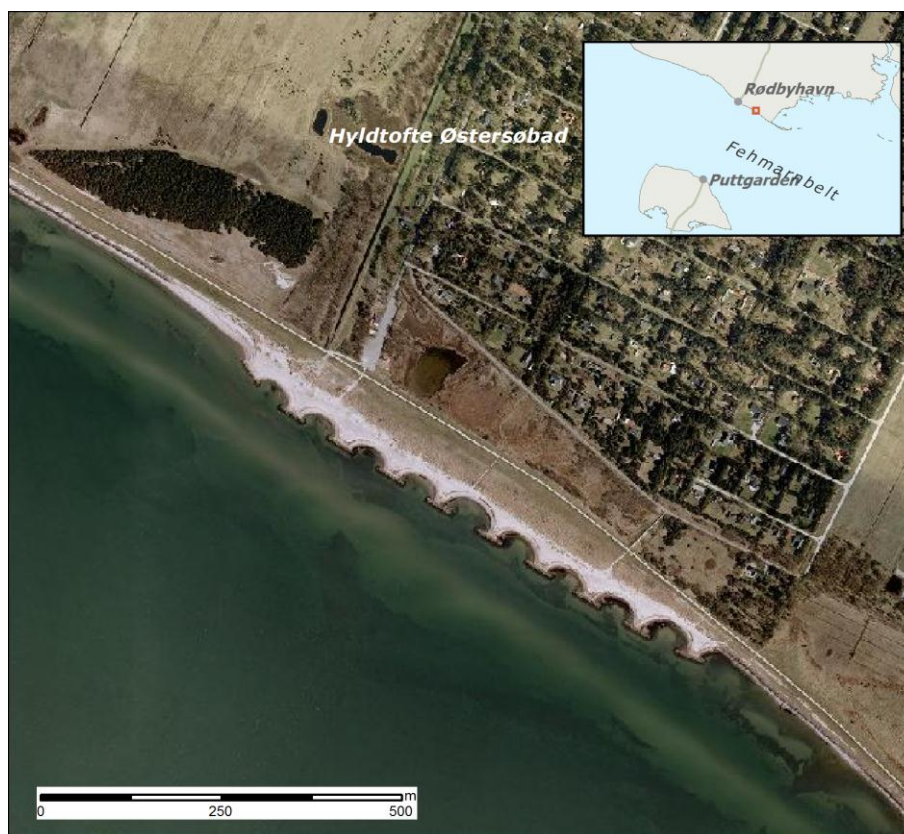
Figure 7.19 Hyltofte Østersøbad. Aerial photo from 2009 (©COWI Orthophoto April 2009)

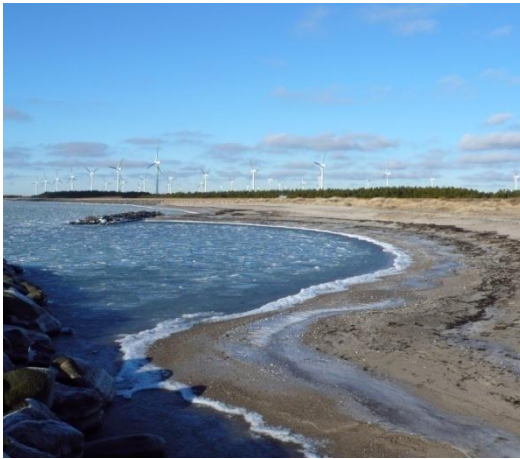
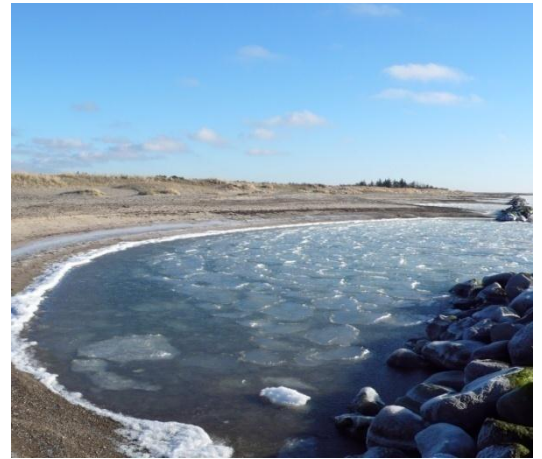
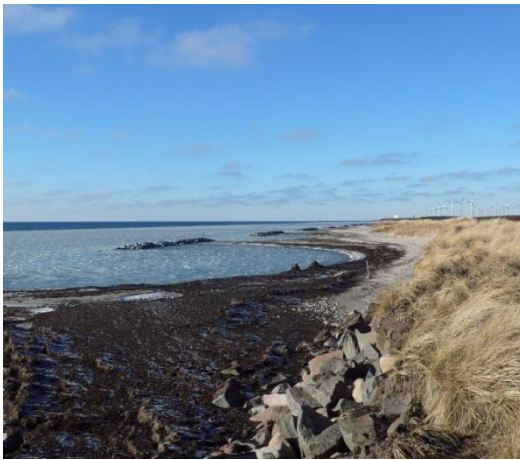
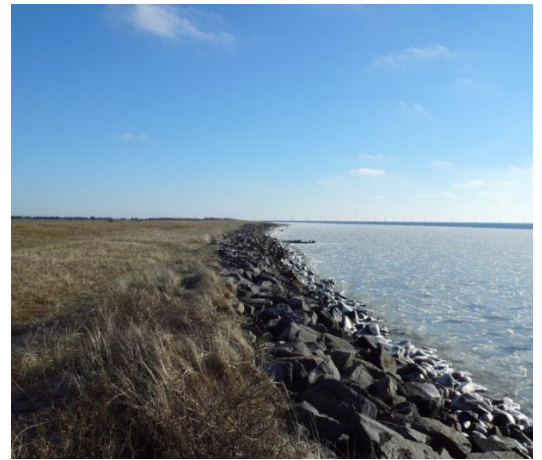
Figure 7.20 Breakwater scheme at Hyltofte Østersøbad. Upper left: west end of scheme. Upper right: pocket beach and tombolo within the scheme. Lower left: accumulation of seaweed in the eastern end of the scheme. Lower right: revetment and no beach SE of the scheme

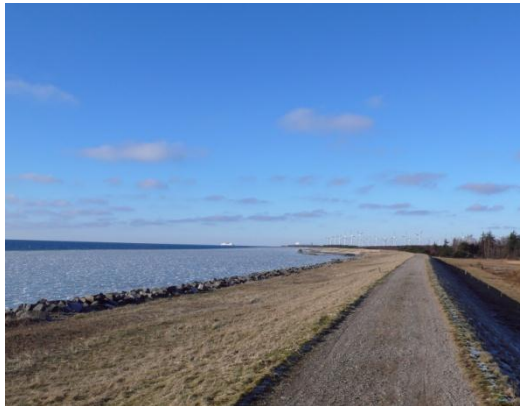
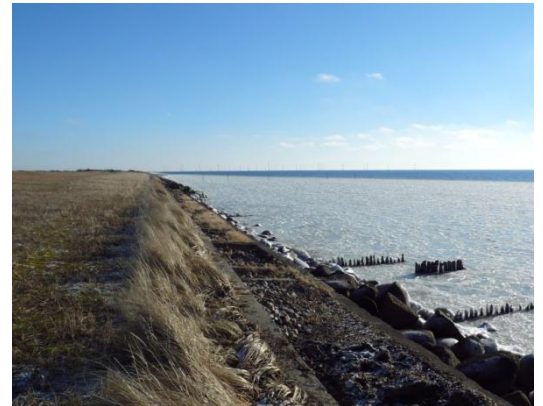
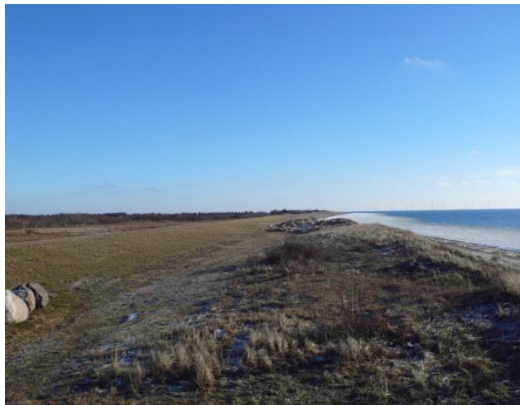
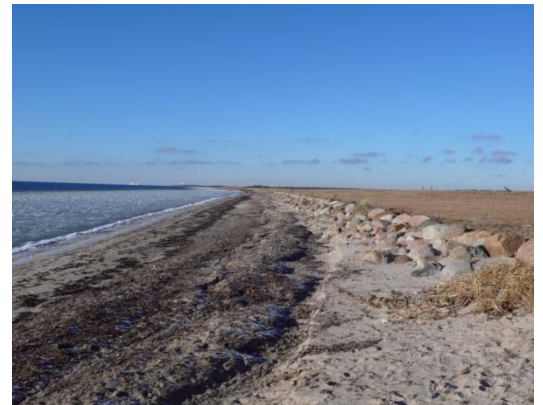
Figure 7.21 Stretch Hyldtofte Østersøbad to Brunddragene. Upper left: east end, breakwater scheme seen in the distant. Upper right: revetment in eastern end, remains of piled groynes. Lower left: middle part, sand undulation and buried revetment. Lower right: termination of revetment in east end of section, sandy beach takes over

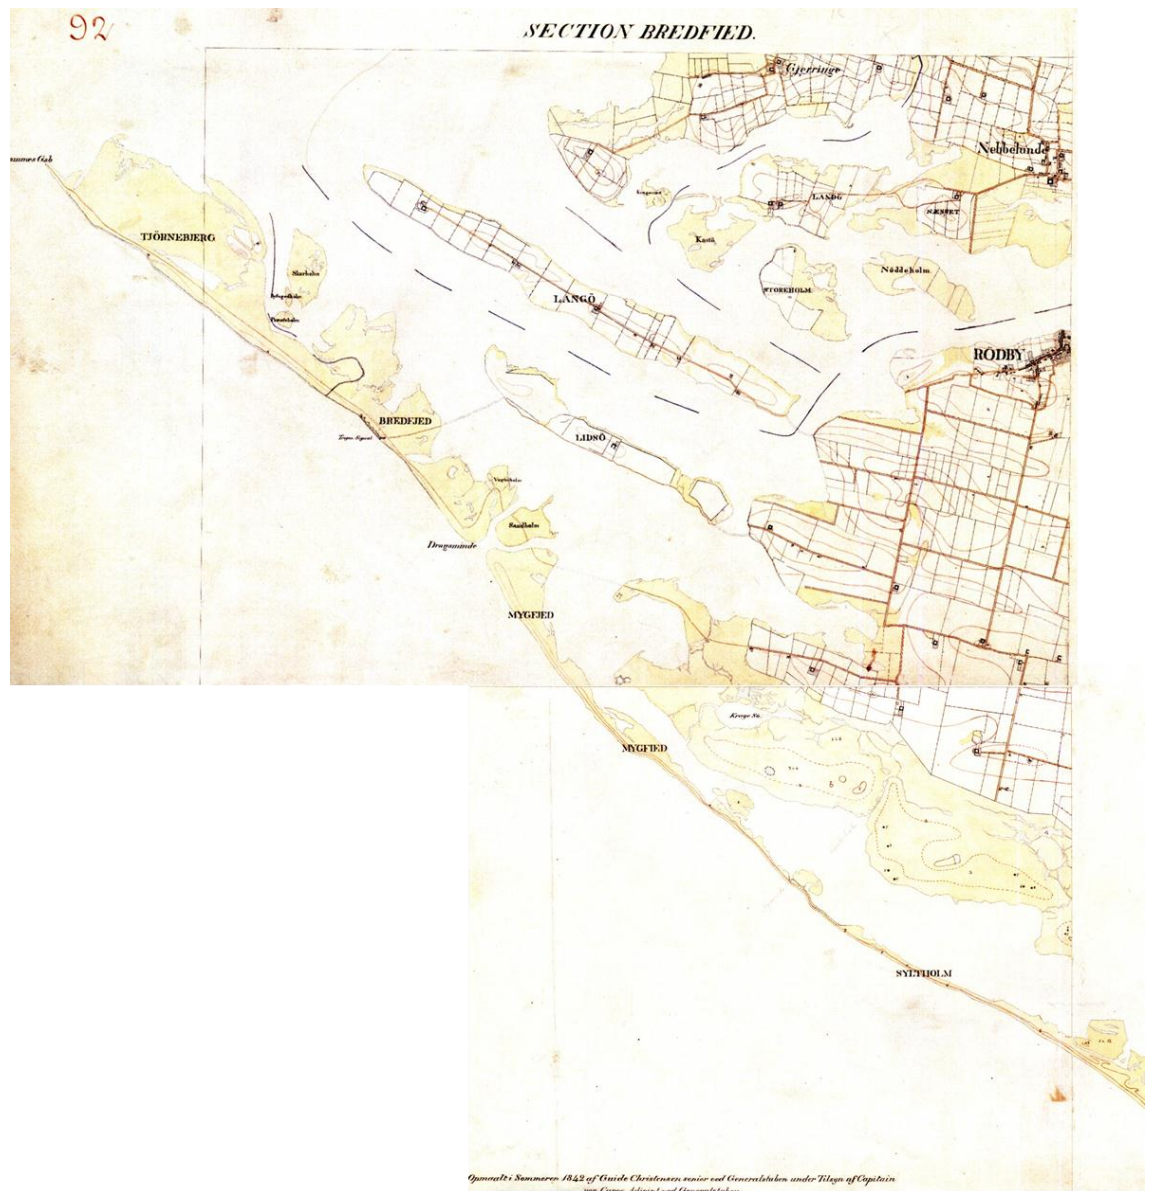
Figure 7.25 Map from 1842 for Rødby area, note the open Rødby Fjord (Contains data from the Danish Geodata Agency, 2010, "Generalkvartermesterstaben")

Before the dike was constructed, the coastal area was an archipelago consisting of a system of coast-parallel islands intersected by shallow coastal lagoons, the so-called Rødby Fjord, see a map of the area near Rødbyhavn from year 1842 in Figure 7.25 and of the Rødby/Rødsand Lagoon area in Figure 6.3 (1763-1805). The islands facing the Fehmarnbelt had the character of barrier islands, which means that they were formed by onshore transport of sand and smoothed by longshore transport processes. These outer islands were clearly different in nature from the other (more inshore) islands due to the active coastal processes. The location and shape of these islands originate from the last glaciation period, where the ice movement was from SSE, see the geological description of this phenomenon in Section 5.

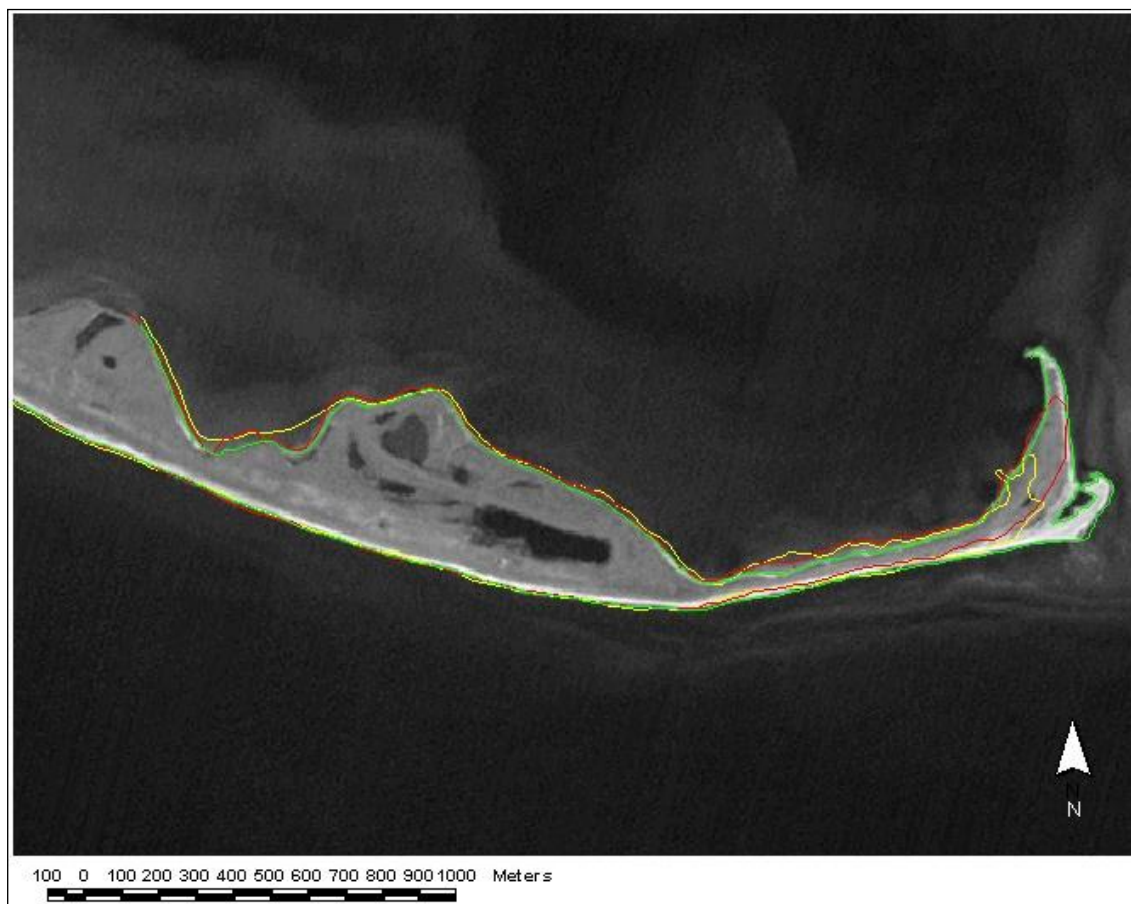
Figure 7.30 Satellite image analysis of the eastern part of Hyllekrog 1973-2003. Background picture dating 2003, marked shorelines: Yellow = 1973. Red = 1986. Green = 2003, from (DHI Water & Environment 2004)

A satellite analysis of the western and eastern parts of Hyllekrog between 1973 and 2003 is presented in Figure 7.29 and Figure 7.30, respectively. The southern shoreline of Hyllekrog formation was generally stable in the period; however, it has been undergoing minor variations. Shifting erosion and accretion takes place along the western and middle sections, where the shoreline is orientated towards SW and SSW. Accretion takes place over the eastern section of about 1 km, where the shoreline has an orientation towards SSE. Prior to this period, between 1945 and 1967, this stretch of shoreline eroded according to (Jensen 2006), see Figure 7.28.

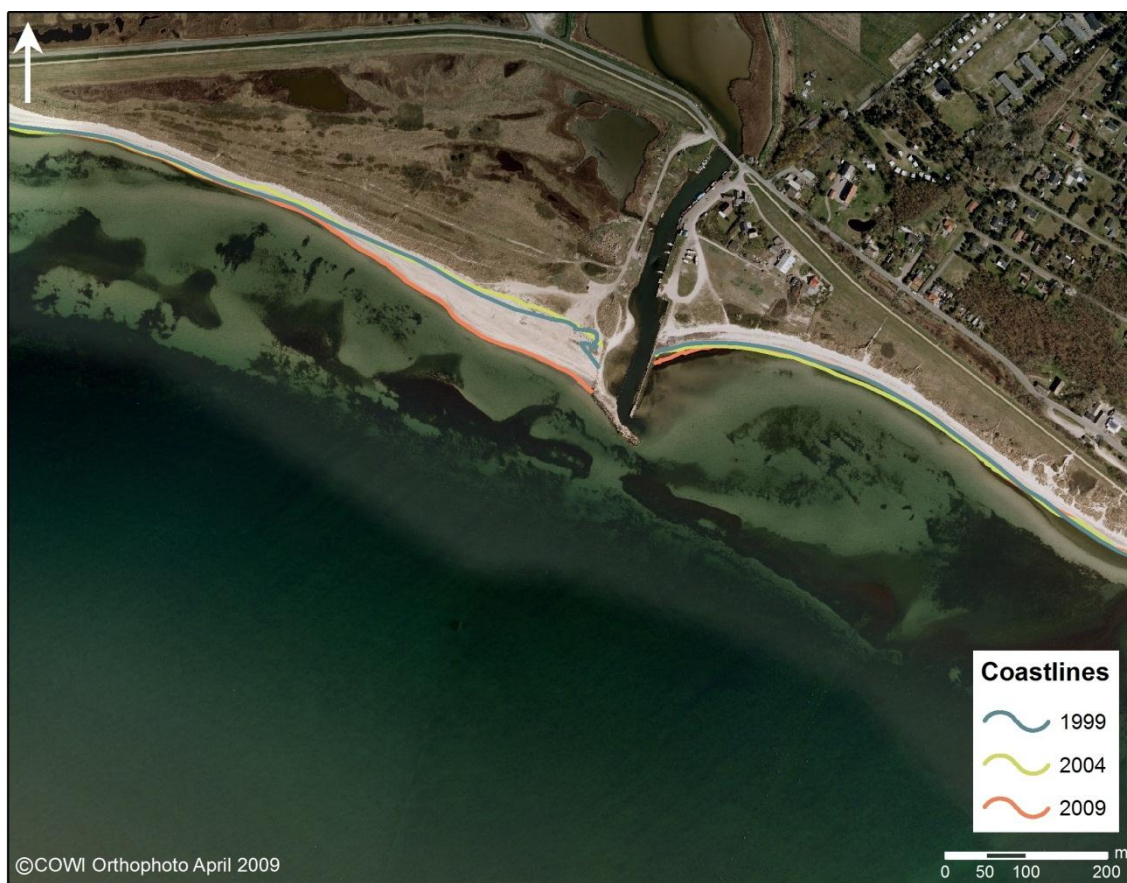
Figure 7.31 Shoreline changes between 1999 and 2009 at Kramnitze. Aerial photo from 2009, (©COWI Orthophoto April 2009)

Sand accumulation takes place west of Kramnitze Fishery Harbour. The accumulation happens over the nearest 400 m west of the western breakwater since 1999, see Figure 7.31. Shorelines from 1999, 2004 and 2009 indicate that a larger sand accumulation took place in the five-year period between 2004 and 2009, than in the previous period between 1999 and 2004, where the shorelines indicate only limited or no erosion/deposition.

Parameter	1999-2004	2004-2009
Length of accumulation (m)	400	400
Height of active coastal profile (m)	3	3
Shoreline movement (m)	~0	+35
Accumulated volume(m ³)	~0	42,000
Dredged volume from accumulation zone (m ³)	30,000	15,000
Total accumulated volume (m ³)	30,000	57,000
Average accumulated volume (m ³ /year)	5,000 m³/year	11,500 m³/year

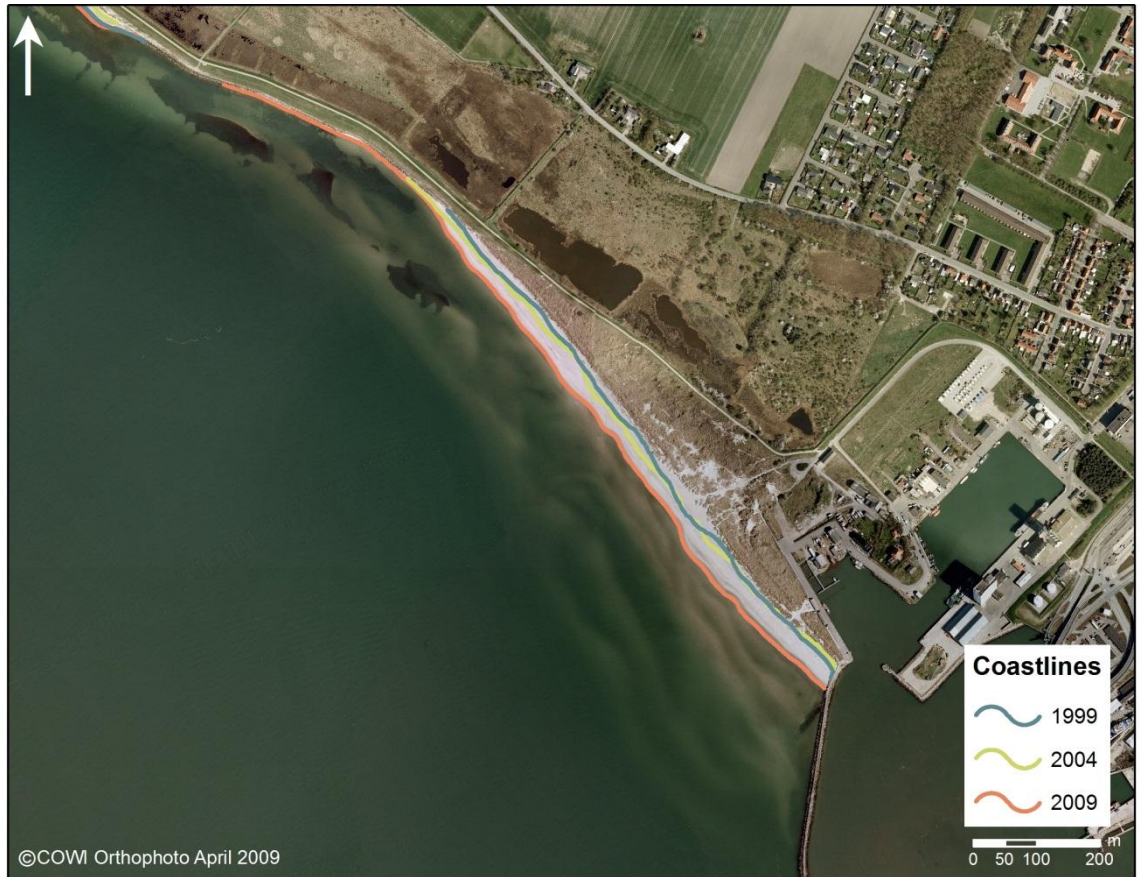
Figure 7.32 Shoreline changes between 1999 and 2009 west of Rødbyhavn. Aerial photo from 2009, (©COWI Orthophoto April 2009)

indicates a larger average annual littoral drift rate along the Lolland coast in the years 2004-2009 than in the previous five years between 1999 and 2004.

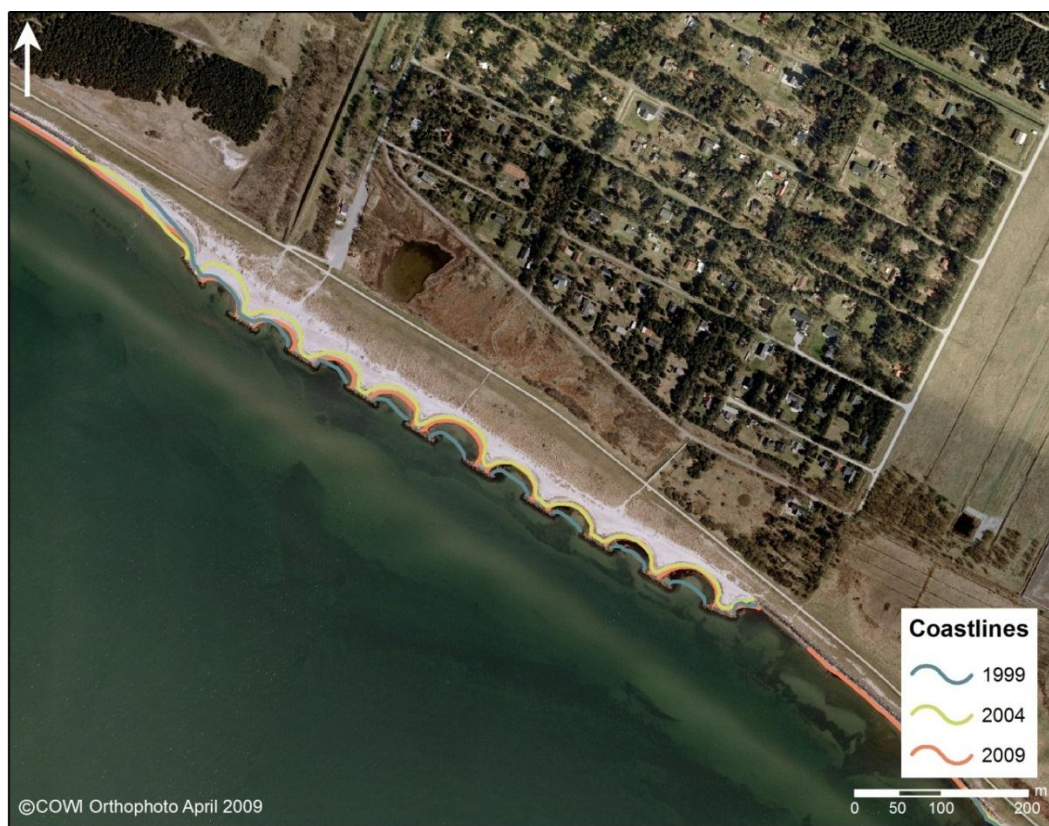
Figure 7.33 Shoreline changes between 1999 and 2009 at Hyldtofte Østersøbad. Aerial photo from 2009 (©COWI Orthophoto April 2009)

An accumulation of sand along the coast about 2.5 km east of Rødbyhavn is seen in the 1999-shoreline (Appendix A, page A-9). The sand volume was a test nourishment of 25,000 m³, which was carried out in 1999 in connection with the construction of the coast protection scheme at Hyldtofte Østersøbad (personal communication with dike engineer S. Aa. Sørensen). The sand "disappeared" over the winter 1999-2000, but the sand was visible in the following years in the bar system eastward of the nourishment location.

Approximately 1.5-2.5 km east of Hyldtofte Østersøbad, erosion takes place and the shoreline retreats with an average rate of up to 1 m/year in the period 1999-2009.

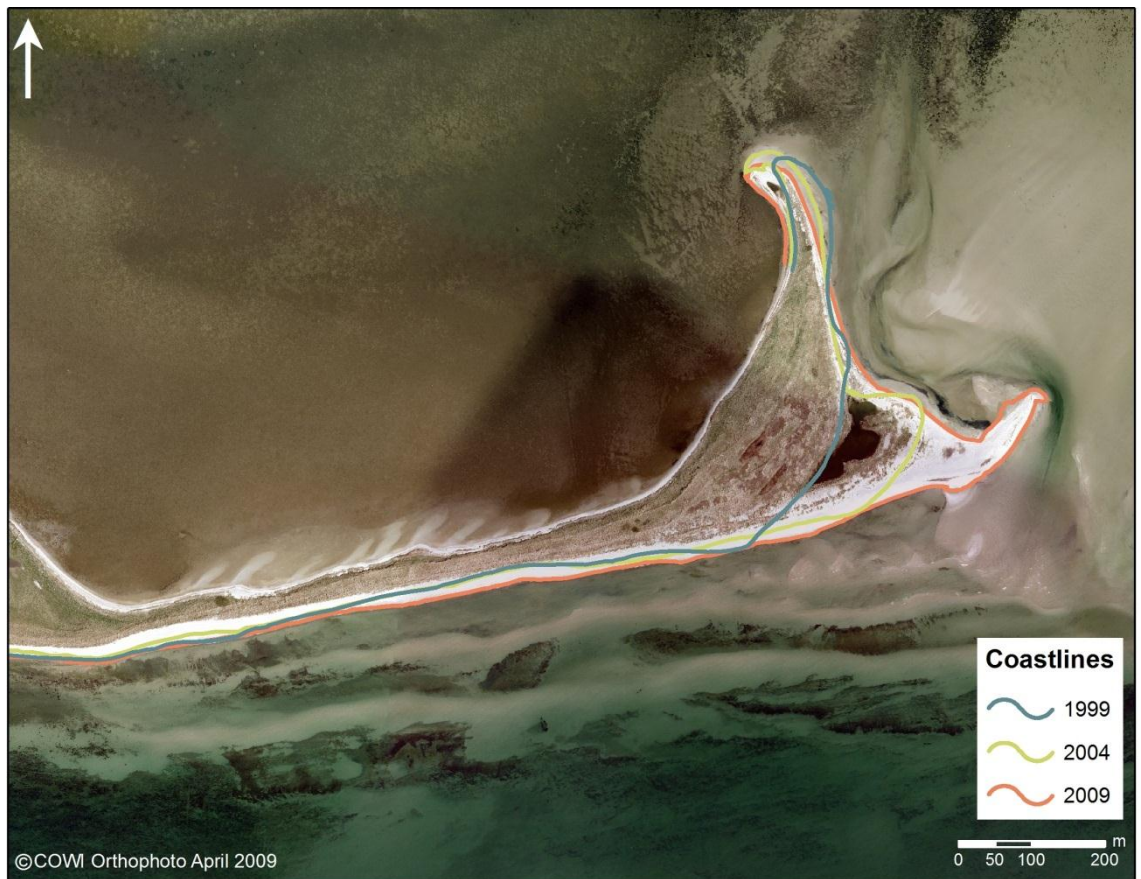
Figure 7.34 Shoreline changes between 1999 and 2009 at Hyllekrog. Aerial photo from 2009 (©COWI Orthophoto April 2009)

The mechanism is probably that when the northward extension becomes too long, it shifts to an eastward extension, which after some years again will shift to a northward extension.

There are no signs of recent over-wash of the formation. Hyllekrog is an active barrier island formation, which is overall stable, however, moving slowly northward and growing towards east. It is evaluated that there is a risk of local over-wash/breaching in the future, especially as a result of the expected sea level rise. However, a breach during an extreme event will probably close again by natural means. It is important for the stability of the Hyllekrog formation that the supply of sand by the littoral drift from west is maintained.

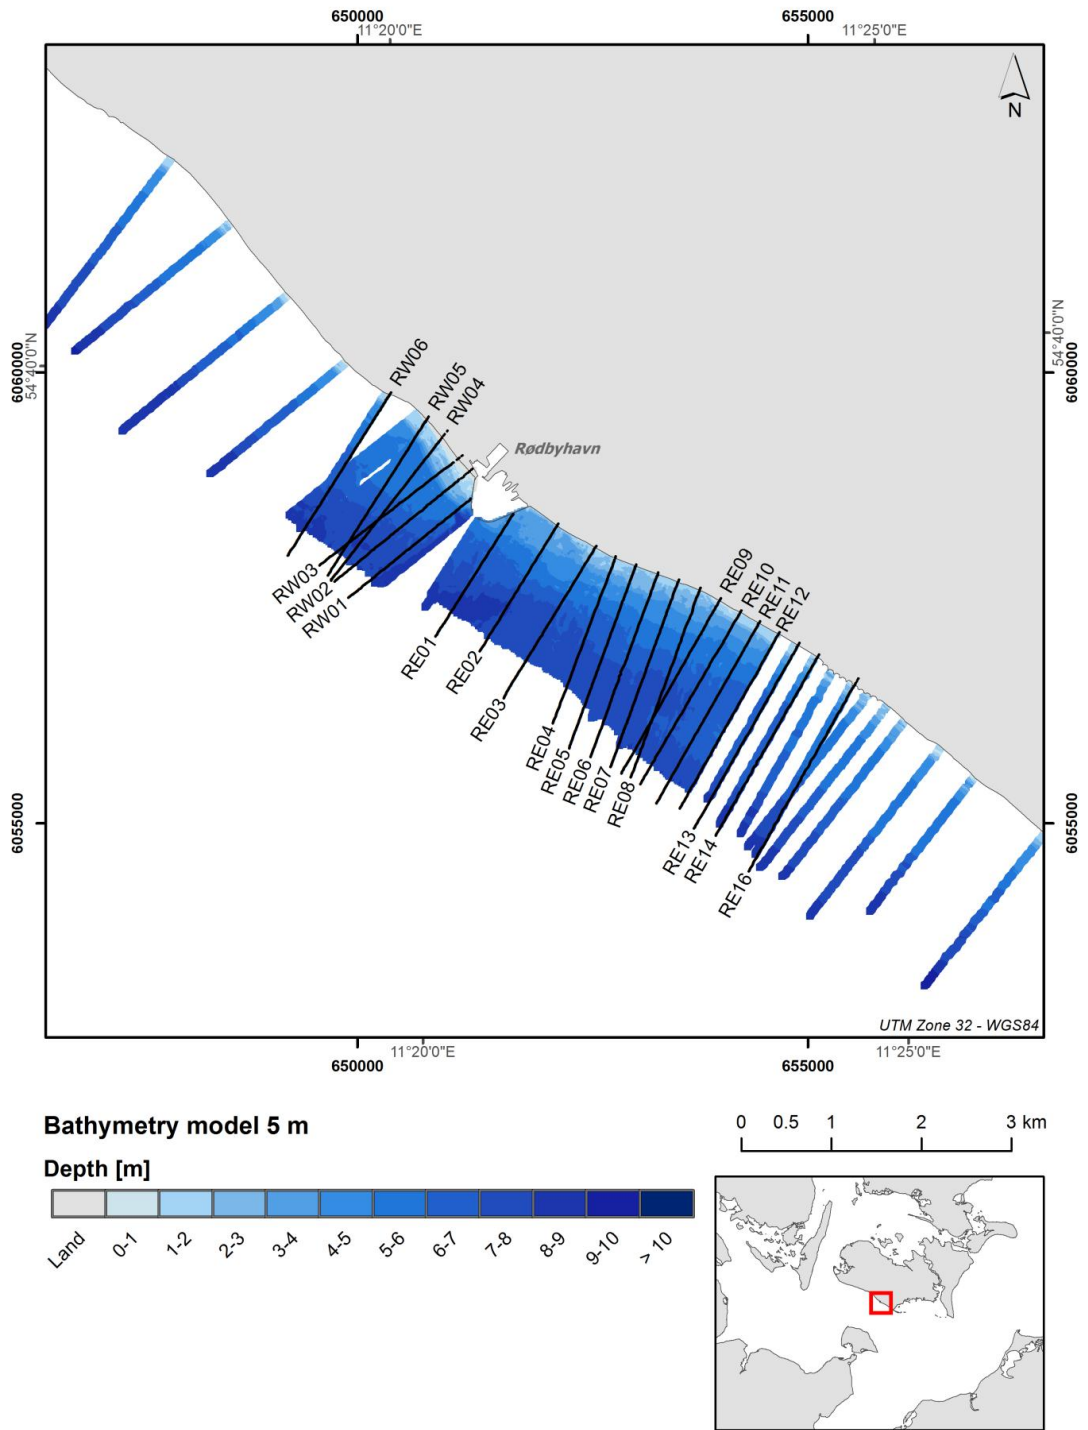
Figure 7.35 Bathymetric map for the Lolland coastal area from the 2009 survey with location of 1998 profiles indicated as black lines

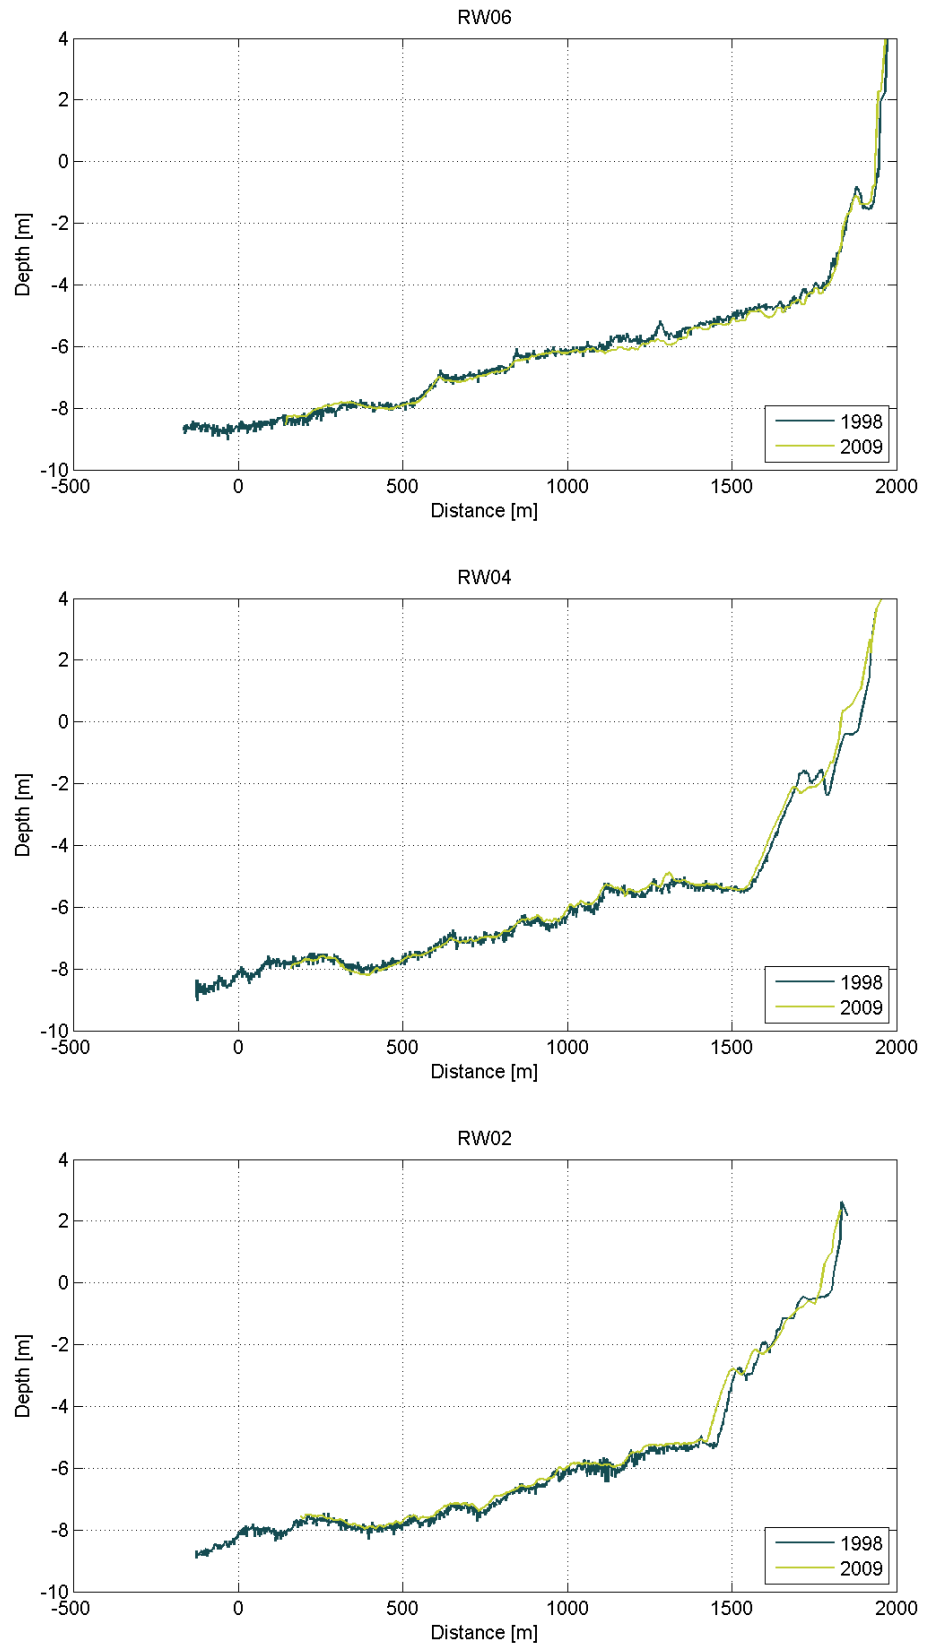
Figure 7.36 Coastal profiles RW06, RW04 and RW02 west of Rødbyhavn, 1998 and 2009. Depths relative to DVR90

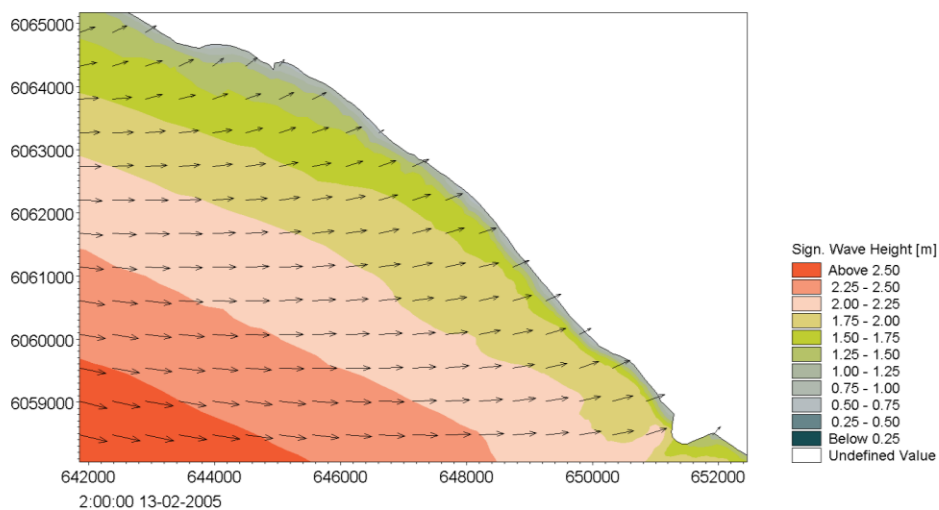
Figure 7.46 Typical wave pattern west of Rødby for westerly waves. Date of situation: 13.02.2005

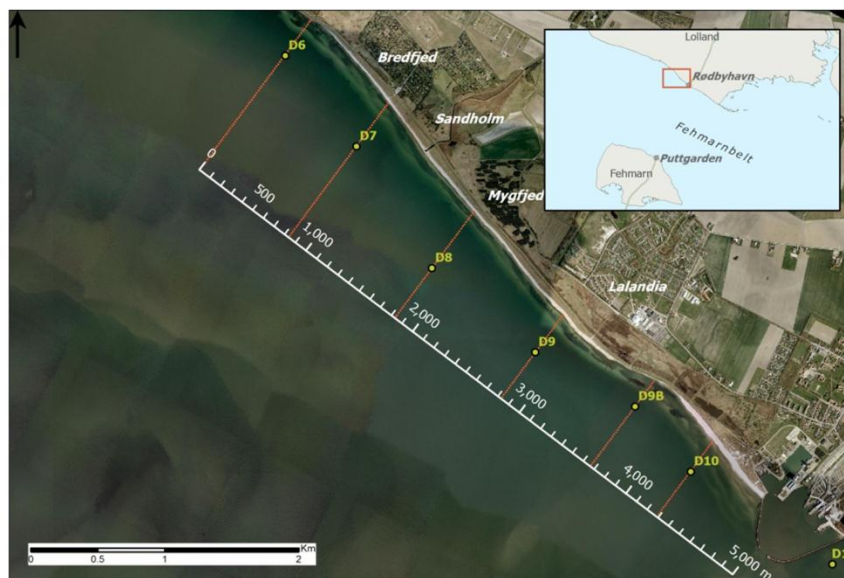
Figure 7.55 Upper panel: baseline and locations of overall sediment budget calculation points. Aerial photo from 2009 (©COWI Orthophoto April 2009)
