FEHMARNBELT FIXED LINK HYDROGRAPHIC SERVICES (FEHY)

Marine Soil - Baseline

Coastal Morphology along Fehmarn and Lolland

E1TR0056 - Volume III

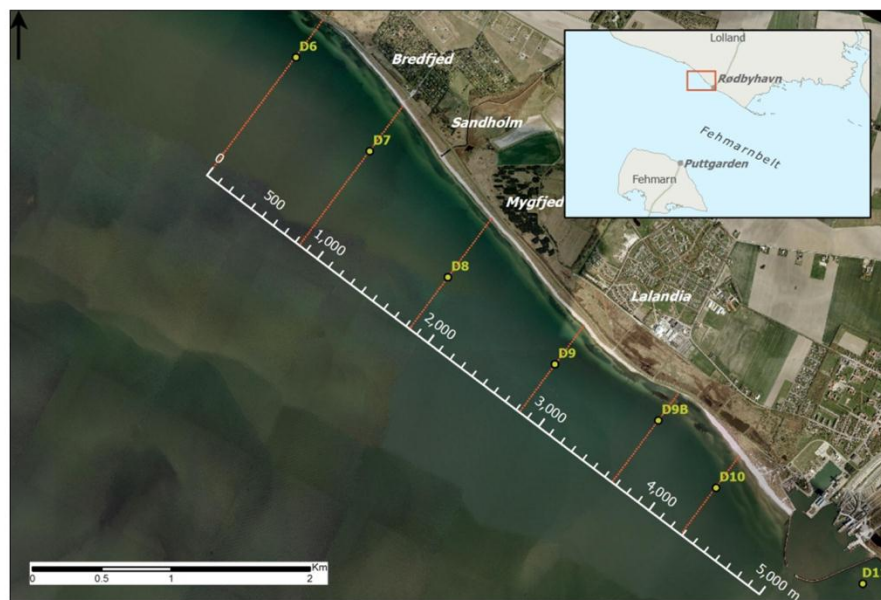
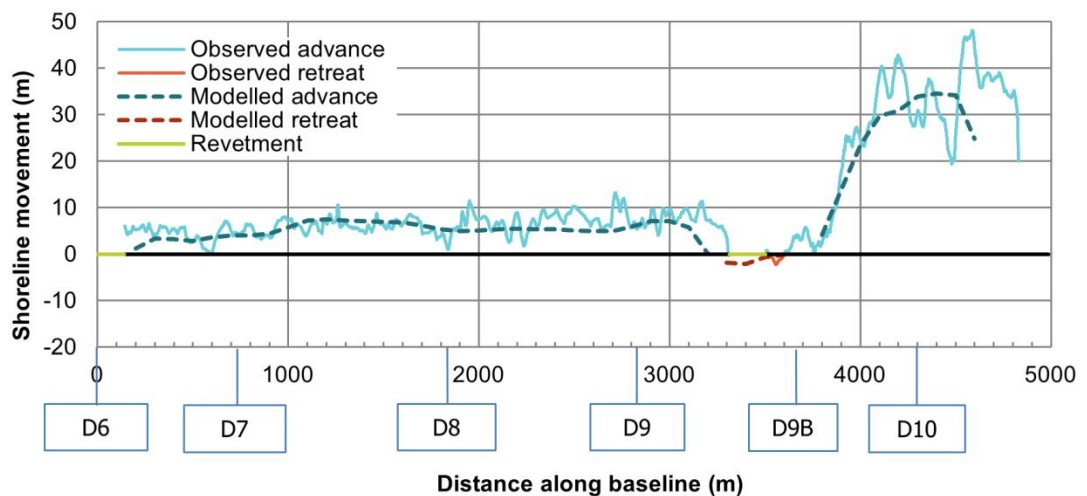
Figure 7.56 Simulated shoreline evolution over 10 years using the long term average wave climate, 1989-2010, compared with the observed shoreline evolution 1999-2009, west of Rødbyhavn. Aerial photo from 2009 (©COWI Orthophoto April 2009)

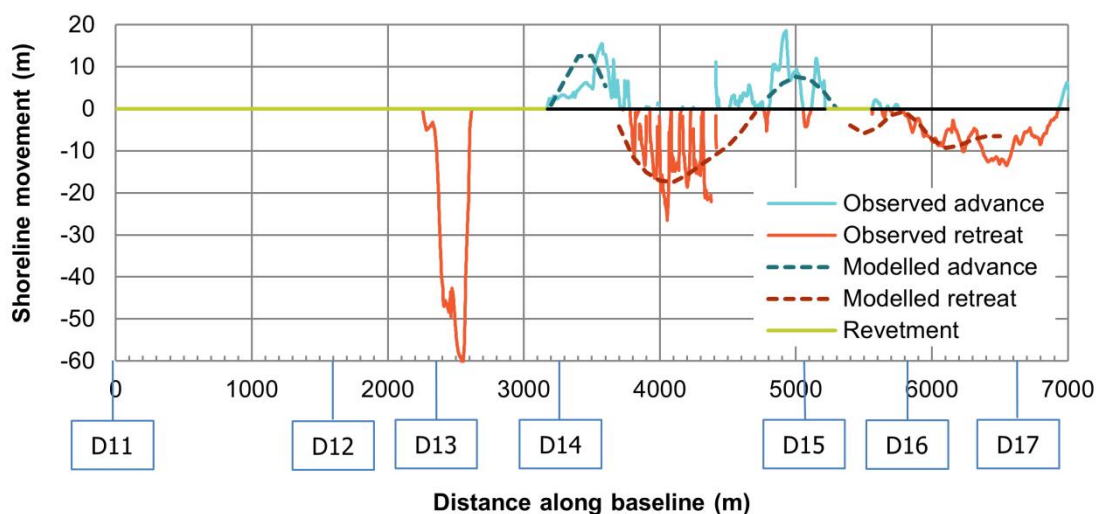
Figure 7.57 Simulated shoreline evolution over 10 years using the long term average wave climate, 1989-2010, compared with the observed shoreline evolution 1999-2009 east of Rødbyhavn. Aerial photo from 2009 (©COWI Orthophoto April 2009)

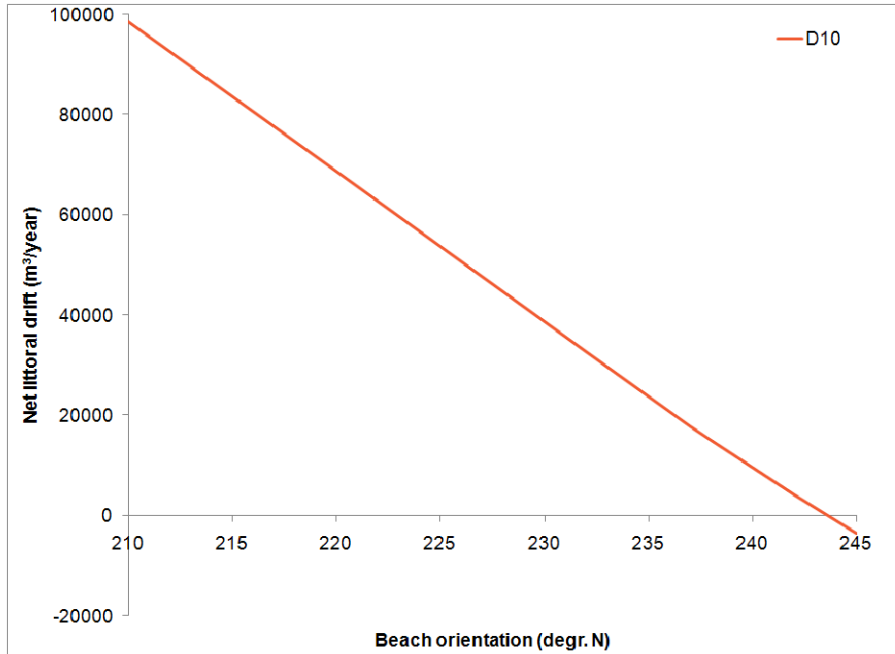
Figure 7.59 "Q-alpha" relation(relation between net littoral drift and shoreline orientation) for D10

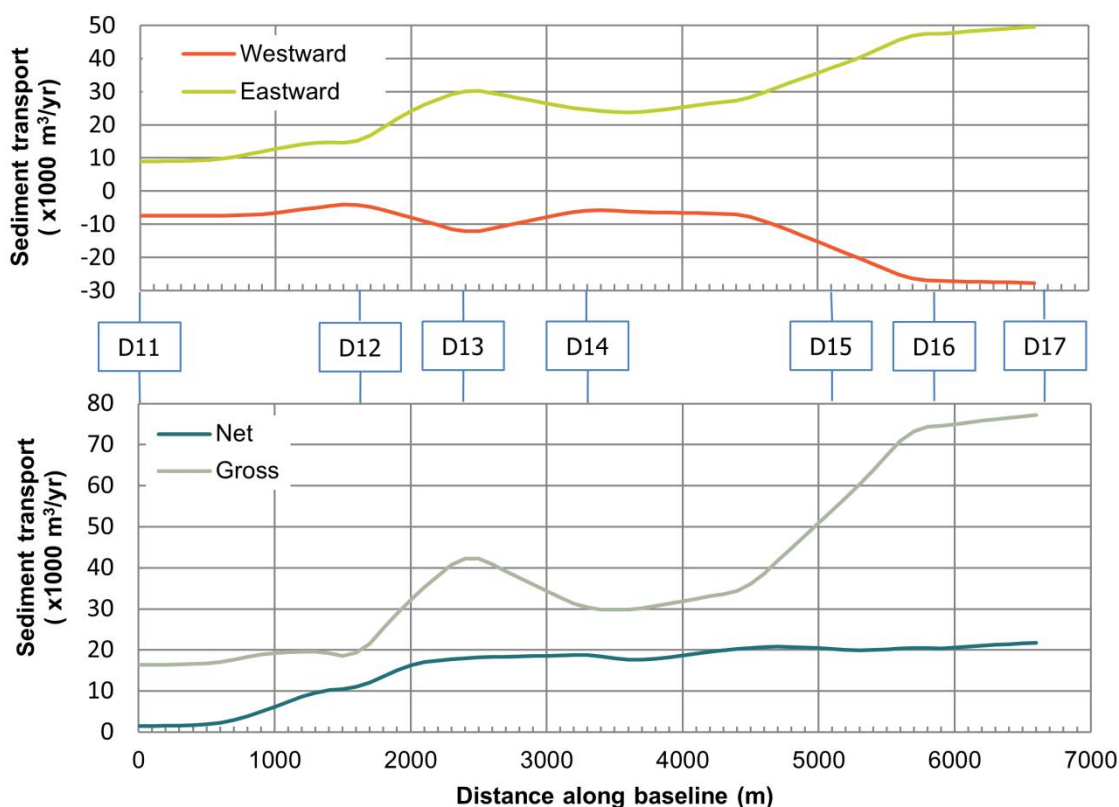
Figure 7.61 Average littoral drift transport rates east of Rødbyhavn. Middle figure: East- and west going transport conditions, Lower figures: net and gross transport rates. Aerial photo from 2009 (©COWI Orthophoto April 2009)

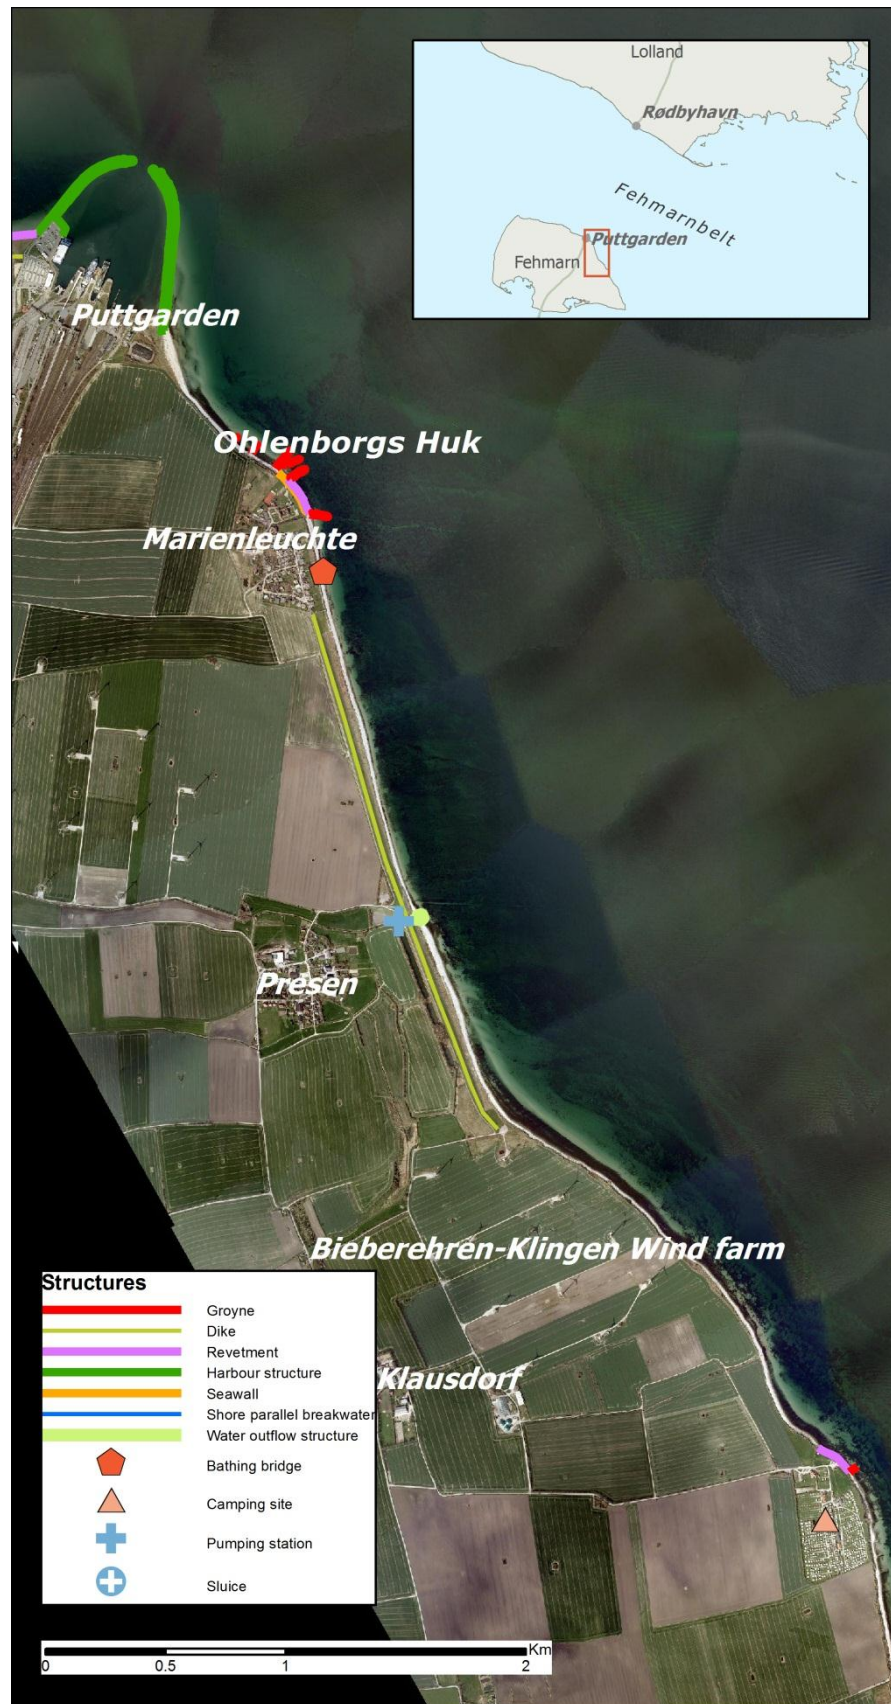
Figure 8.3 Overview of coastline and coastal structures from Puttgarden and Klausdorf. Aerial photo from 2009 (©COWI Orthophoto April 2009). Note: Bieberehren-Klingen wind farm is not the correct name of the wind farm south of Presen.

Aerial photos indicate also submerged groynes protecting cables in this area (Figure 8.3).

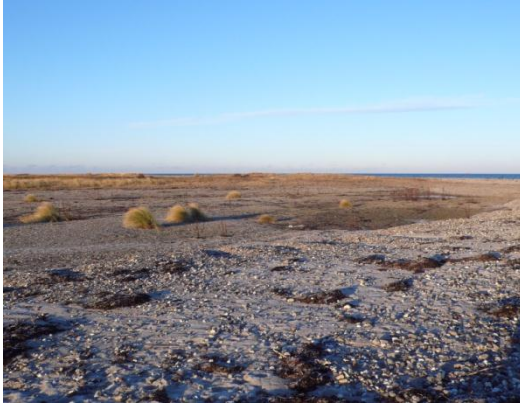
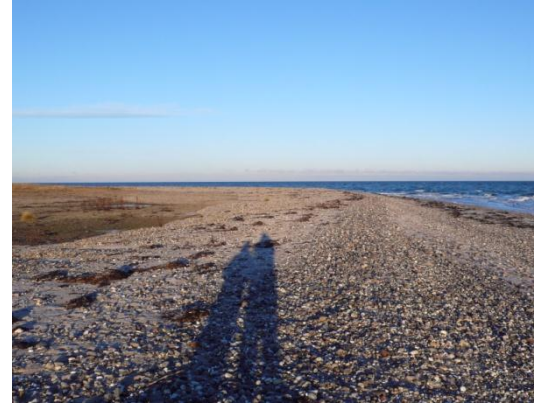
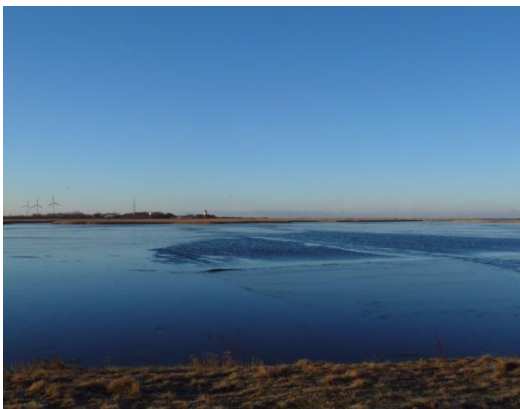
Figure 8.4 Markendorfer Huk cusplate foreland. Upper: spit and tidal meadow formations near the Huk. Lower left: westernmost part of Nördlicher Binnensee. Lower right: sand/gravel beach at north coast of Markendorfer Huk

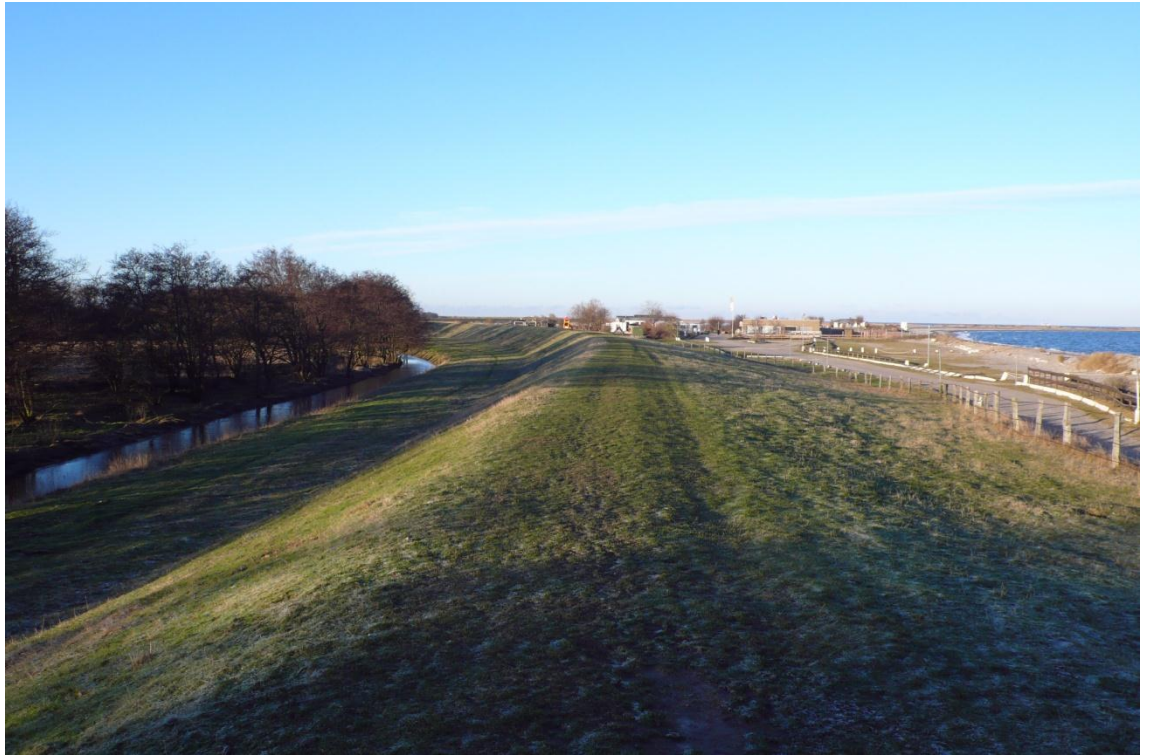
Figure 8.5 Dike at the east end of the westernmost of the three Binnensee lakes

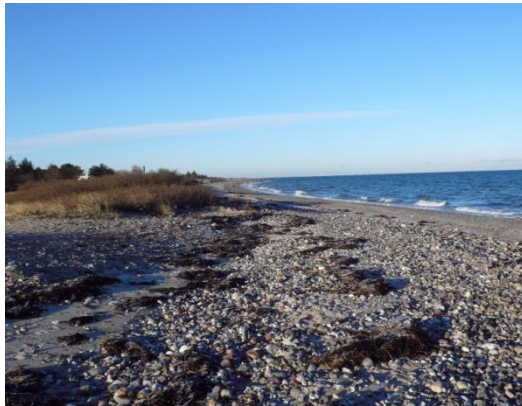
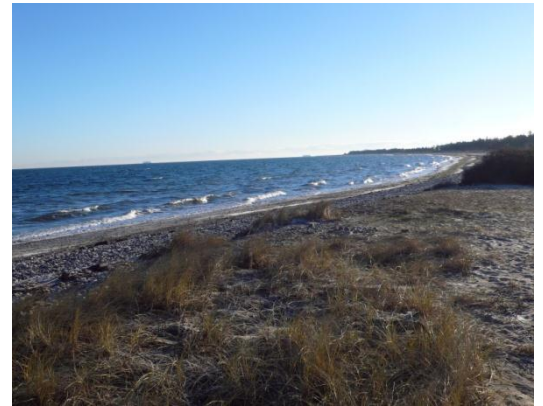
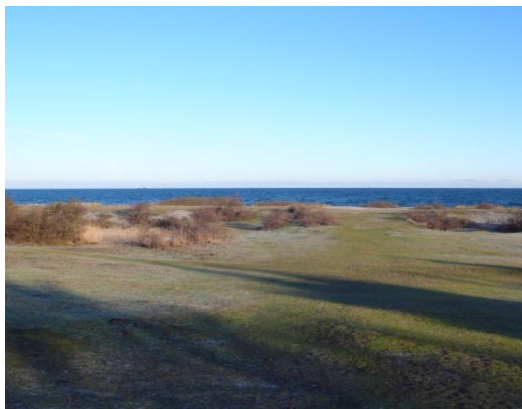
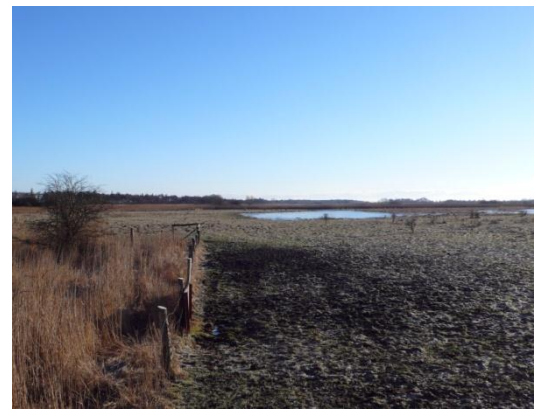
Figure 8.6 *Teichhof off Wenkendorf. Upper: sand/gravel beach. Lower left: wide dune area off the dike. Lower right: part of the easternmost Binnensee, photo taken from the road towards east*

Along the stretch from Markelsdorfer Huk to Gammendorf a series of irregular beach undulations is present. The width of the beach varies along this stretch and some places a relatively wide coastal area can be seen with dunes in front of the dike, see Figure 8.6.

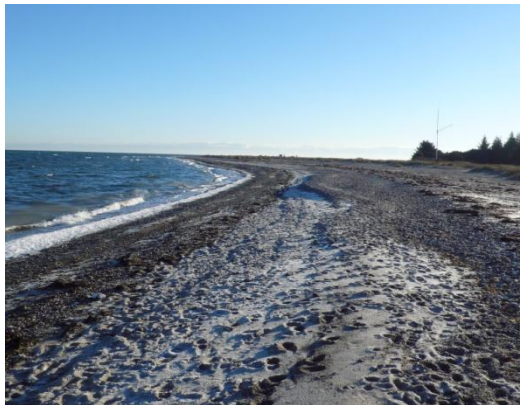
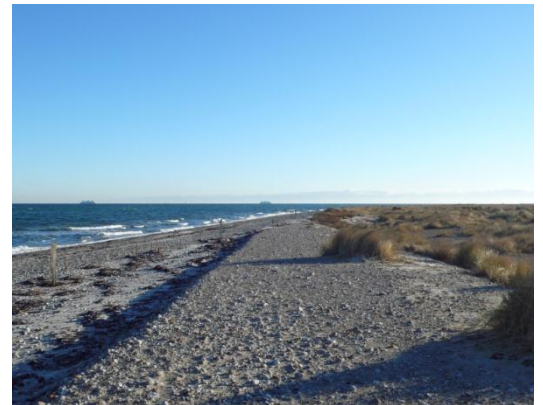
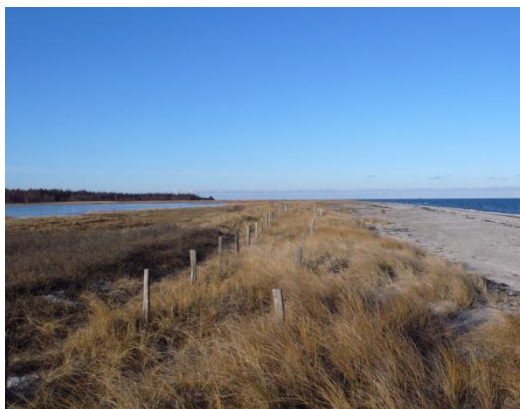
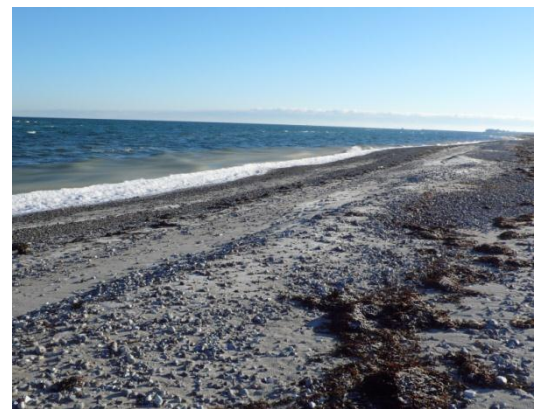
Figure 8.9 Grüner Brink. Upper left: western end of GB where it departs from the original shoreline. Upper right: overwash fan at the north facing part of GB. Lower left: mid part of GB, coastal lagoon, dunes and backshore. Lower right: Mid part of GB, sandy beach with gravel and seabed berms

The Grüner Brink has a total length along the coast of 2.3 km and a width perpendicular to the shoreline of about 400 m. Photos in Figure 8.9 - Figure 8.11 illustrate the coastline at the Grüner Brink. Photos from the west and mid part of Grüner Brink are presented in Figure 8.9.

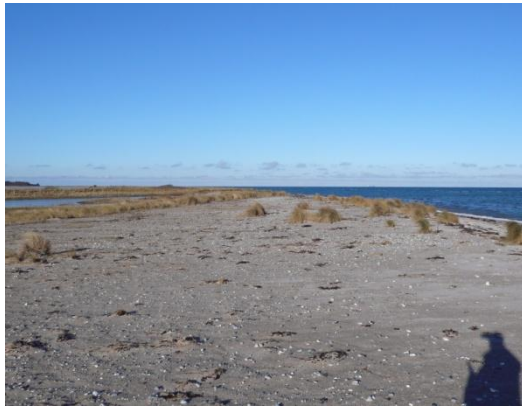
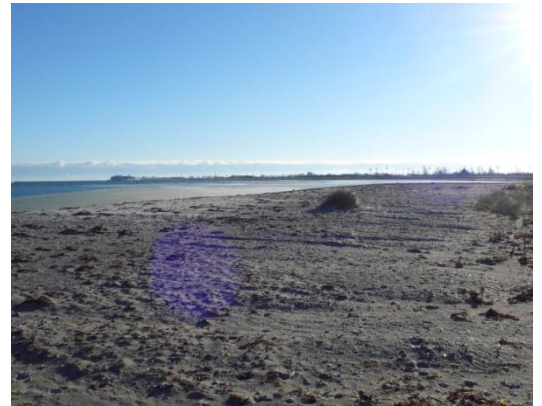
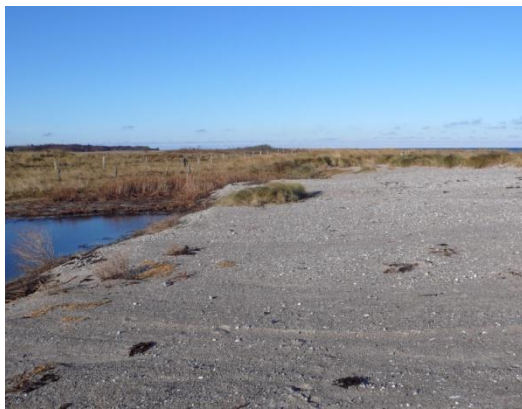
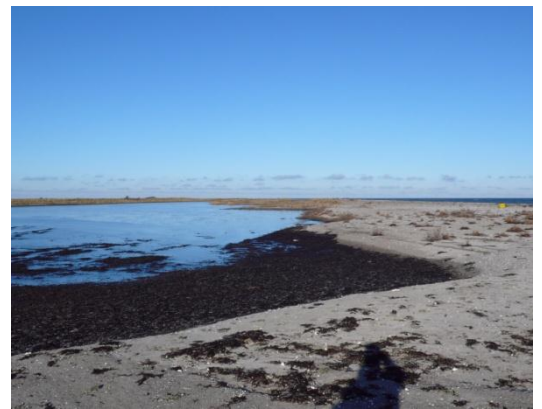
Figure 8.10 *Brüner Brink, eastern part. Upper left: root of sand spit towards NW. Upper right: along the sand spit, towards SE. Lower left: overwash fan at NW end of sand spit. Lower right: coastal lagoon behind sand spit with seaweed accumulations*

The present sand spit, which is nearly connected to land and encloses a new small coastal lagoon, is seen in the photos in Figure 8.10. A lot of seaweed accumulates in the lagoon.

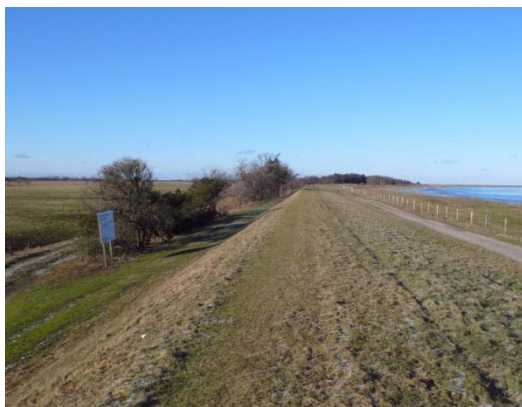
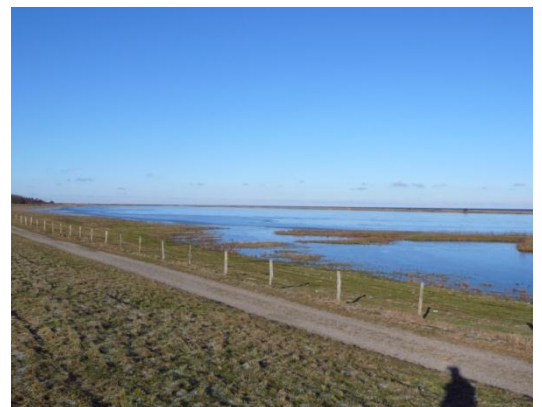
Figure 8.11 *Dike landwards of Grüner Brink and the coastal lagoon. Left: the dike. Right: the coastal lagoon of Grüner Brink*

The dike runs on the landward side of the Grüner Brink Lagoon, see the photos in Figure 8.11.

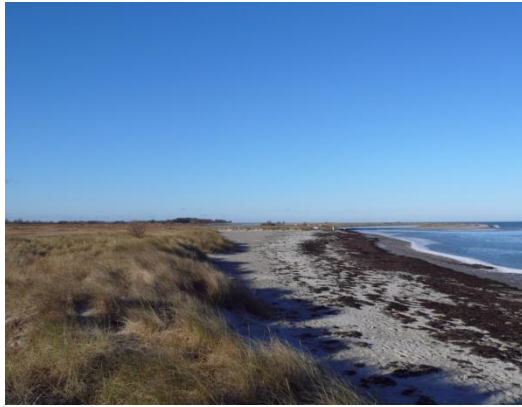
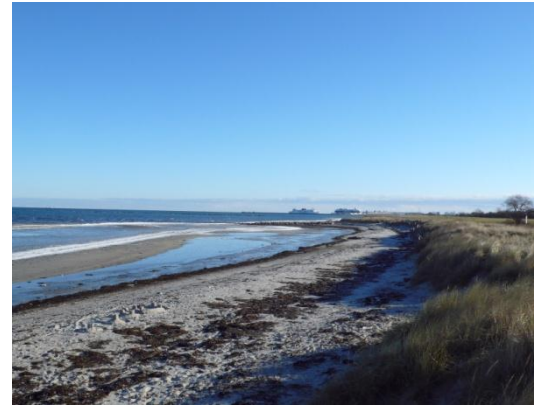
Figure 8.12 Beach east of Grüner Brink. Left: towards NE, sand spit of GB in the background. Right: towards ESE, outlet structure in the background

There is a sandy beach from the eastern end of Grüner Brink and about 1 km towards east, see photos in Figure 8.12. The beach is a public beach with parking facilities and a restaurant available behind the dike. The backshore is artificially cleaned for vegetation, see left photo in Figure 8.12 and aerial photo in Figure 8.2.

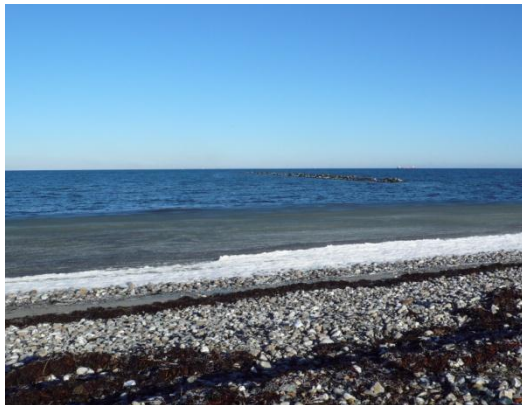
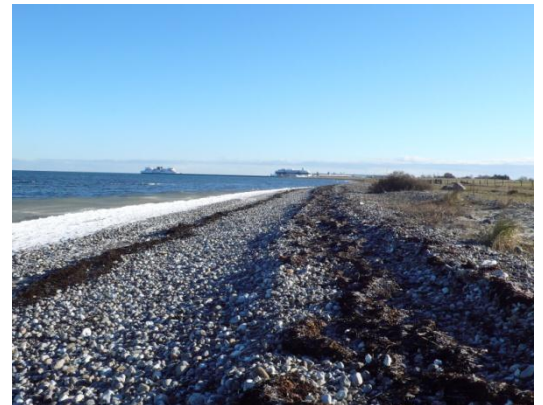
Figure 8.13 Shingle beach landward of the long groyne. Left: shingle beach at salient, groyne in the background. Right: eastern part of the salient, shingle beach

There is a salient in the shoreline landward of the long detached groyne, see photos in Figure 8.13, indicating a local westward net transport east of the groyne. The beach consists mainly of shingle at this location.

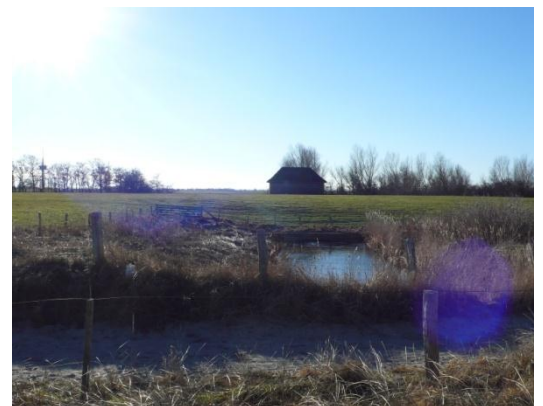
Figure 8.14 Drain outlet for the Blankwisch wetland. Left: outlet protected by rubble mound jetties. Right: channel from pumping station leading to outlet

There is a drainage outlet in the middle of this section from the Blankenwisch wetland, which is protected by two 30 m long rubble mound jetties, see photos in Figure 8.14.

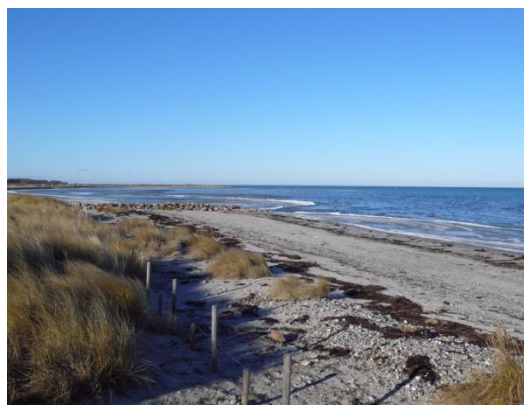
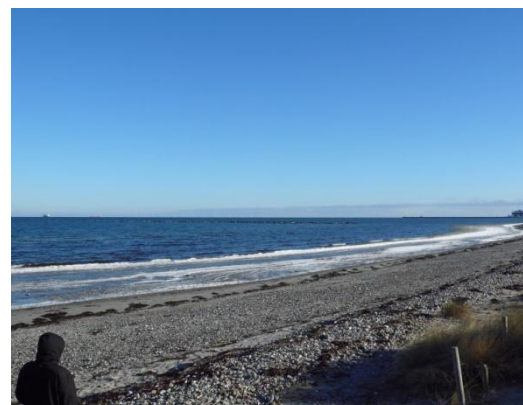
Figure 8.15 Beach east of outlet for the Blankenwisch wetland, sandy beach with shingle berms. Left: beach east of the outlet supported by the outlet structure. Right: view towards E, the long detached groyne is seen in the background

Sand has accumulated east of the drainage structures indicating a local westward littoral transport in the area east of the outlet structure, see photos in Figure 8.15.

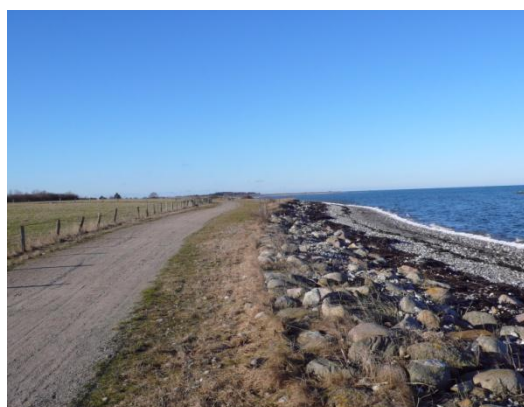
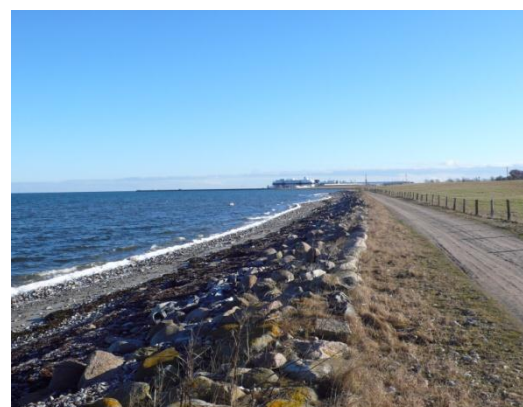
Figure 8.16 Revetment starting about 100 m east of the long groyne. Left: towards west, revetment and shingle beach, long groyne is seen in the background. Right: towards east, revetment and very narrow shingle beach in front of the dike

There is only a very narrow shingle beach along the dike between the salient at the long groyne and Puttgarden; the dike is protected by a revetment along this stretch, see photos in Figure 8.16. No natural development of the shoreline has taken place along this stretch the last 100 years. A caravan site is located behind the dike approximately 0.5 km west of Puttgarden.

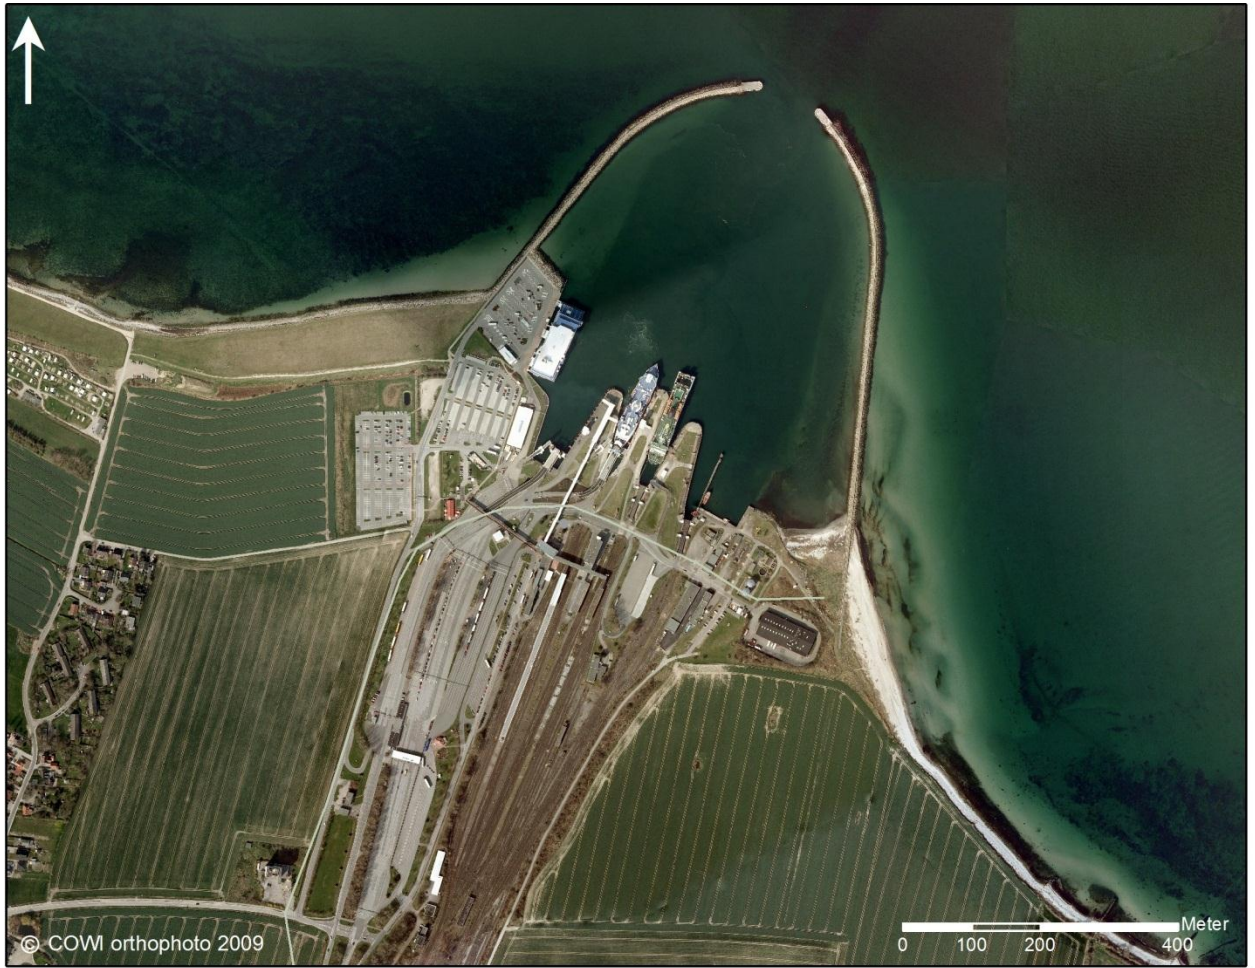
Figure 8.17 Puttgarden (©COWI Orthophoto April 2009)

Puttgarden (Figure 8.17) was constructed in 1962-63, and at the same time a long groyne (approximately 350 m) detached from the shoreline was built about 1.4 km west of the harbour as described above.

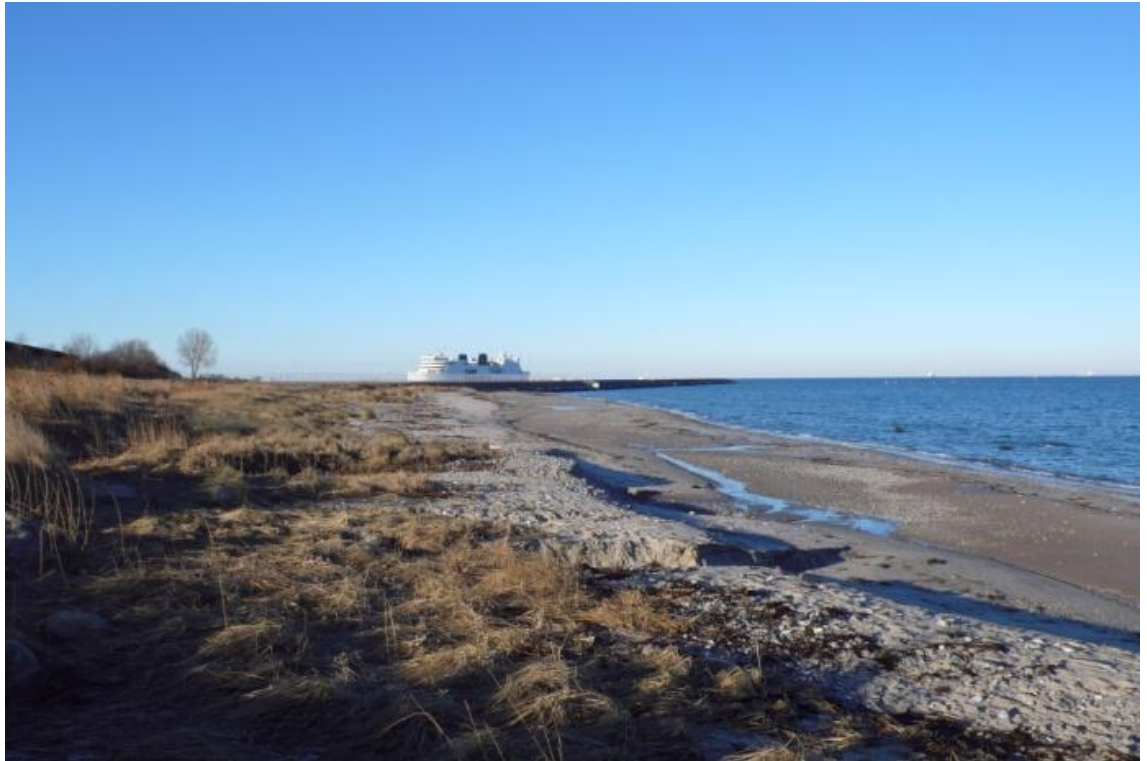
Figure 8.18 Sand accumulation SE of Puttgarden

A small sand accumulation is located SE of the east breakwater of Puttgarden, in the corner between the breakwater and the coastline. The very small sand accumulation indicates that the supply of sand to the area is very small since sand has accumulated over a period of about 50 years. Photos from the accumulated beach are presented in Figure 8.20.

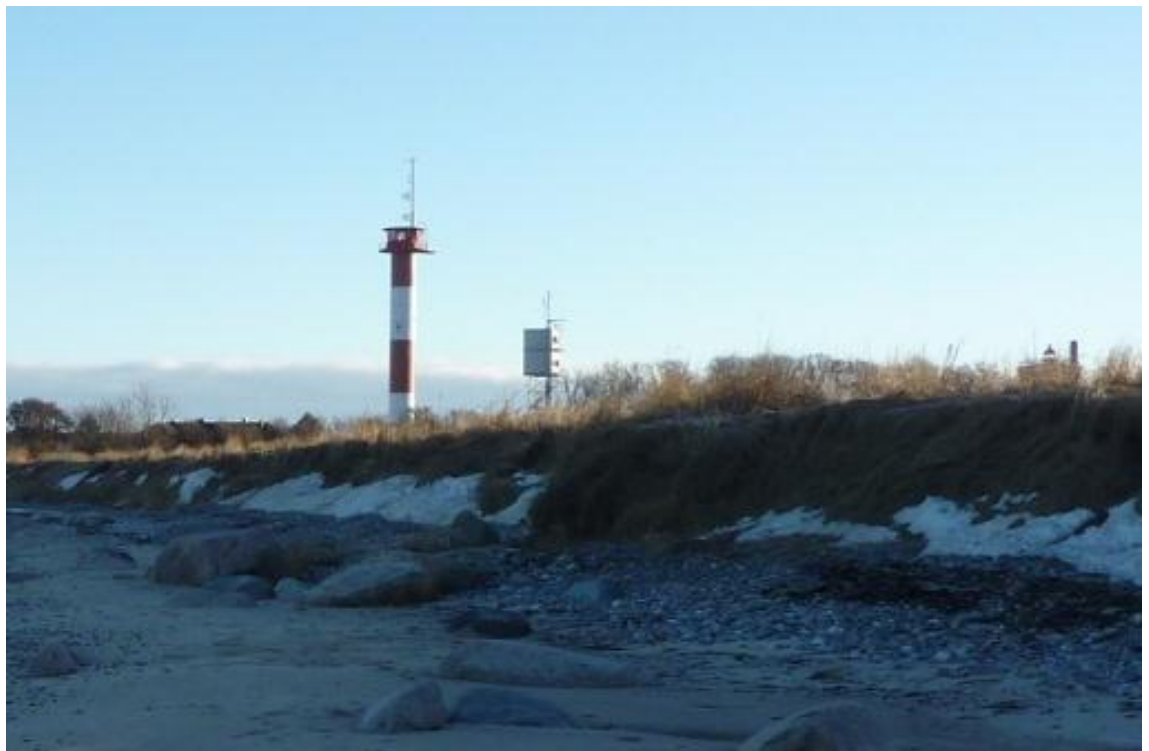
Figure 8.19 New Lighthouse at Marienleuchte. The old lighthouse is seen (partly behind the cliff) to the right in the photo.

The village of Marienleuchte is located about 700 m SE of Puttgarden immediately south of the headland Ohlenborgs Huk, which is an about 5 m high till formation. The northern part of the town is occupied by the naval coastal station Marienleuchte (“Marineküstenstation Marienleuchte”) with a lighthouse, see Figure 8.19.

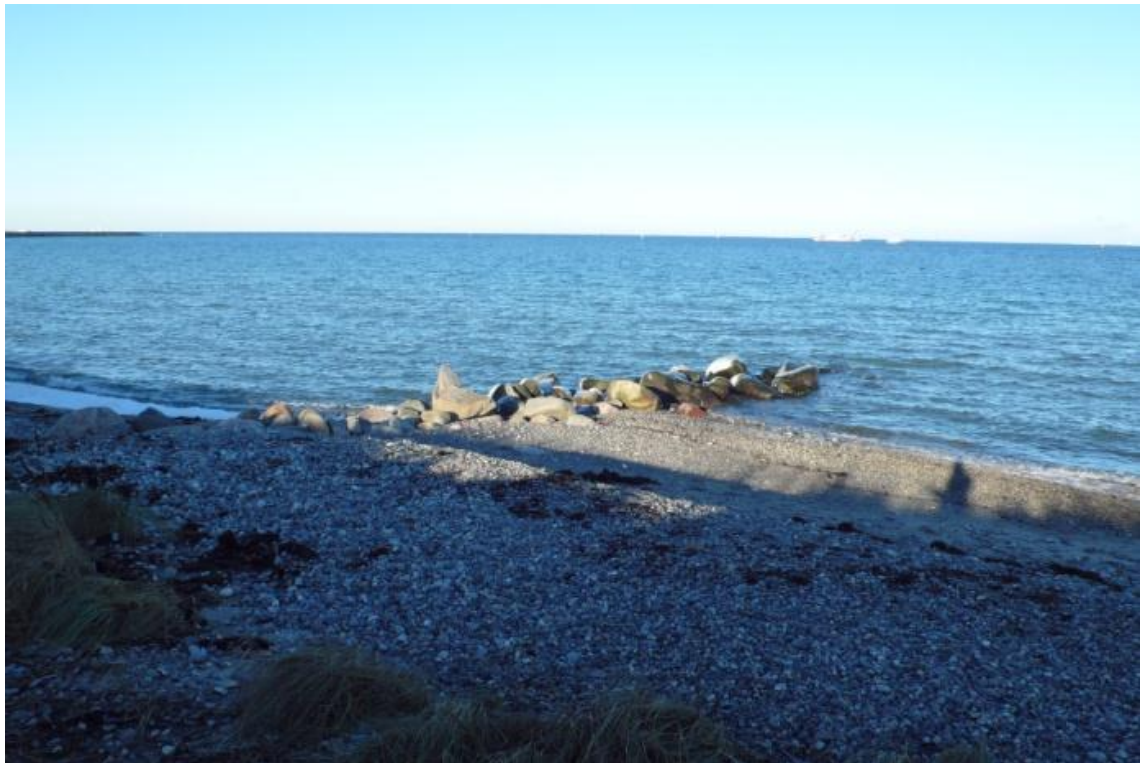
Figure 8.20 *Stretch between Puttgarden and Marienleuchte. Shingle accumulation at groyne located NW of Marineleuchte*

There are three small groynes immediately north of Marienleuchte. Accumulation of sediment occurs at the southeastern side of these small groynes indicating a net transport of sand towards northwest in this area (Figure 8.20). The accumulated material in the groynes is mainly shingle.

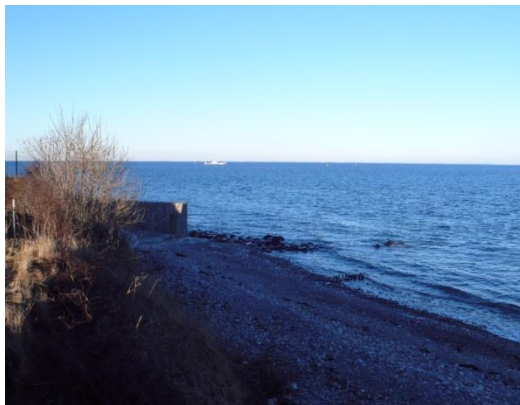
Figure 8.21 *Seawall at naval coastal station Marienleuchte. Left: Southern part of seawall at naval coastal station with remains of groynes. Right: vertical seawall fronted by glacis*

The naval coastal station Marienleuchte is protected by a massive vertical seawall fronted by a stone glacis/revetment and there are remains of some groynes near the southern end of the seawall, see photos in Figure 8.21.

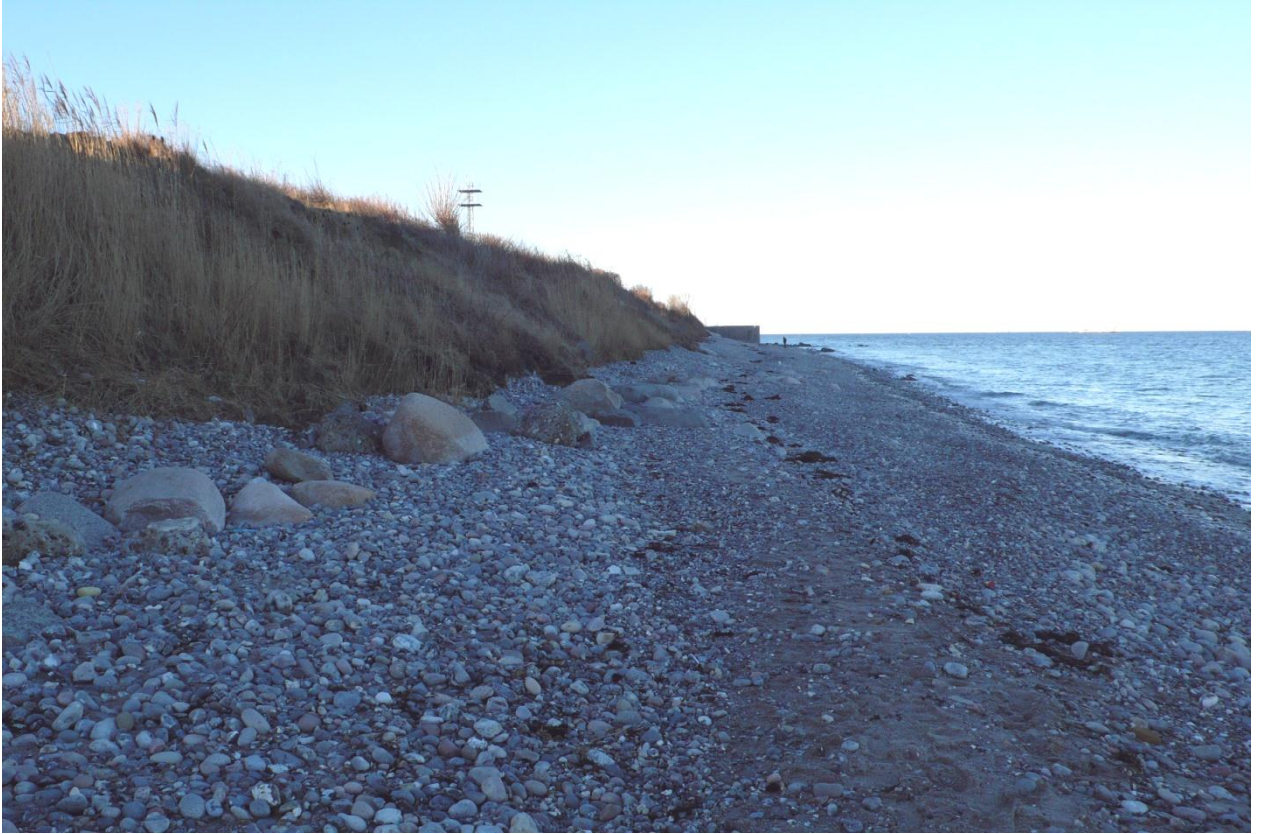
Figure 8.22 Cliff off Marienleuchte village, seawall at naval coastal station seen in the background. Shingle beach and a low revetment

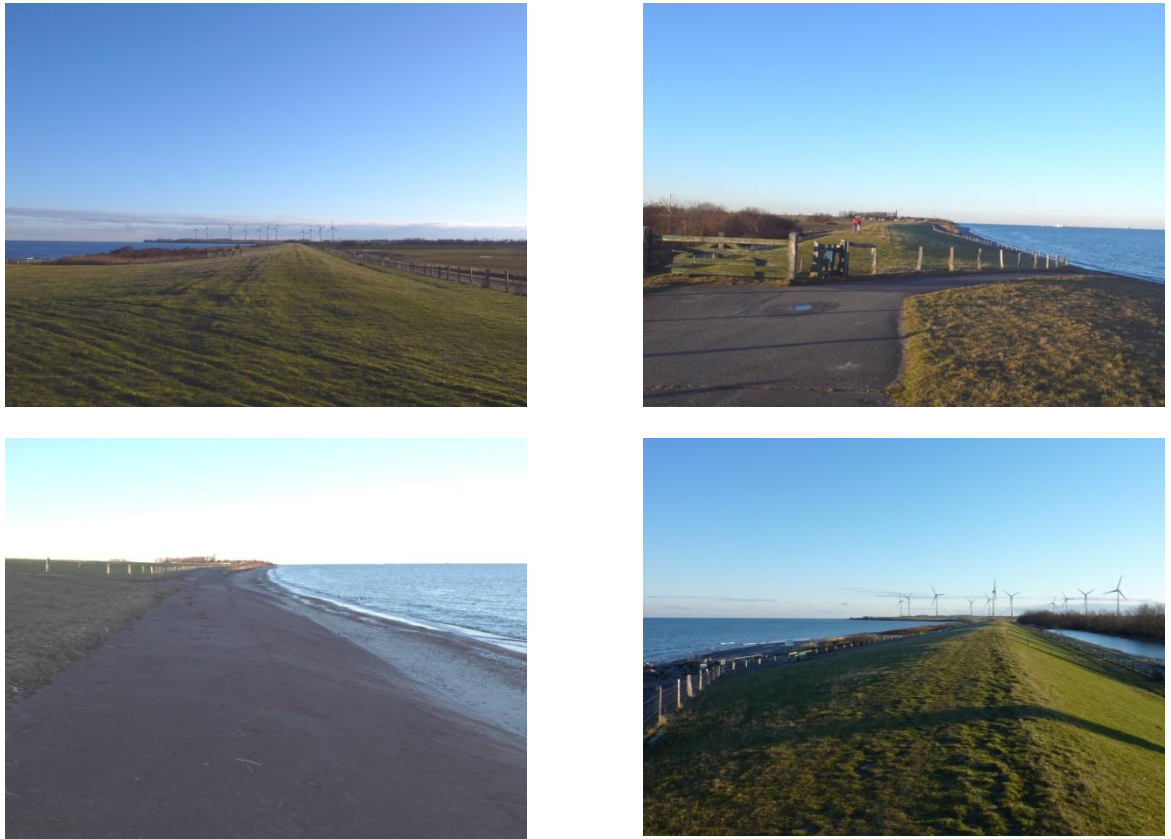
Figure 8.23 Dike between Marienleuchte and the till cliff off Klausdorf, protecting the low lying land around Presen. Upper left: northern end of dike immediately south of Marienleuchte. Upper right: southern part of dike north of pumping station off Presen. Lower left: asphalt revetment of dike north of drainage outlet at Presen, sandy/shingle beach off the dike. Lower right: dike from pumping station towards SSE, drainage canal along dike

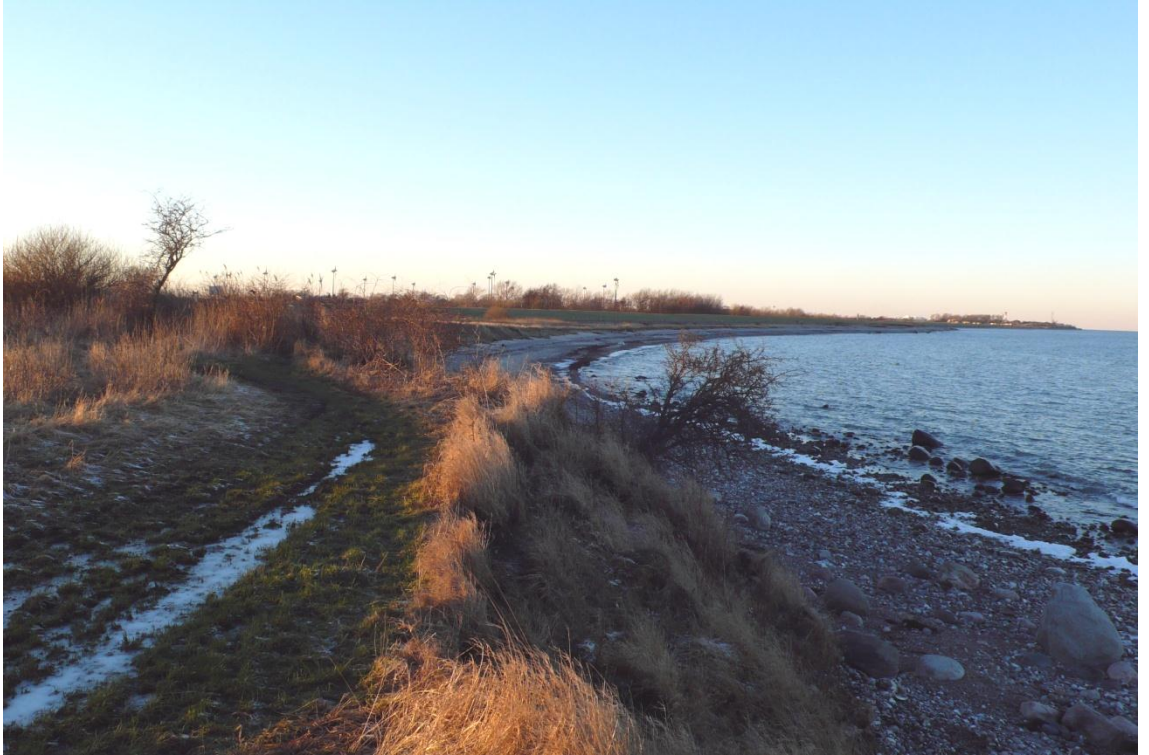
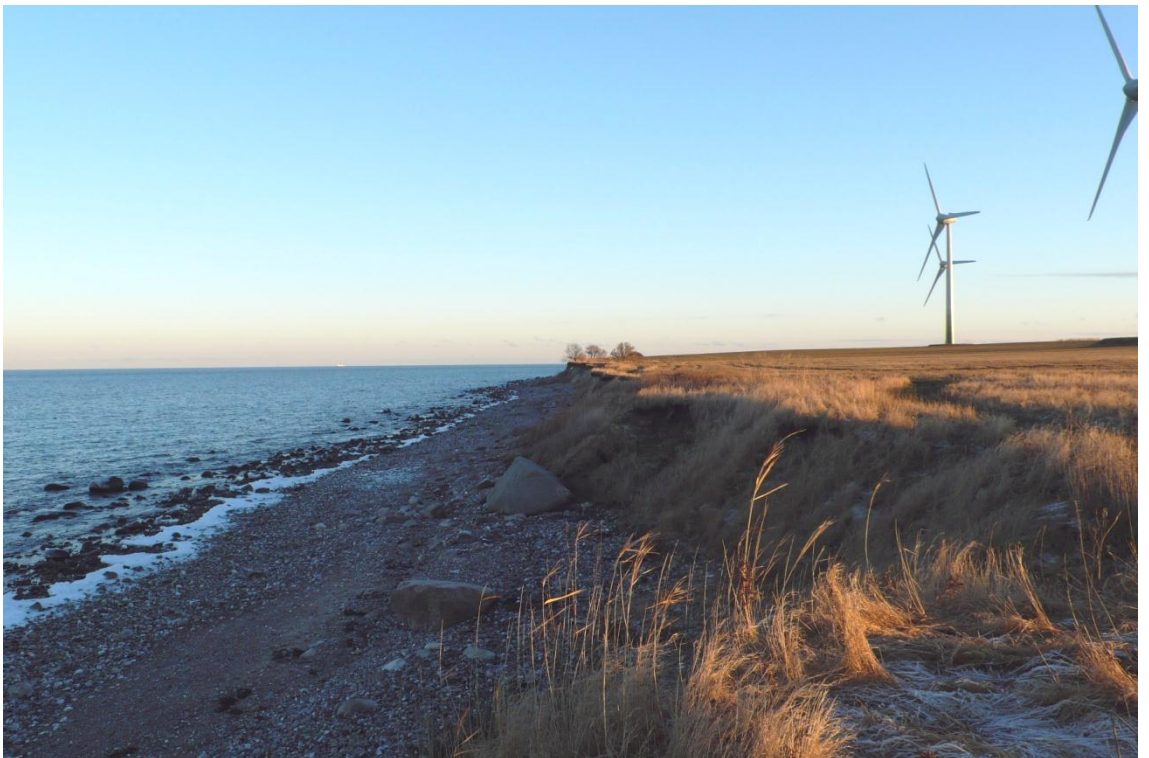
Figure 8.25 Coast off Klausdorf. Left: transition from dike to cliff. Right: till cliff, shingle beach with boulders, Klingen Wind farm in the hinterland

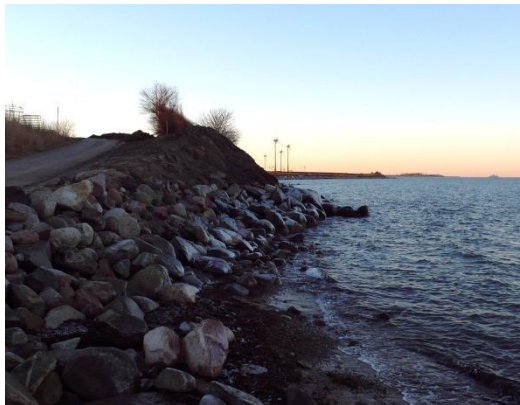
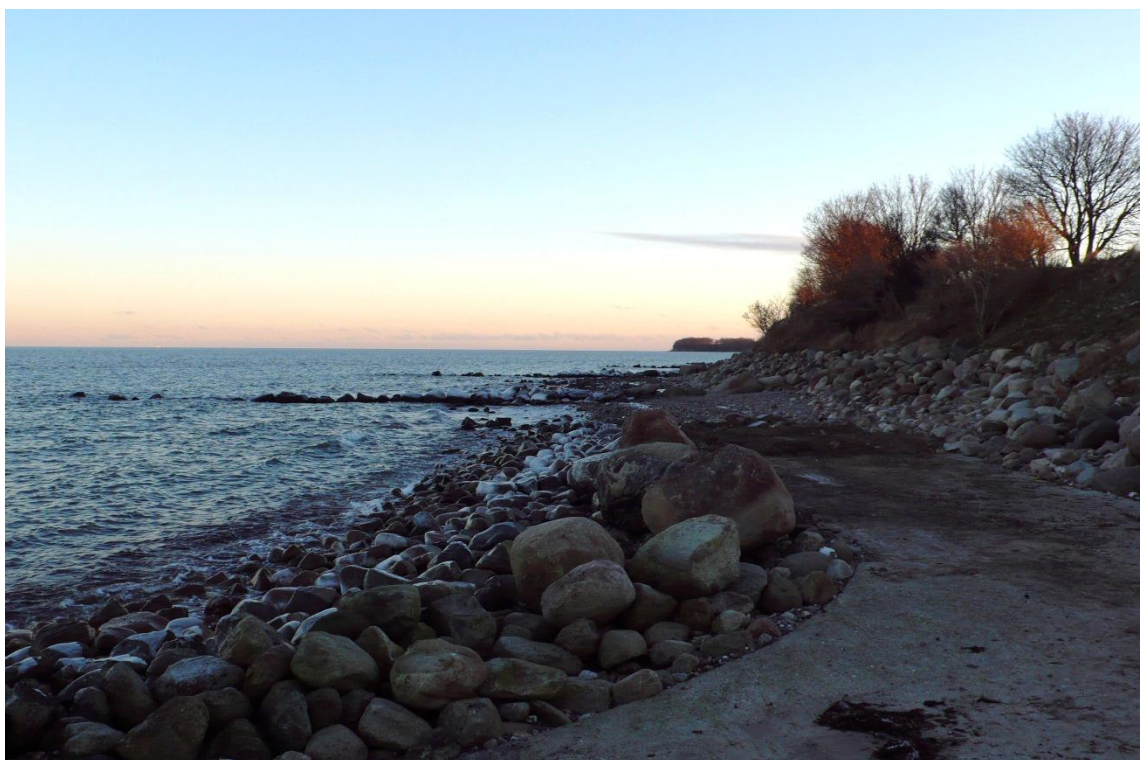
Figure 8.26 At Klausdorf Strand Camping Site. Upper left: headland protected by revetment. Upper right: boat ramp between two groynes. Lower: revetment and groynes towards SSE, shingle/boulder beach

The cliff and shingle/boulder type of beach continues further SSE-ward. There is a caravan site, Klausdorf Strand Camping site, 2 km further down the coast at a local headland. The access road to the beach at this location is protected by a revetment and some groynes; there is also a small boat ramp, see photos in Figure 8.26.
