FEHMARNBELT FIXED LINK HYDROGRAPHIC SERVICES (FEHY)

Marine Soil - Baseline

Coastal Morphology along Fehmarn and Lolland

E1TR0056 - Volume III

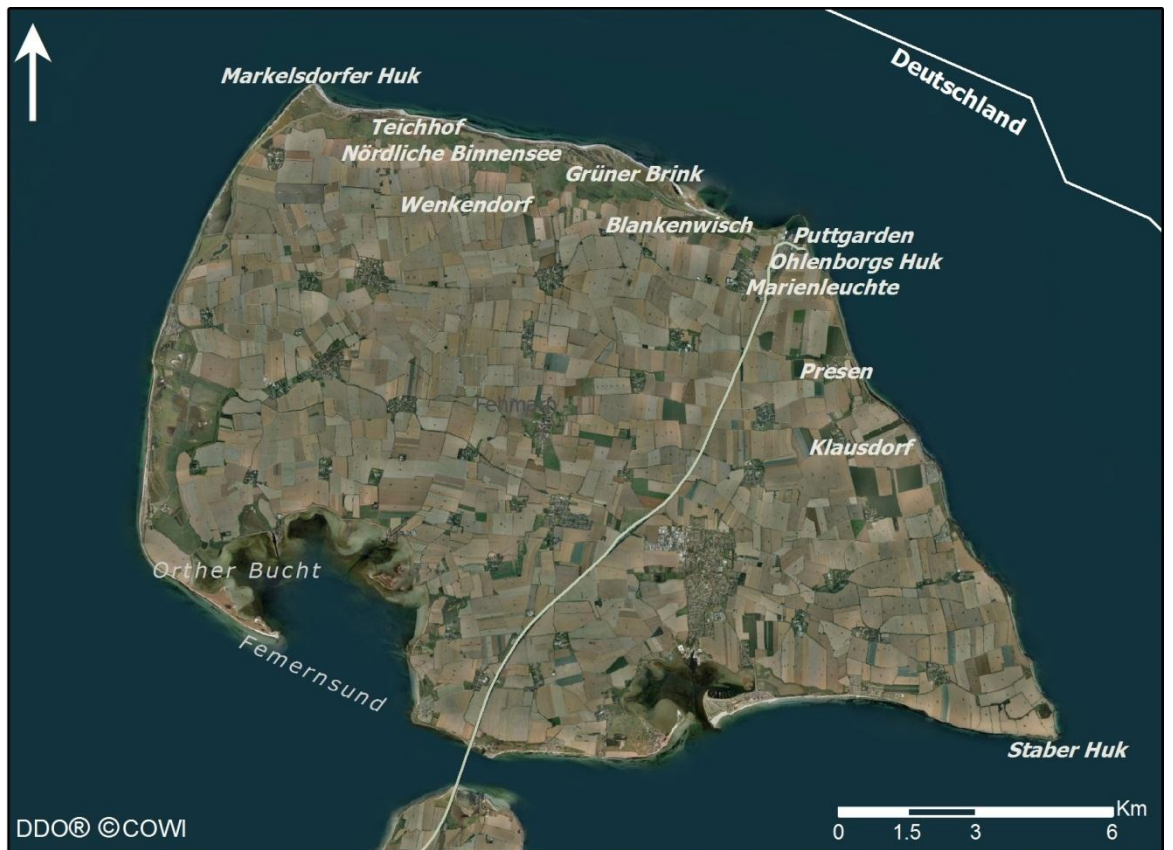
Figure 8.30 Aerial photo of Fehmarn today (DDO® 2008, © COWI). Note: Bieberehren-Klingen wind farm is not the correct name of the wind farm south of Presen.

The construction of the dikes at Fehmarn resulted therefore in a great loss of coastal lagoons and lowlands. The north- and west coast of Fehmarn were before the construction of the dike after the 1872-storm dominated by sand spits, barrier islands and shallow coastal lagoons, see historical maps of Fehmarn from 1852 and 1858 in Figure 8.28 and Figure 8.29. It is noted that the dike alignment is landwards of the Grüner Brink formation and Markelsdorfer Huk. Presently, these are the only remaining areas of this type of coast along the north coast of Fehmarn. An aerial photo of Fehmarn today is shown in Figure 8.30.

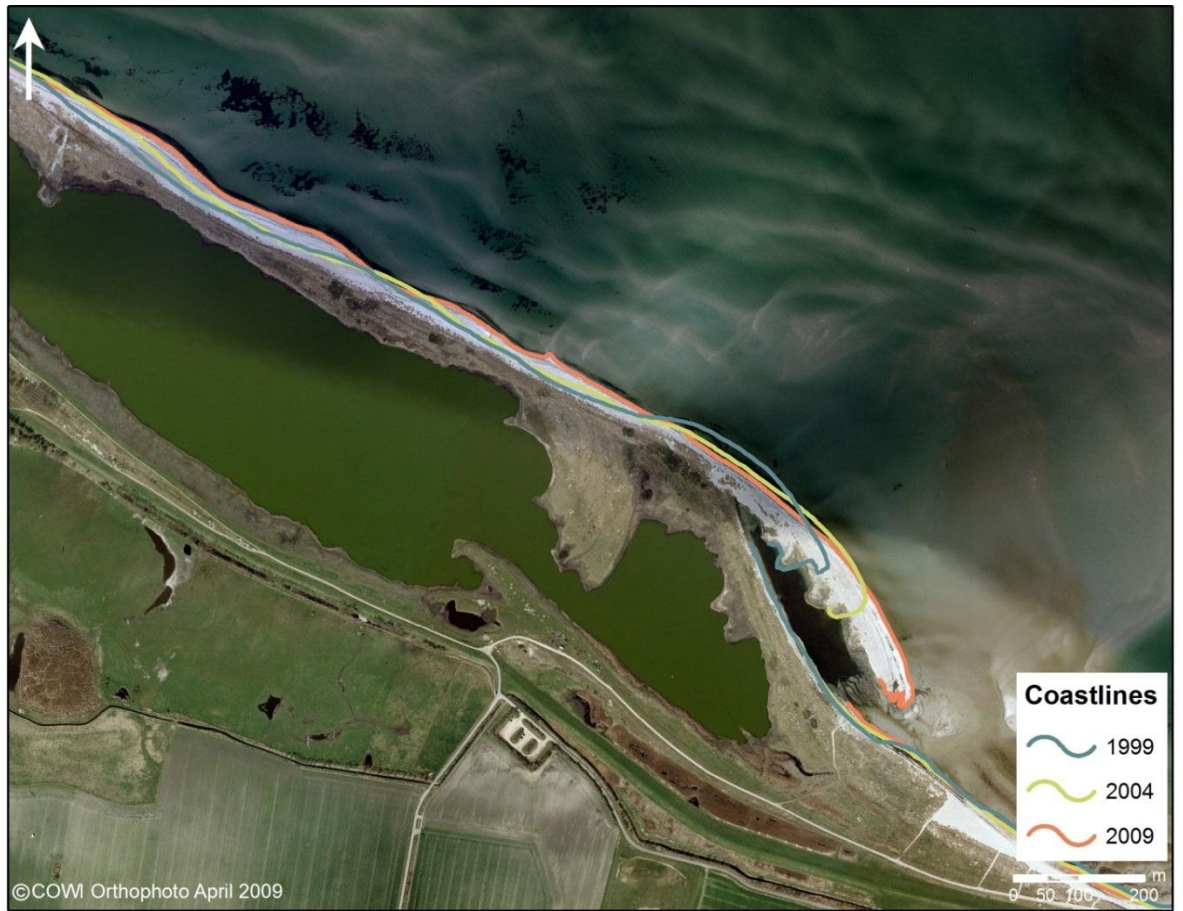
Figure 8.32 Development of the spit of Grüner Brink 1999-2009. Aerial photo from 2009 (©COWI Orthophoto April 2009)

The development of the Grüner Brink formation between 1999 and 2009 is seen in Figure 8.32 and Figure 8.33. The spit at the eastern part of the formation has increased about 200 m in length over the period 1999 to 2009, i.e. a growth rate of 20 m/year (Figure 8.32). The deposited volume of littoral drift to provide this migration of the spit is estimated to be about 6,000 m³. The width and height of the spit are estimated to about 60 and 0.5 m, respectively, see Table 8.1.

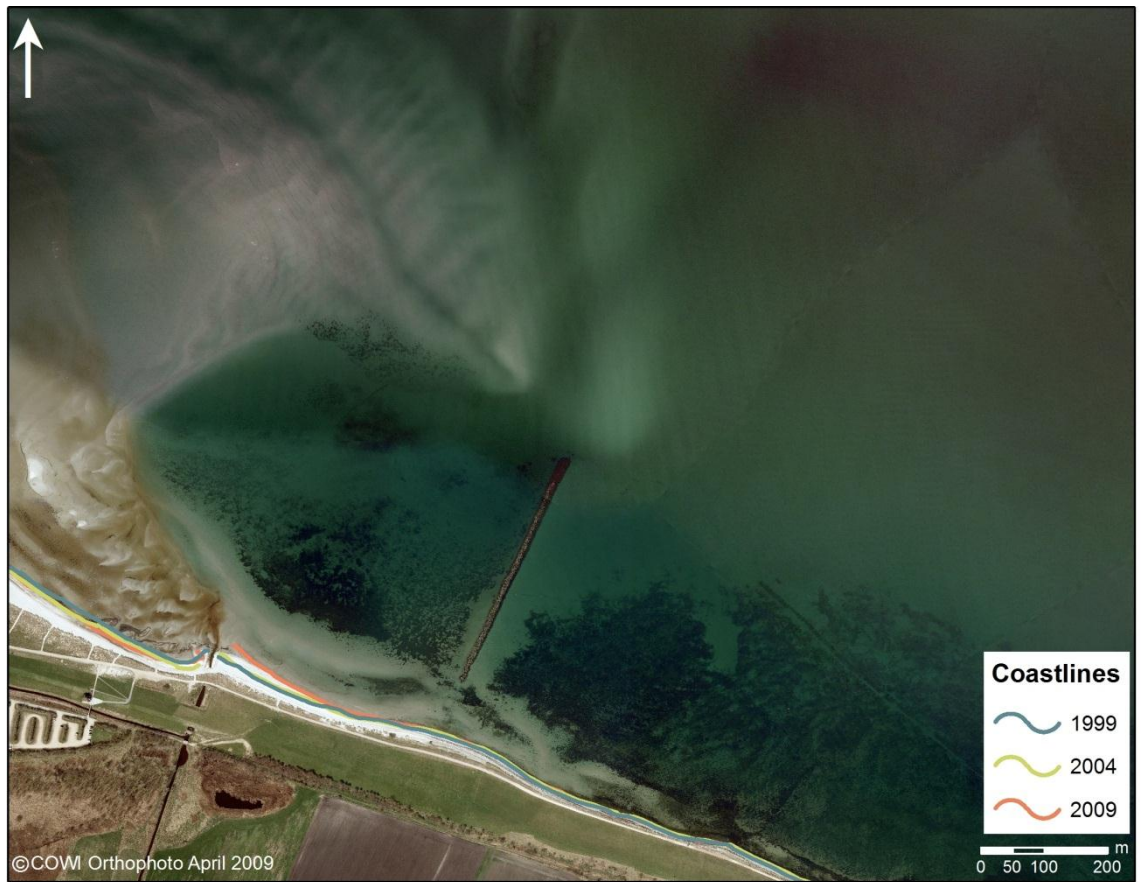
Figure 8.34 Recent shoreline evolution at the drainage outlet structure between Grüner Brink and the long detached groyne. Shorelines 1999, 2004 and 2009. Based on analysis of aerial photos, see Section 4.3. Aerial photo from 2009 (©COWI Orthophoto April 2009)

A local sand accumulation east of the structures protecting the water outlet from Blankenwisch is seen (Figure 8.34). The local accumulation is estimated by assuming the following: the shoreline has moved by about 25 m at the outlet decreasing to 0 m 350 m further east. The accumulation is assumed to take place across the active part the coastal profile assumed to be about 2.5 m height. The total accumu-

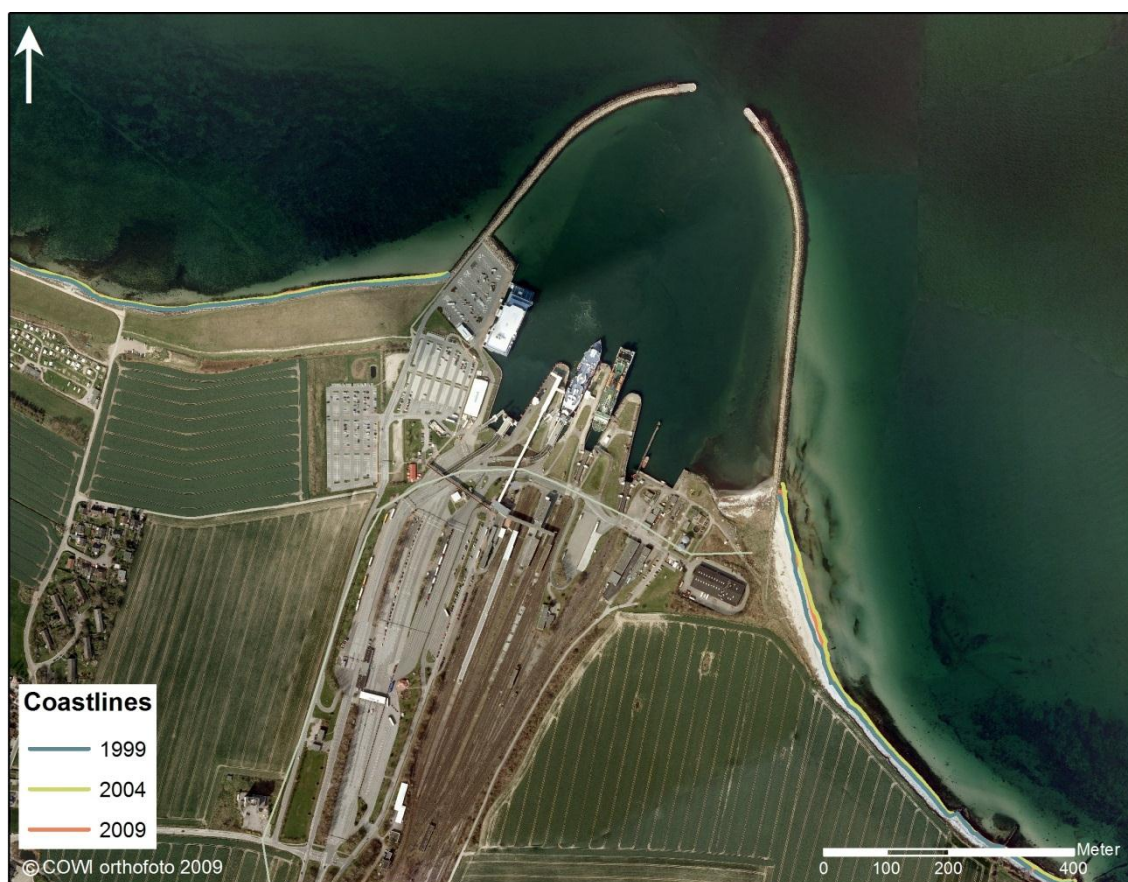
Figure 8.35 Recent shoreline evolution near Puttgarden. Shorelines 1999, 2004 and 2009. Based on analysis of aerial photos, see Section 4.3. Aerial photo from 2009 (©COWI Orthophoto April 2009)

There is no sandy beach along the coast immediately west of Puttgarden. There is only a minor accumulation of sand at the seabed in front of the dike in the corner between the coastline and the west breakwater, see the detail of the aerial photo from 2009 in Figure 8.35. The sand accumulation reaches only a short distance along the breakwater, which indicates that there is no transport of sand along the breakwater to the entrance area of the harbour. The lack of sedimentation confirms that there is no or very limited supply of sand to the area between Grüner Brink and Puttgarden, see discussion in Section 8.1.2 and Section 0.

A small sand accumulation has taken place between 1999 and 2004 in the transition between the east breakwater and the adjacent coast towards south, see Figure 8.35. The shoreline along this sand accumulation has been stable since 1999. An active sand transport zone can be seen along this sand accumulation and half way along the breakwater; however, the transport zone does not reach the tip of the breakwater.

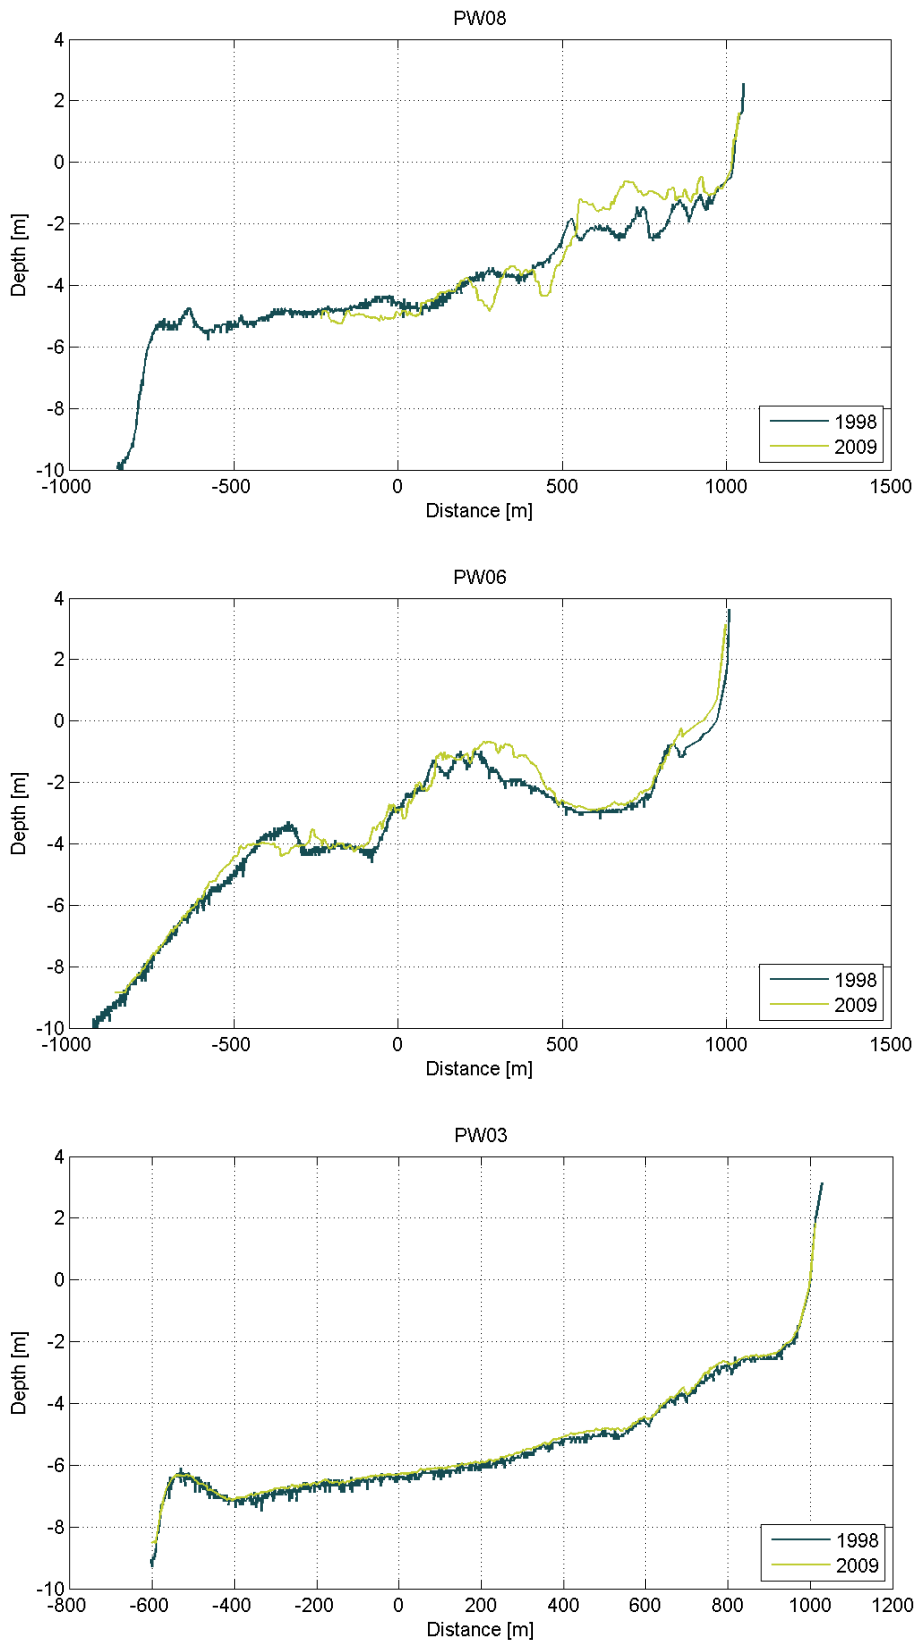
Figure 8.37 Coastal profiles PW08, PW06 and PW03 west of Puttgarden, 1998 and 2009. Depths relative to DVR90

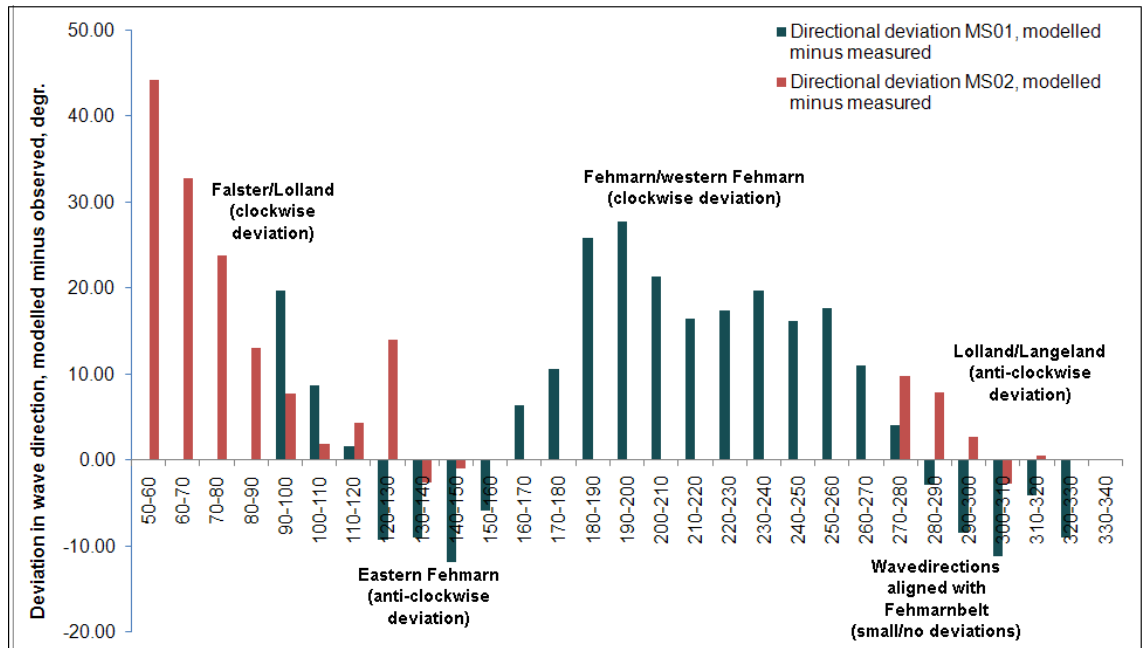
Figure 8.43 Deviations between modelled and measured wave directions at measuring station MS01 and MS02. The analysis is made for measured wave heights >0.8 m at MS01 and >1 m at MS02

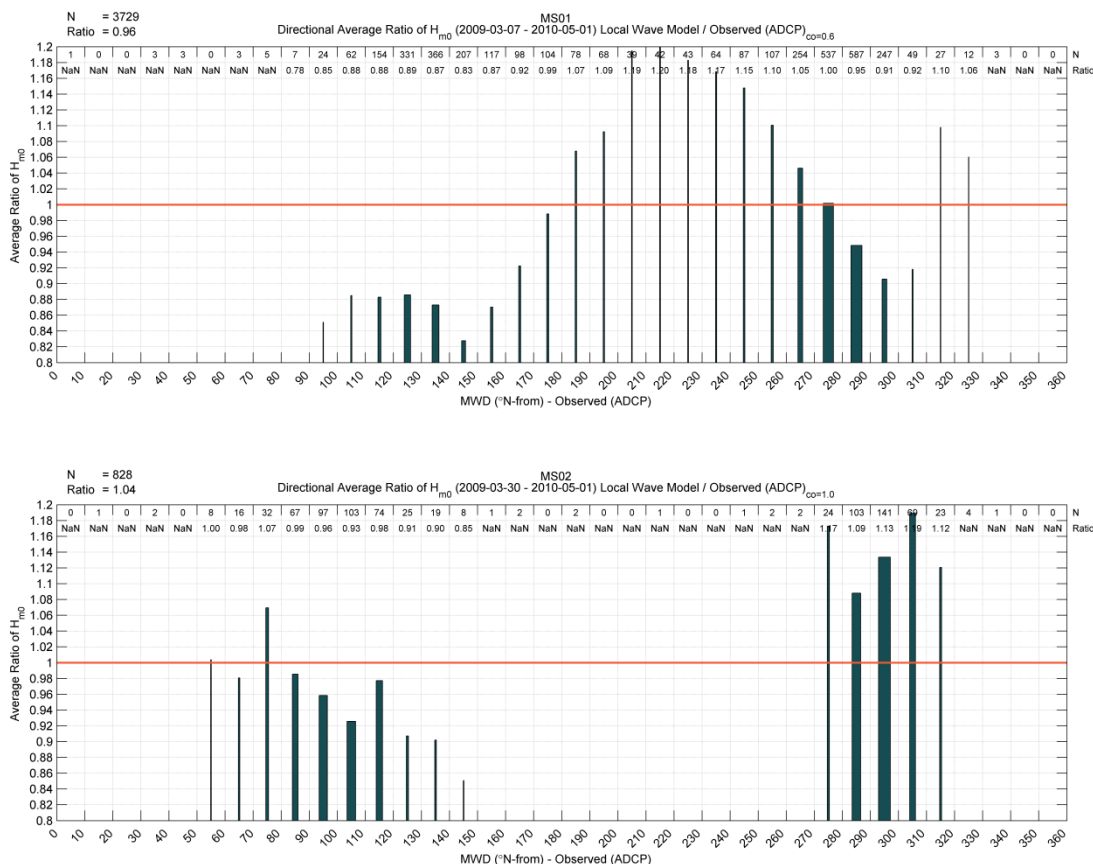
Figure 8.45 Deviations between modelled and measured wave heights at measuring station MS01 and MS02. The analysis is made for measured waves >0.8 m at MS01 and >1m at MS02

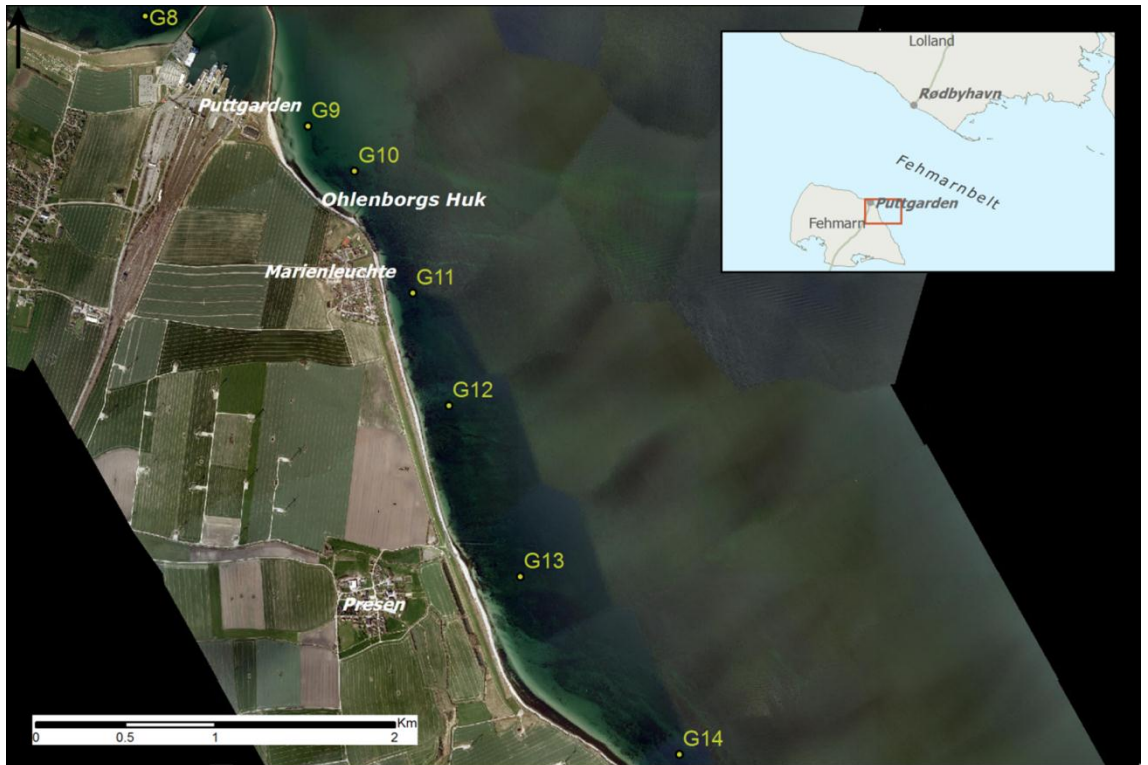
Figure 8.49 Bathymetry west of Puttgarden

It is seen that the waves east of and along Grüner Brink are divided in two distinct directional climates. The main waves are from NW, i.e. at a large angle with the orientation of the shoreline (the orientation is defined as the normal to the shoreline) and the secondary waves are from ENE. This very oblique wave approach of the predominant waves is responsible for the development of Grüner Brink. Typical wave patterns for the area west of Puttgarden are presented in Figure 8.47 and Figure 8.48 for waves from NW and SE, respectively. The corresponding bathymetry is presented in Figure 8.49.

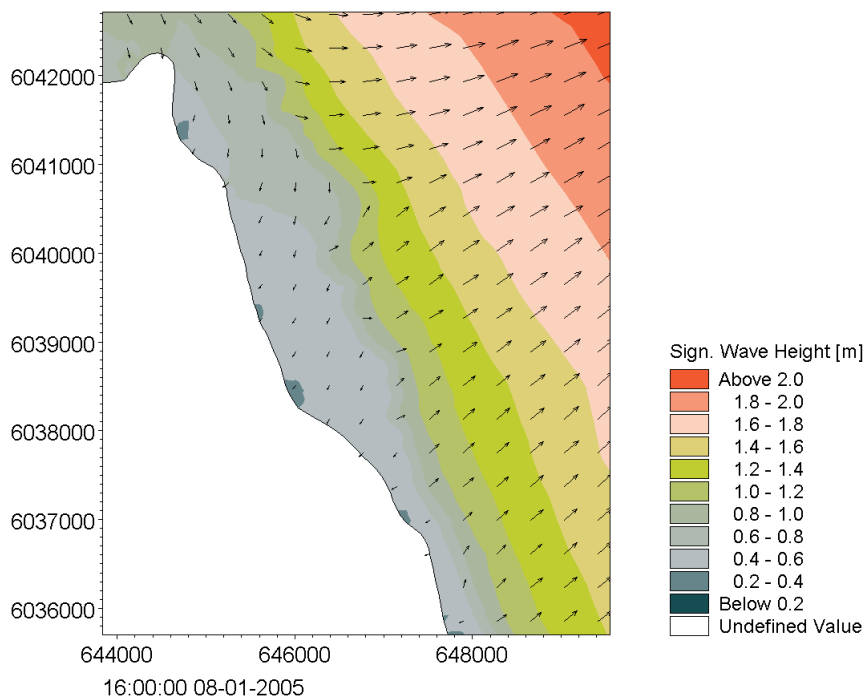
Figure 8.51 Typical wave pattern SE of Puttgarden for NW-erly waves. Date of situation: 8.01.2005

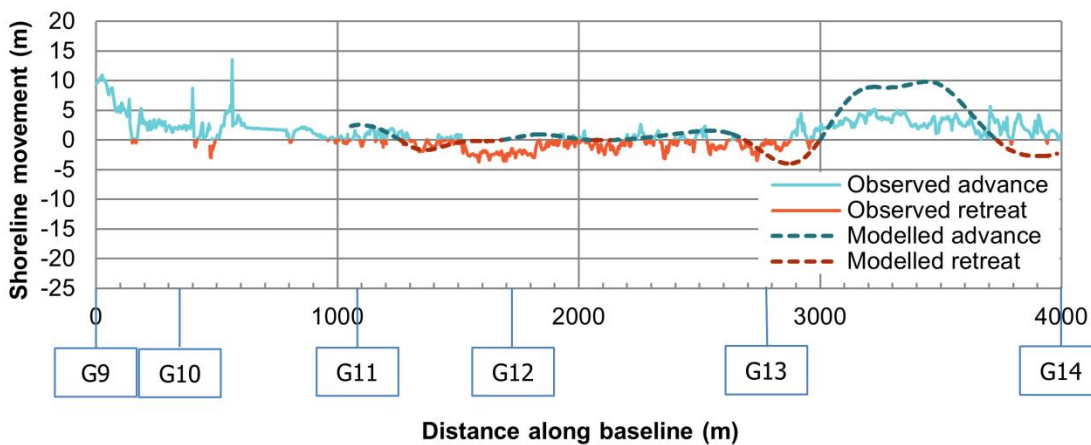
Figure 8.57 Comparison of observed shoreline changes 1999-2009, and predicted shoreline changes for 10 years by the model (average conditions 1989-2010) east of Puttgarden. Aerial photo from 2009 (©COWI Orthophoto April 2009). Note: Bieberehren-Klingen wind farm is not the correct name of the wind farm south of Presen.

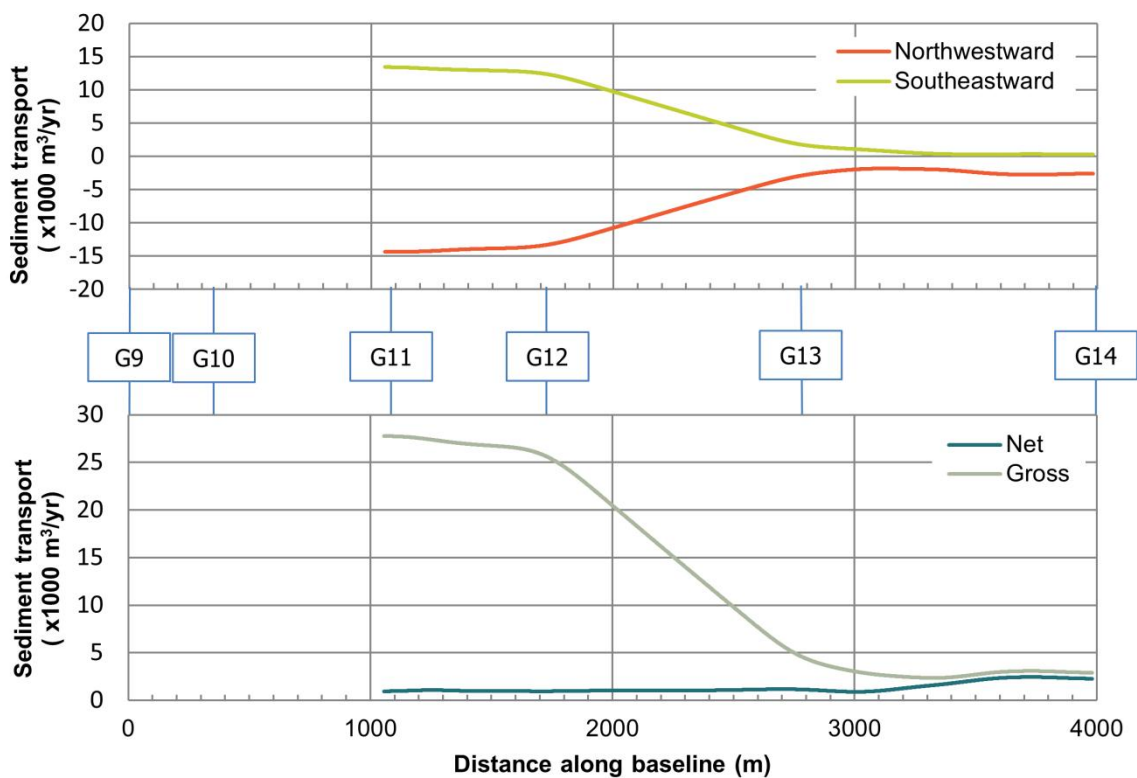
Figure 8.60 Littoral drift transport rates east of Puttgarden. Average year 1989-2010. Central figure: northwest- and southeast going transport conditions. Lower figure: net and gross transport rates. Aerial photo from 2009 (©COWI Orthophoto April 2009). Note: Bieberehren-Klingen wind farm is not the correct name of the wind farm south of Presen.

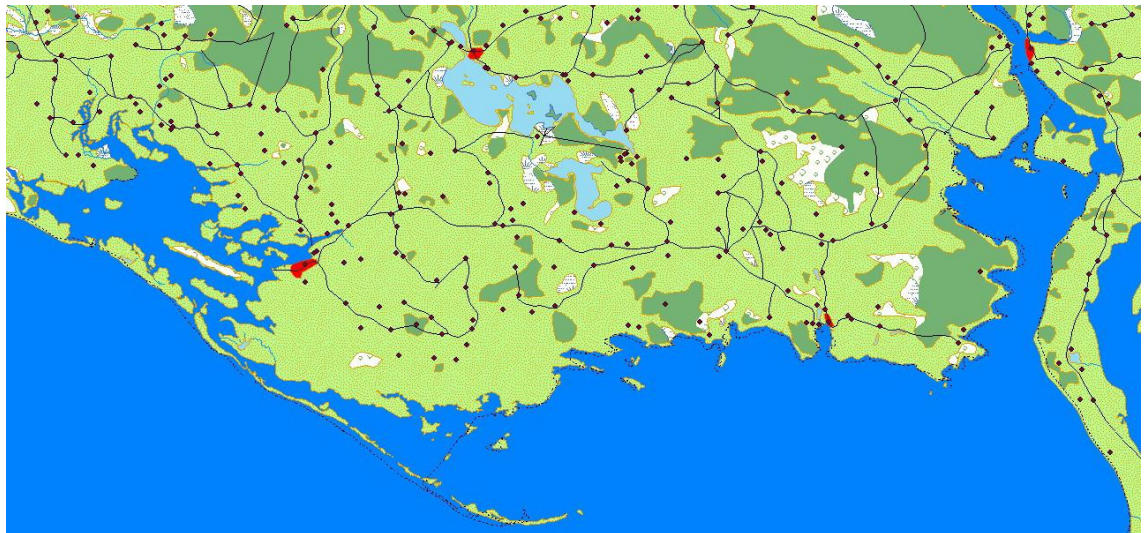
Figure 9.1 *Historical map for the south coast of Lolland for the period 1763-1805 by the Scientific Society (Videnskabernes Selskab (Geographical Institute at Copenhagen University)). The alignment of the dike is also indicated*

The dike was constructed in response to the very extreme storm surge event in 1872, where the entire southern Lolland was flooded. Before the construction of the dike the south coast of Lolland was characterised by a series of islands aligned with today's shoreline. These islands constituted a barrier between Fehmarn Belt and sheltered coastal lagoons behind the barrier. Rødby Fiord and Rødsand Lagoon were the most prominent coastal lagoons. Historical maps show they were connected by a strait sheltered by the row of islands. The barrier islands had a similar nature as the present Hyllekrog spit, see Figure 9.1.

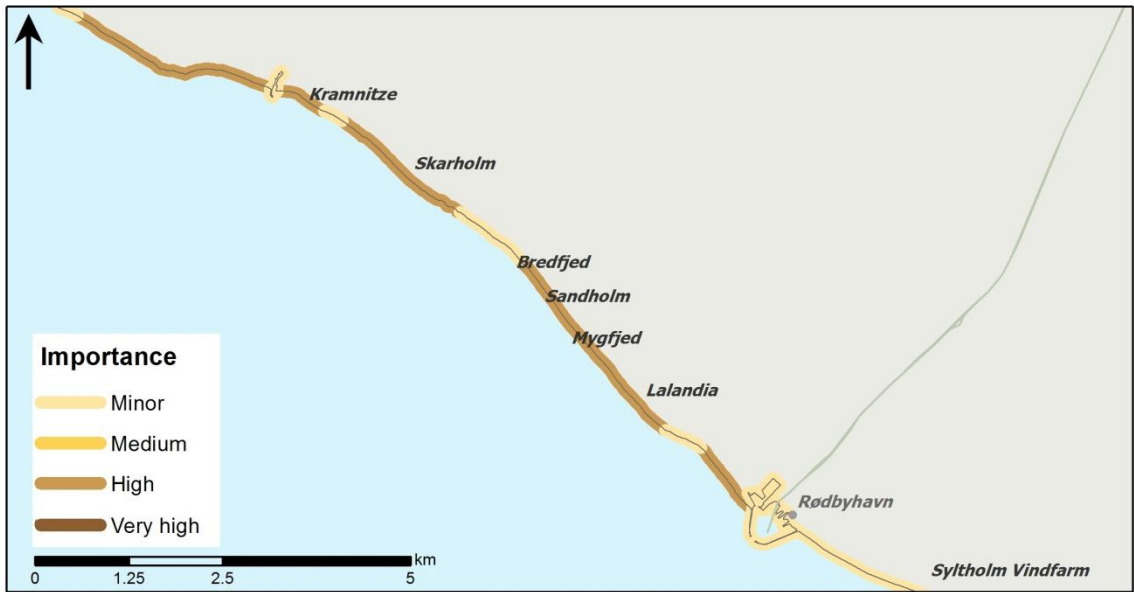
Figure 10.1 Importance criteria for sub-factor Marine Soil component Coastal Morphology along the Lolland coast

The importance levels assigned to coastal sections within the investigation area on Lolland are seen in Figure 10.1 and similarly in Figure 10.2 for Fehmarn.

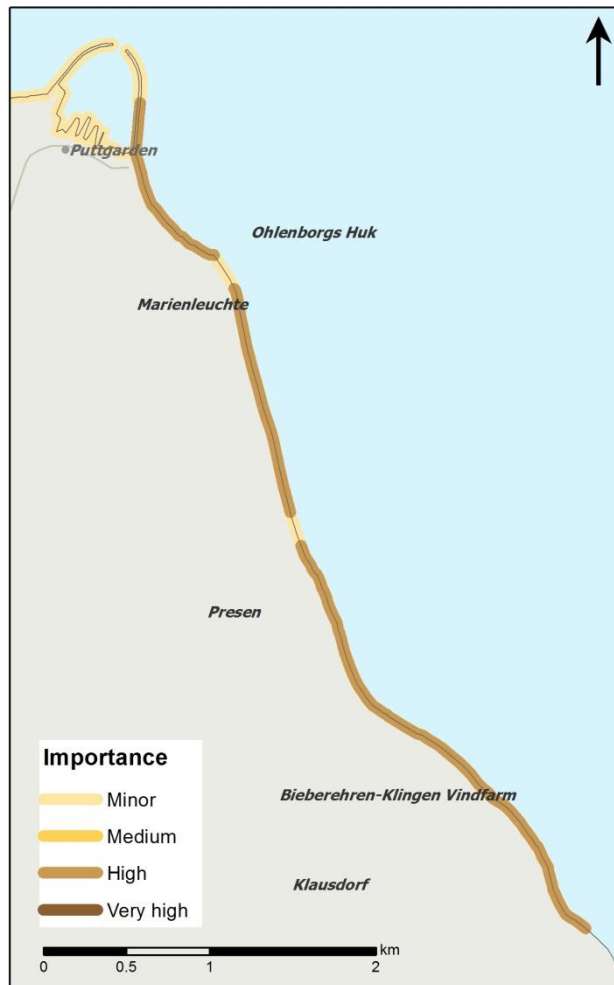
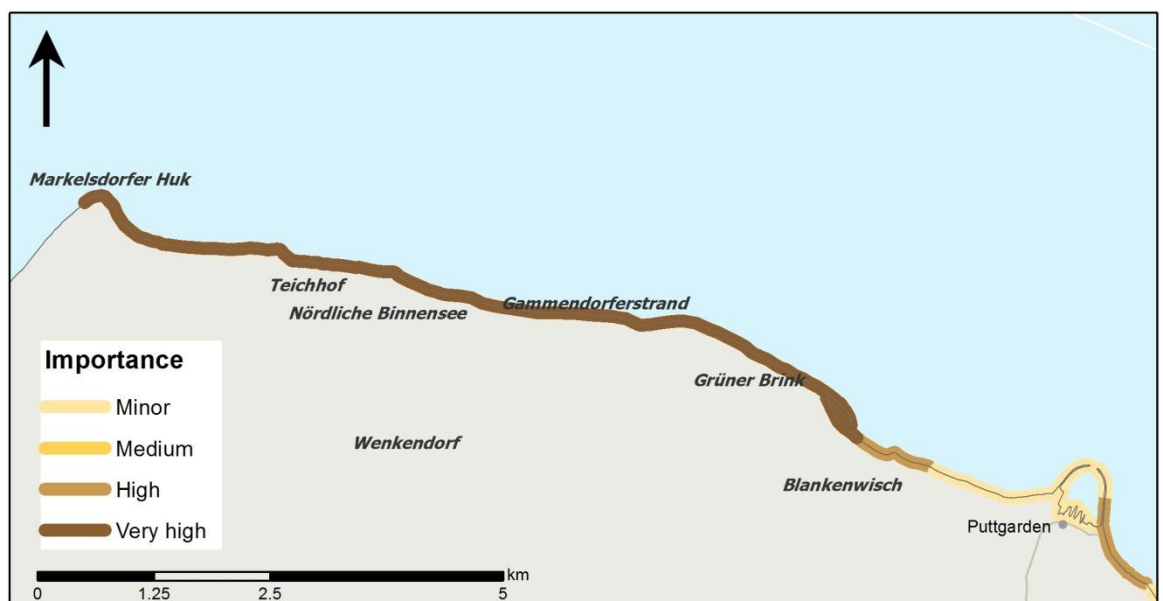
Figure 10.2 Importance criteria for the Marine Soil component Coastal Morphology along the Fehmarn coast. Note: Bieberehren-Klingen wind farm is not the correct name of the wind farm south of Presen.
